# STRUCTURAL AUDIT REPORT

NOOR CO-OP. HOUSING SOCIETY LTD,

VASHI,

**Taamra Engineering Consultants Private Limited**

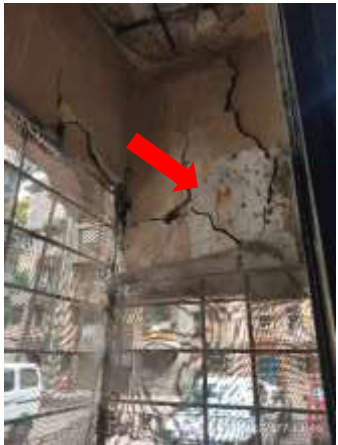
| h) | External | Chajja | | | Major structural cracks | Refer attachment I : TYPE VI |

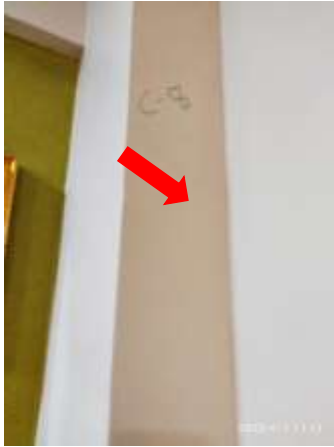
| k) | Bedroom | Column<br>C 8 | | | Column with<br>hollow sound | Refer attachment<br>I : TYPE XVII |

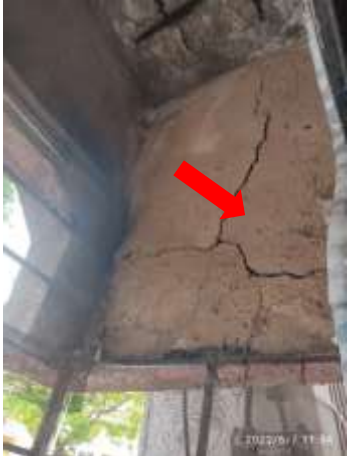
| n) | Bedroom | Chajja | | | Major structural crack | Refer attachment I : TYPE VI |

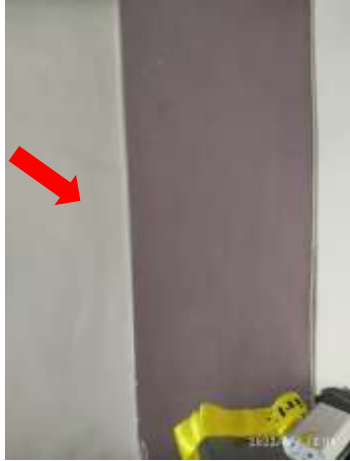
| b) | Living Room | Column C 4 | | | Hollow sound at bottom | Refer attachment I : TYPE XVII |

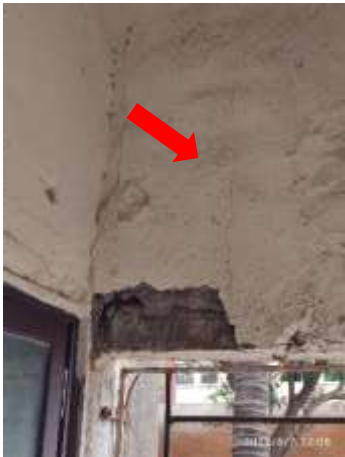
| i) | Bedroom | Chajja | | | Major Structural crack | Refer attachment I : TYPE VI |

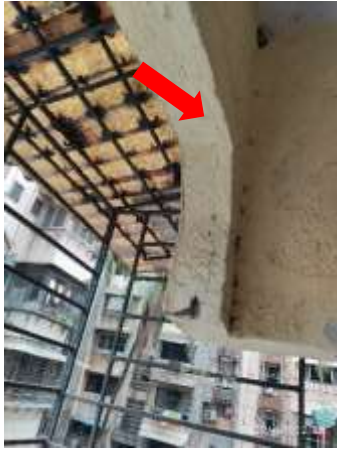
| j) | External | chajja | | | Plaster crack | Refer attachment<br>I : TYPE V |

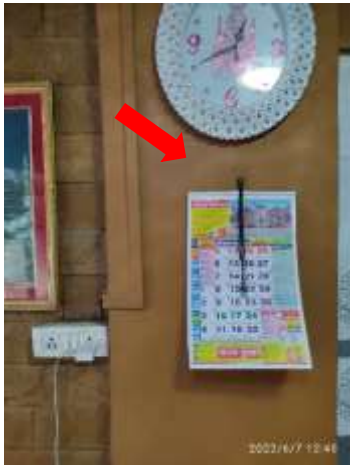
| a) | Living Room | Column C 20 | | | Column with hollow sound | Refer attachment I : TYPE XVII |

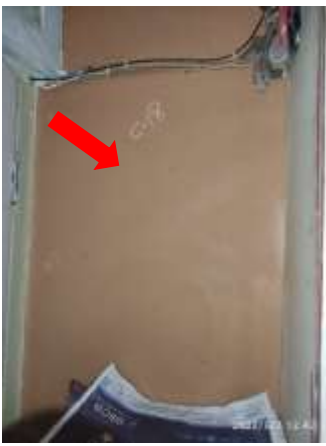
| e) | Living room | Column C 18 | | | Column with hollow sound | Refer attachment I : TYPE XVII |

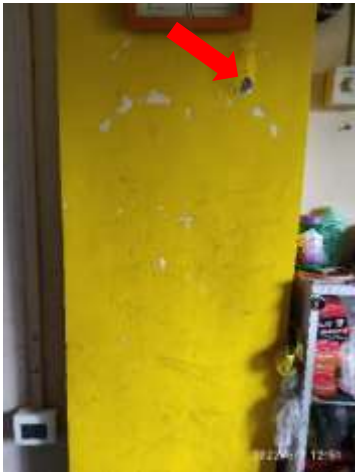
| c) | Living room | Column C 1 | | | Column with hollow sound | Refer attachment I : TYPE XVII |

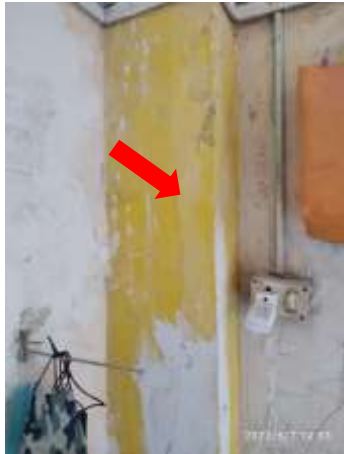
| f) | Bedroom | Column C 8 | | | Structural crack, Column with hollow sound | Refer attachment I : TYPE VI, TYPE XVII |

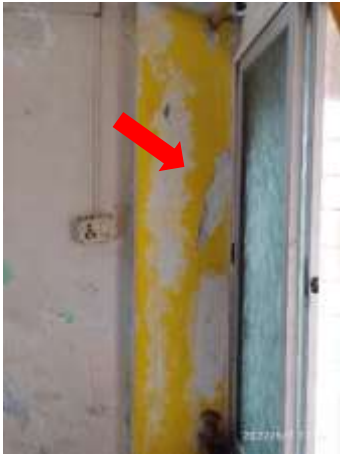
| j) | Bedroom | Column C 7 | | | Major structural crack | Refer attachment<br>I : TYPE VI |

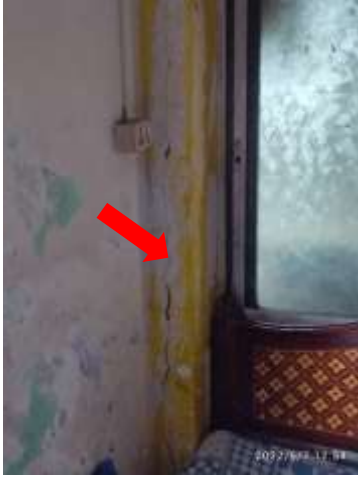
| l) | Bedroom | Column C 7 | | | Major structural crack | Refer attachment I : TYPE VI |

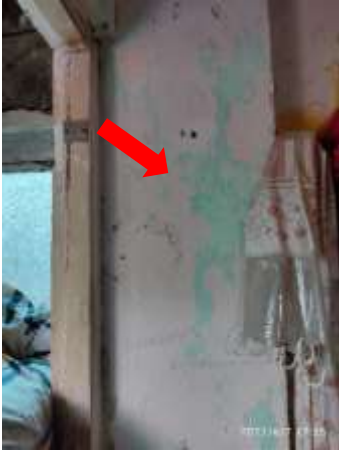
| n) | Bedroom | Column C 6 | | | Plaster crack, Column with hollow sound | Refer attachment I : TYPE V, TYPE XVII |

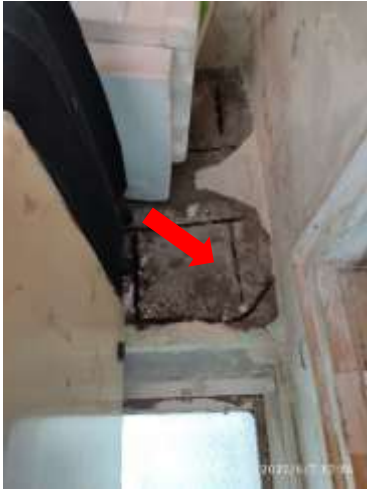
| r) | Bedroom Balcony | Corbel | | | Major structural crack (Plaster spall off, Corroded) | Refer attachment I : TYPE VI |

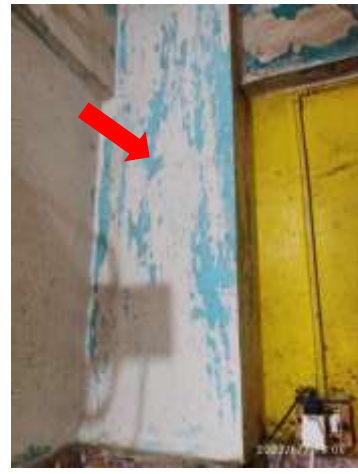
| aa) | Kitchen | Column C 5 | | | Column with hollow sound | Refer attachment I : TYPE XVII |

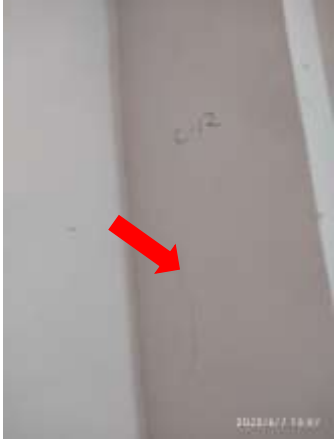
| i) | Bedroom | Column C 12 | | | Structural crack | Refer attachment I : TYPE VI |

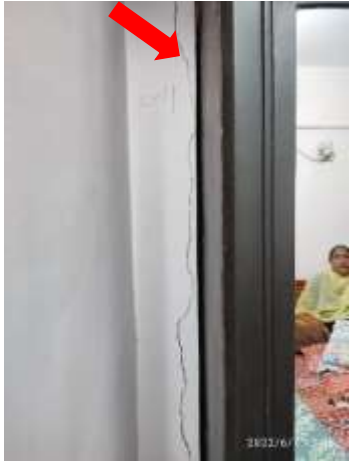
| j) | Bedroom | Column C 11 | | | Major structural crack | Refer attachment I : TYPE VI |

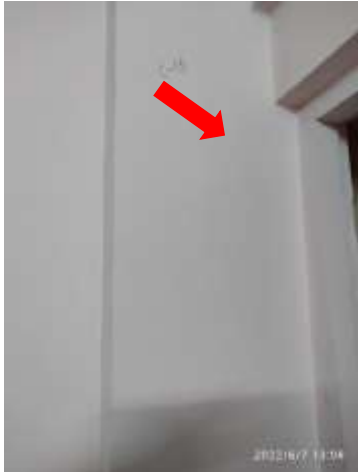
| k) | Bedroom | Column C 13 | | | Column with hollow sound at bottom | Refer attachment I : TYPE XVII |

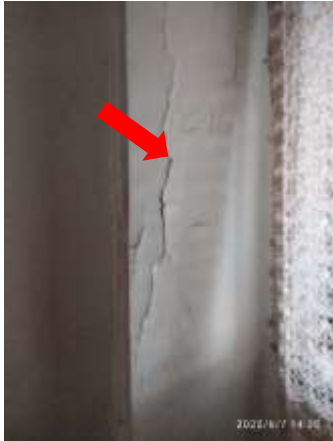
| j) | Bedroom | Column<br>C 16 | | | Structural<br>crack, Column<br>with hollow<br>sound | Refer attachment<br>I : TYPE VI, TYPE<br>XVII |

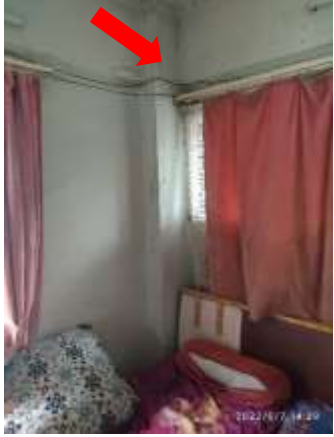
| k) | Bedroom | Column C 16 | | | Structural crack, Column with hollow sound | Refer attachment I : TYPE VI, TYPE XVII |

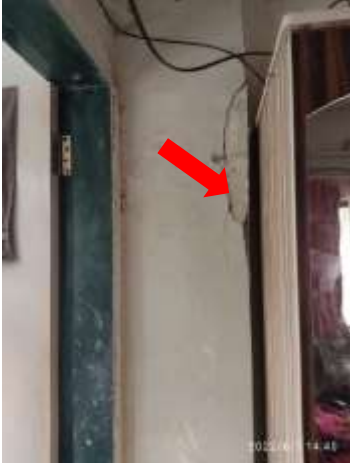
| m) | Bedroom | Column C 17 | | | Major structural crack, Column with hollow sound | Refer attachment I : TYPE VI, TYPE XVII |

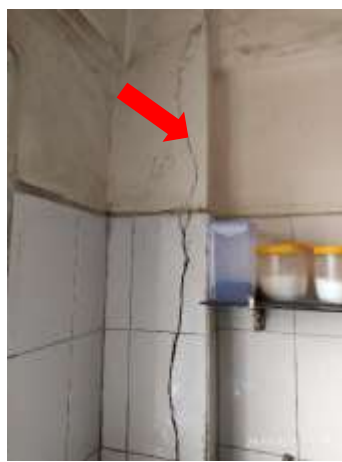
| e) | Kitchen | Column C 5 | | | Major structural crack | Refer attachment I : TYPE VI |

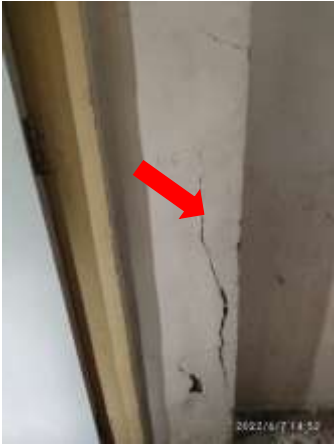
| l) | Bedroom | Column C 6 | | | Major structural crack | Refer attachment I : TYPE VI |

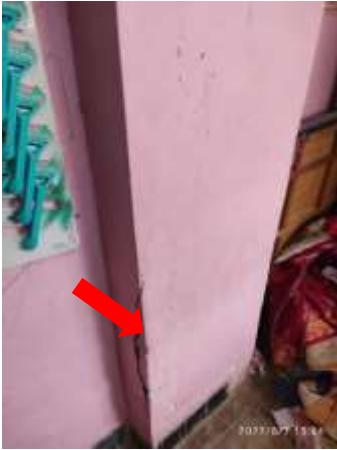
| n) | Bedroom | Column C 13 | | | Major structural crack | Refer attachment I : TYPE VI |

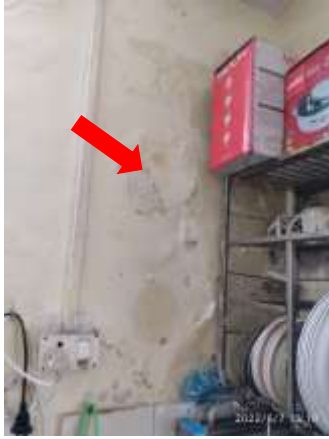
| b) | Kitchen | Wall | | | Seepages from Adjacent Bathroom | Refer attachment I : TYPE XI |

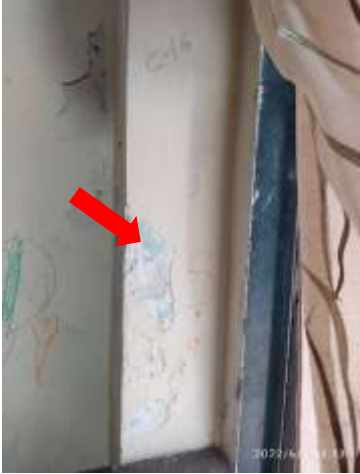
| h) | Bedroom | Column<br>C 16 | | | Column with<br>hollow sound | Refer attachment<br>I : TYPE XVII |

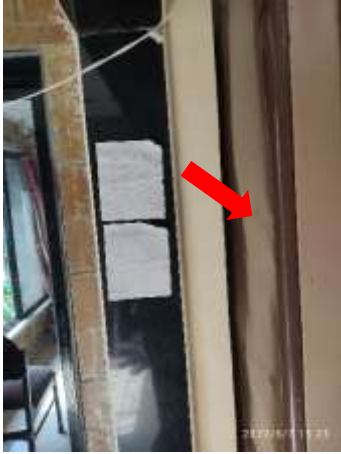
| b) | Living Room | Column C 2 | | | Column with hollow sound | Refer attachment I : TYPE XVII |

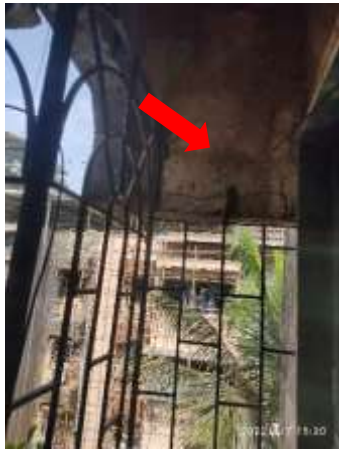
| e) | Bedroom | Chajja | | | Structural crack | Refer attachment I : TYPE VI |

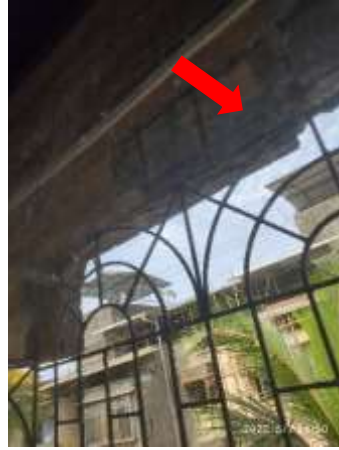
| f) | Bedroom | Chajja | | | Structural crack<br>(Plaster spall off) | Refer attachment I : TYPE VI |

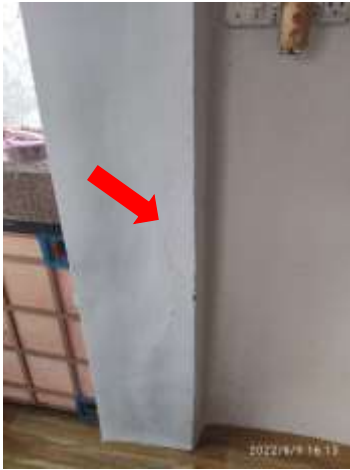
| f) | Bedroom 1 | Column C 18 | | | Structural crack | Refer attachment I : TYPE VI |

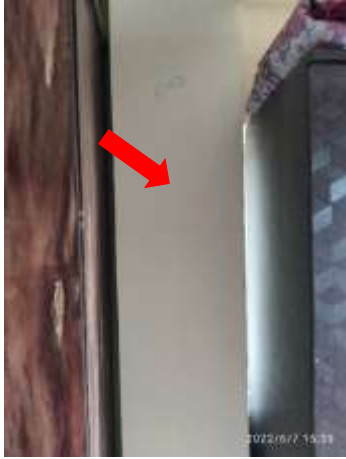
| j) | Bedroom<br>1 | Column<br>C 23 | | | Column with<br>hollow sound | Refer attachment<br>I : TYPE XVII |

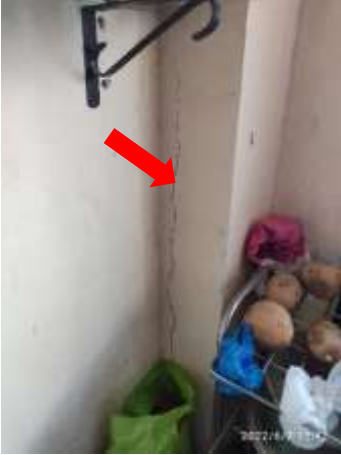
| q) | Kitchen | Column | | | Structural<br>crack | Refer attachment<br>I : TYPE VI |

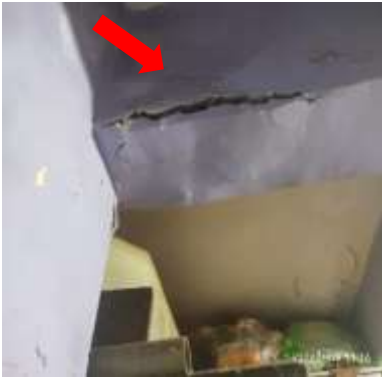
| n) | Passage | Beam & Ceiling | | | Major Structural crack | Refer attachment 1-TYPE VI |

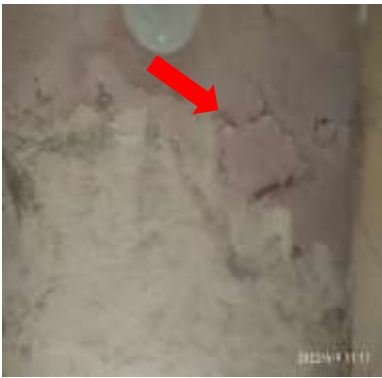
| p) | Toilet | Sunk | | | Plaster crack, Seepages from Flat no 2/5 | Refer attachment 1-TYPE V, TYPE XI |

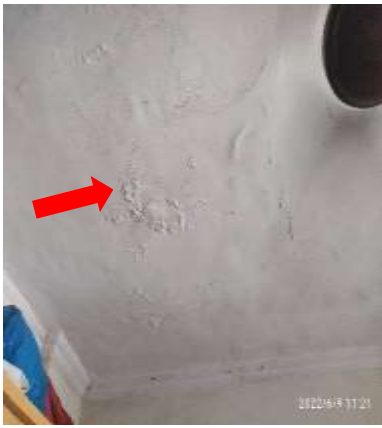
| b) | Bedroom | Ceiling | | | Ceiling cracks & Seepages from Flat no 2/6 Bathroom | Refer attachment 1-TYPE XIII, TYPE XI |

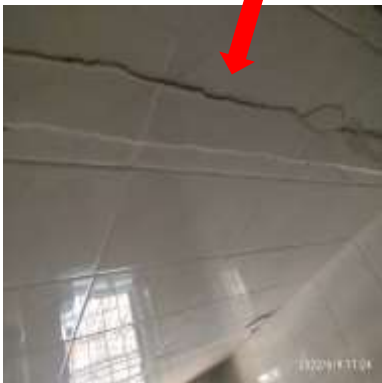
| h) | Bathroom | Loft | | | Tile crack | Refer attachment 1-TYPE I |

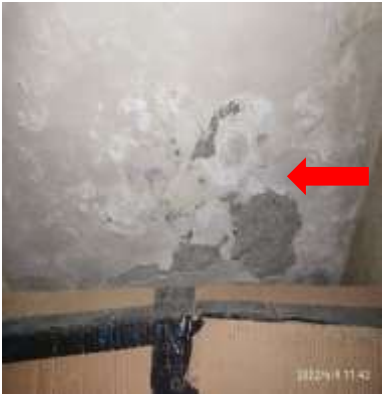
| r) | Passage | Ceiling | | | Seepages<br>from flat no<br>2/8 | Refer attachment<br>1-TYPE XI |

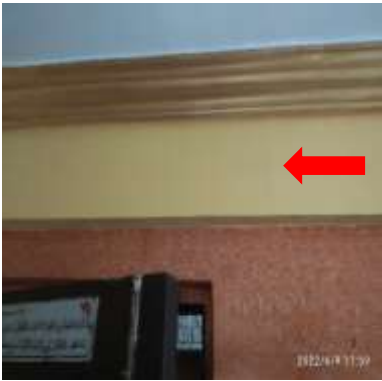
| a) | Living Room | Beam | | | Plaster crack | Refer attachment<br>1-TYPE V |

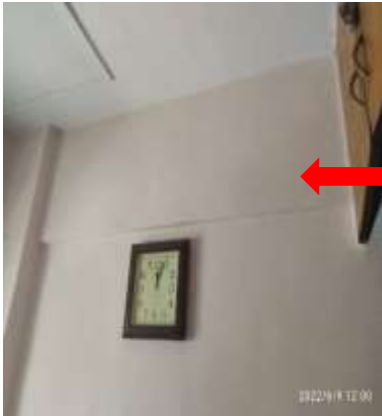
| c) | Bedroom | Beam | | | Plaster with<br>hollow sound | Refer attachment<br>1-TYPE XVIII |

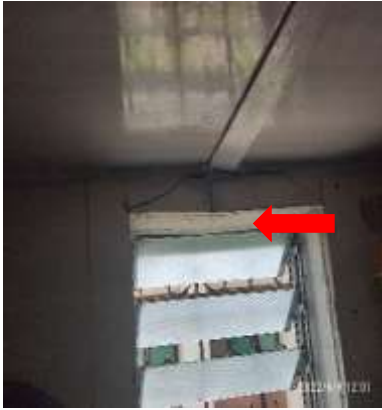
| d) | Bathroom | Lintel Beam | | | Window lintel crack | Refer attachment 1-TYPE XIX |

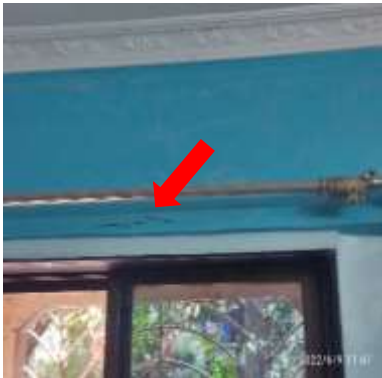
| a) | Bedroom | Lintel Beam | | | Window top lintel found with crack, Structural crack | Refer attachment 1-TYPE XIX, TYPE VI |

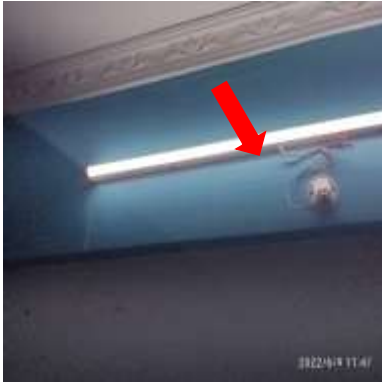
| c) | Bedroom | Beam | | | Plaster crack,<br>Plaster with<br>hollow sound | Refer attachment<br>1-TYPE V, TYPE<br>XVIII |

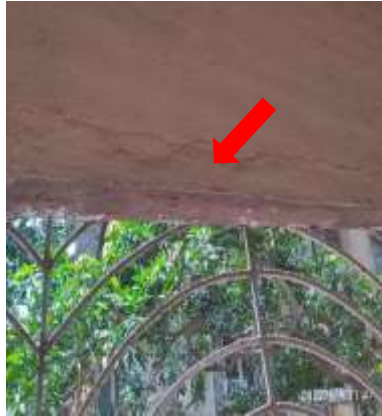
| e) | Bedroom | Chajja | | | Plaster crack | Refer attachment<br>1-TYPE V |

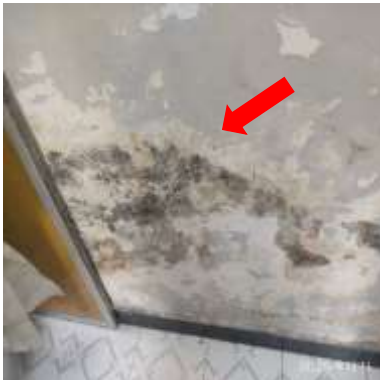
| s) | Bedroom | Wall | | | Capillary<br>action marks<br>from adjacent<br>Bathroom | Refer attachment<br>1-TYPE IV |

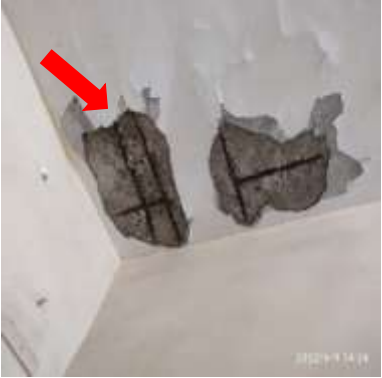
| a) | Living Room | Ceiling | | | Major structural crack (reinforcement Corroded & Plaster spall off) | Refer attachment 1-TYPE VI |

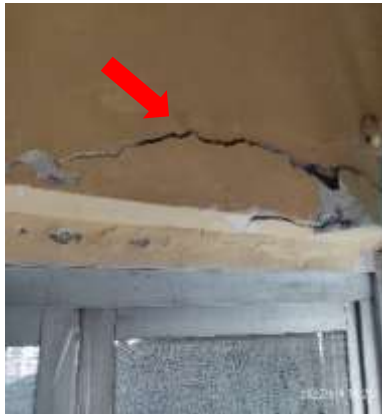
| l) | Bedroom Balcony | Beam | | | Major structural crack (Need to be support immediately) | Refer attachment 1-TYPE VI |

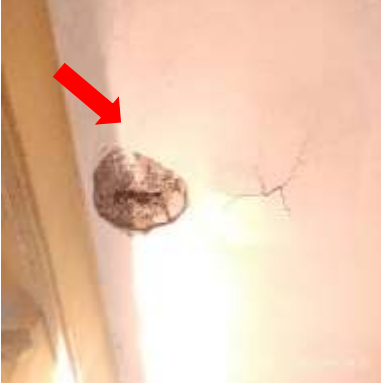
| o) | Bathroom | Ceiling | | | Ceiling crack<br>(Reinforce-<br>ment corroded,<br>Plaster spill<br>off) | Refer attachment<br>1-TYPE XIII |

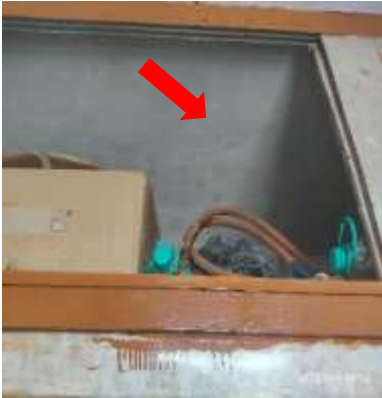
| c) | Kitchen | Loft | | | Seepage<br>Marks | Refer attachment<br>1-TYPE III |

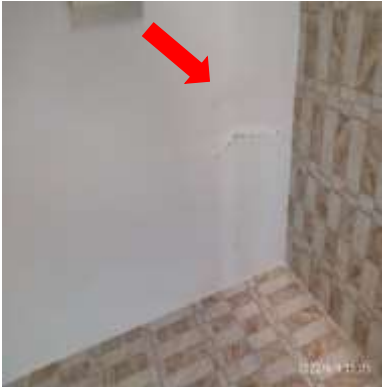
| d) | Bedroom Balcony | Ceiling | | | Ceiling cracks | Refer attachment 1-TYPE XIII |

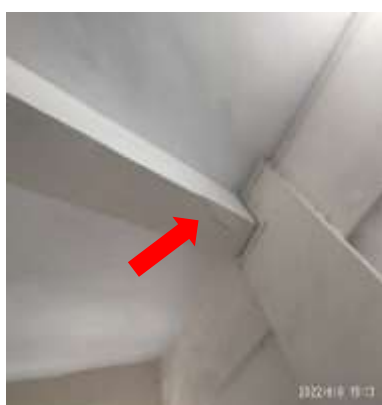
| a) | Living Room | Beam | | | Structural crack | Refer attachment 1-TYPE VI |

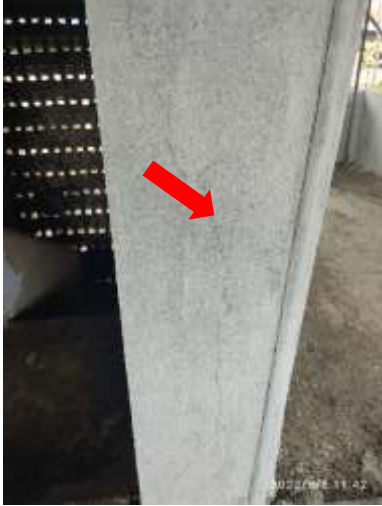
| h) | Terrace | Column | | | Structural<br>crack | Refer attachment<br>1-TYPE VI |

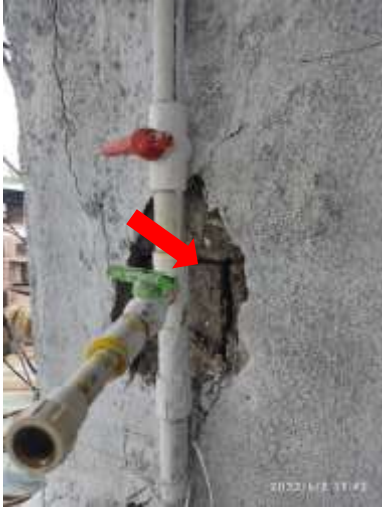
| q) | Terrace | Column | | | Major structural crack (plaster spall off) | Refer attachment 1-TYPE VI |

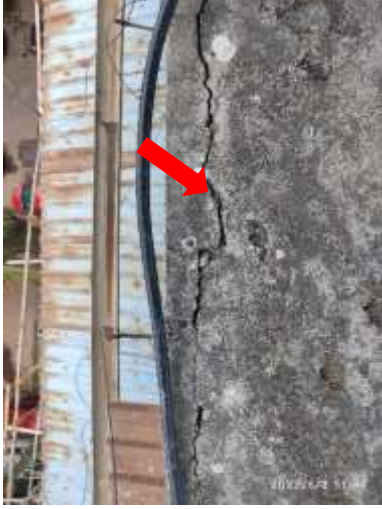
| y) | Terrace | Water Tank Floor | | | Structural crack | Refer attachment 1-TYPE VI |

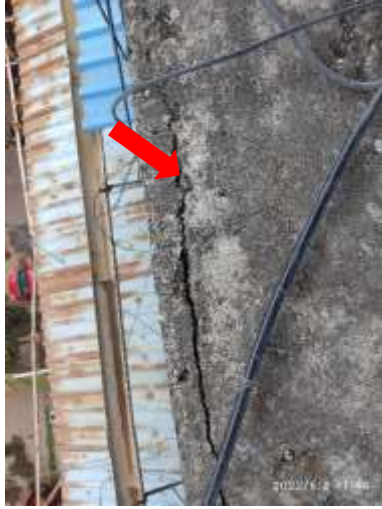
| z) | Terrace Water tank | Floor | | | Structural crack | Refer attachment 1-TYPE VI |

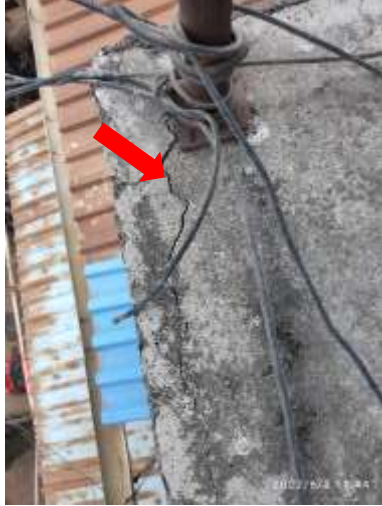
| aa) | Water tank | Floor | | | Structural crack | Refer attachment 1-TYPE VI |

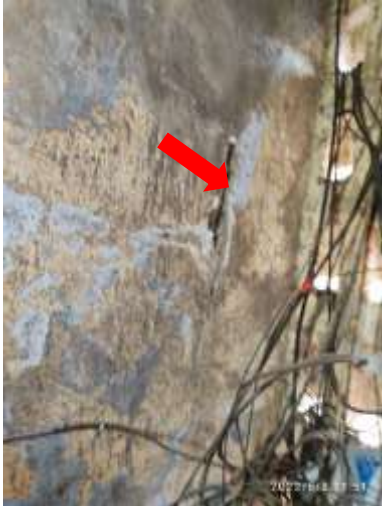
| d) | Mumpty room | Column | | | Structural crack | Refer attachment 1-TYPE VI |

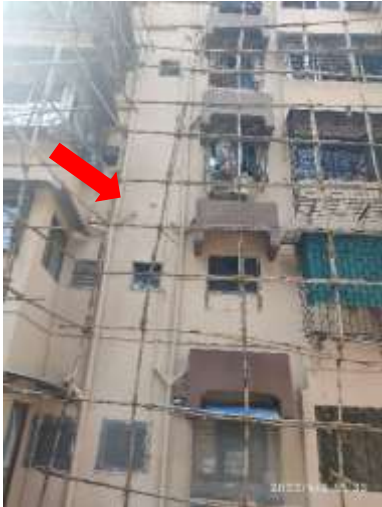
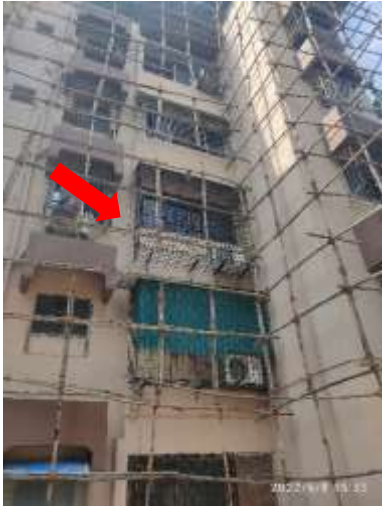
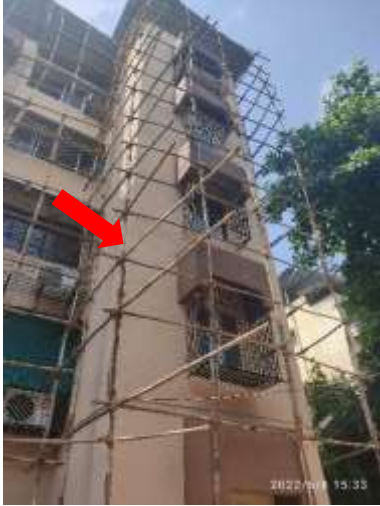
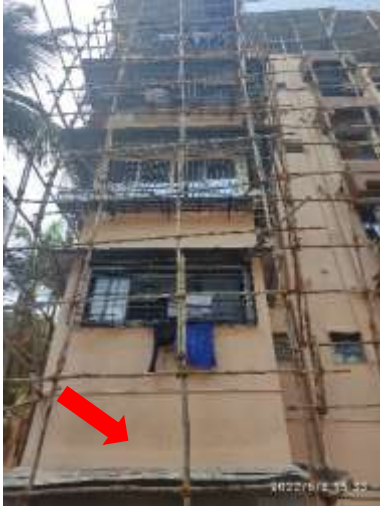
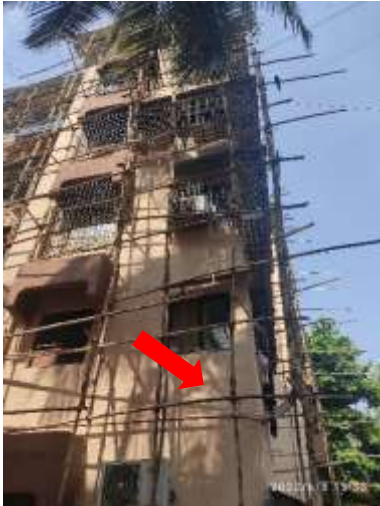
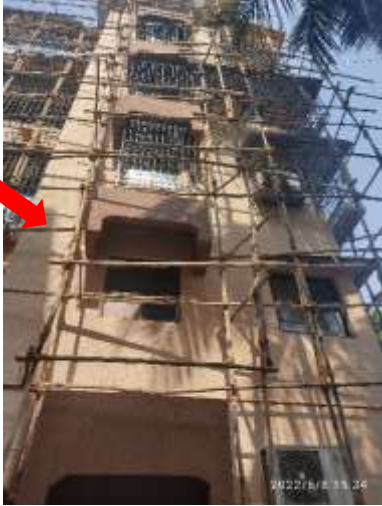
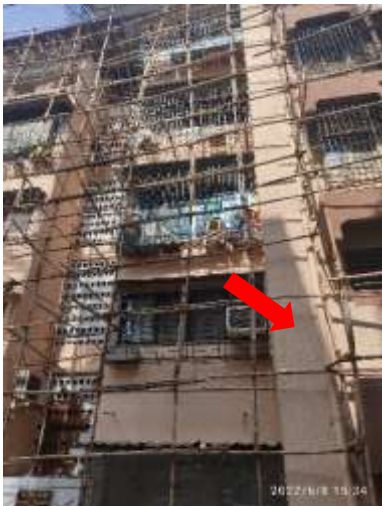
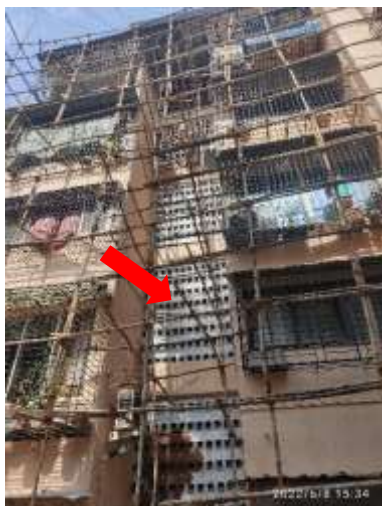
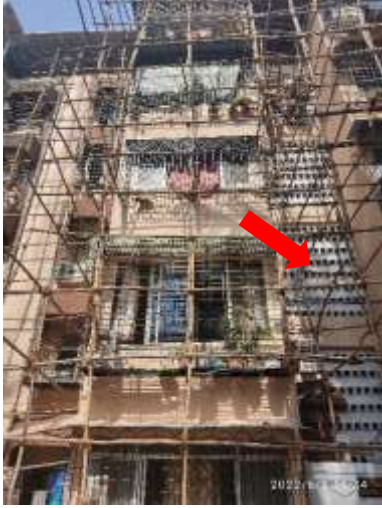
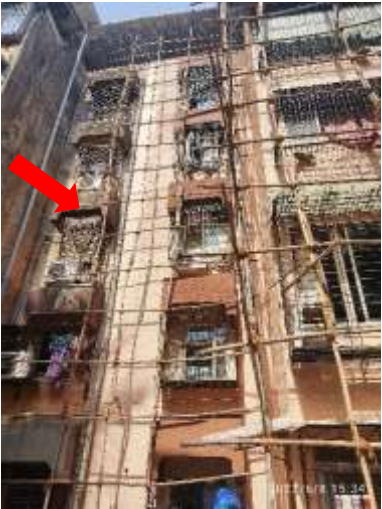
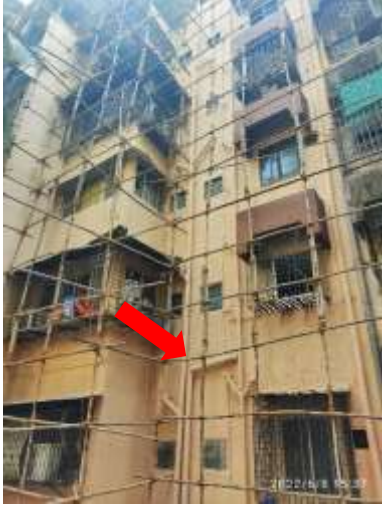
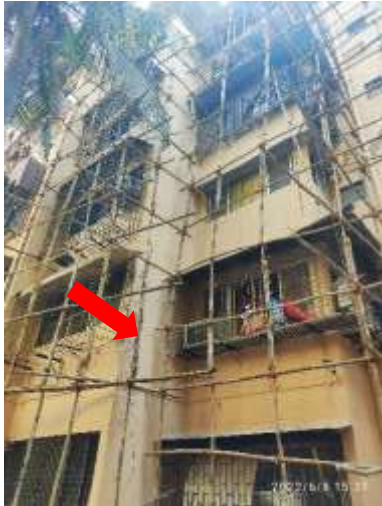
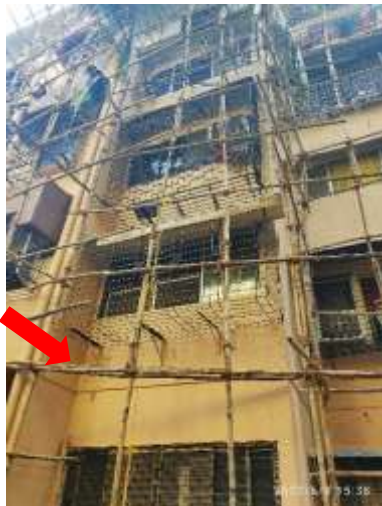
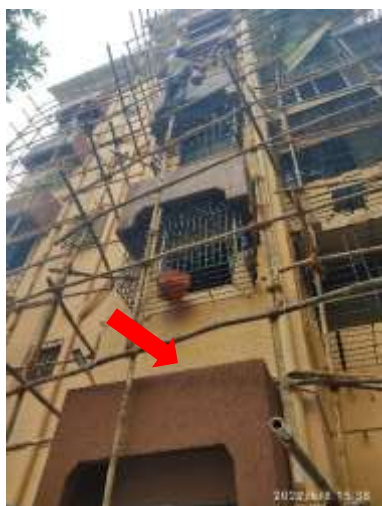
| a) | External | - | | | Painted & repaired | Methodology not known |
