# STRUCTURAL AUDIT REPORT

NOOR CO-OP. HOUSING SOCIETY LTD,

VASHI,

**Taamra Engineering Consultants Private Limited**

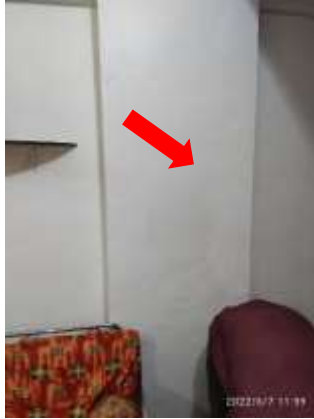
| Sr No. | LOCATION | AREA DESCRIPTION | | PHOTOS | DEFECTS | PROCESS FOR AMELIORATIONS |
|---|---|---|---|---|---|---|
| a) | Living Room | Column C 1 | | | Column with Hollow sound | Refer attachment I : TYPE XVII |

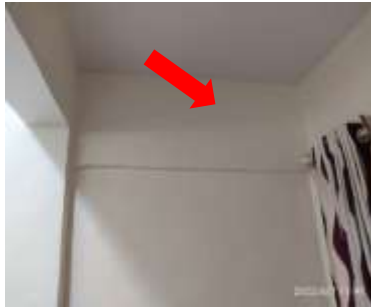
| Sr No. | LOCATION | AREA DESCRIPTION | | PHOTOS | DEFECTS | PROCESS FOR AMELIORATIONS |
|---|---|---|---|---|---|---|
| b) | Living Room | Beam | | | Beam With hollow sound | Refer attachment I : TYPE XVIII |

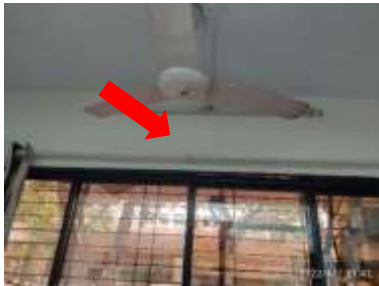
| Sr No. | LOCATION | AREA DESCRIPTION | | PHOTOS | DEFECTS | PROCESS FOR AMELIORATIONS |
|---|---|---|---|---|---|---|
| c) | Living Room | Lintel Beam | | | Separation cracks | Refer attachment I : TYPE X |

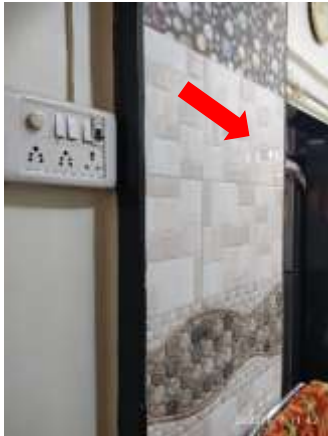
| Sr No. | LOCATION | AREA DESCRIPTION | | PHOTOS | DEFECTS | PROCESS FOR AMELIORATIONS |
|---|---|---|---|---|---|---|
| d) | Living Room | Column C 2 | | | Column covered with Tiles | Noting Visible |

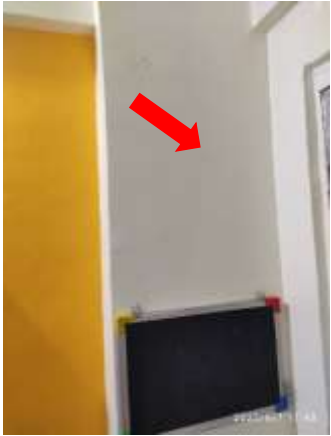
| e) | Living room | Column C 3 | | | Column with hollow sound | Refer attachment I : TYPE XVII |

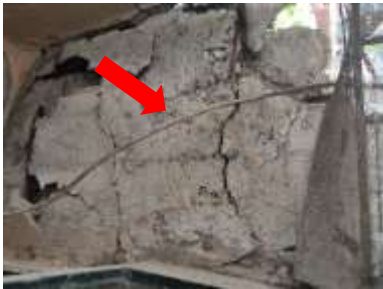
| f) | External | Chajja | | | Major Structural cracks | Refer attachment I : TYPE VI |

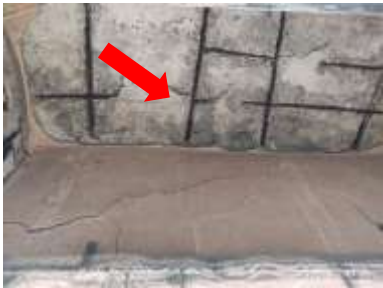
| g) | External | Chajja Ceiling | | | Major structural crack (Structural distress, Reinforcement corroded, Plaster spall off) | Refer attachment I : TYPE VI |

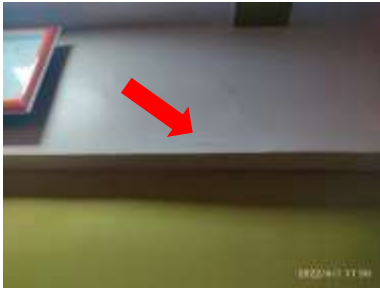
| j) | Bedroom | Beam | | | Structural<br>crack | Refer attachment<br>I : TYPE VI |

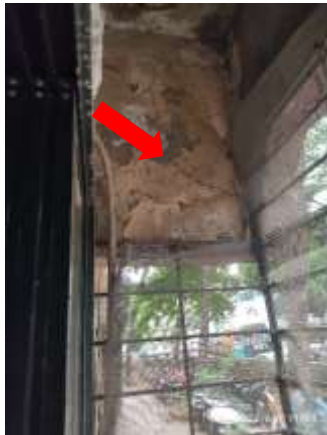
| l) | Bedroom | Chajja | | | Major<br>structural<br>cracks | Refer attachment<br>I : TYPE VI |

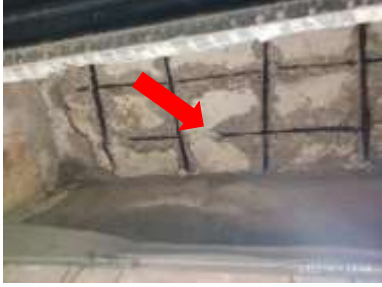
| m) | Bedroom | Chajja Ceiling | | | Major structural crack (Major structural distress, Reinforcement corroded, Plaster spall off) | Refer attachment I : TYPE VI |

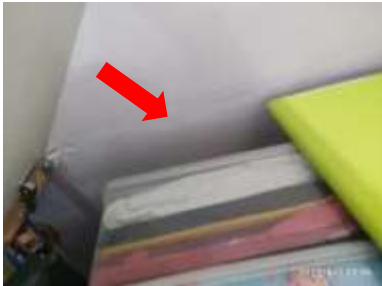
| o) | Living Room | Ceiling | | | Ceiling cracks | Refer attachment I : TYPE XIII |

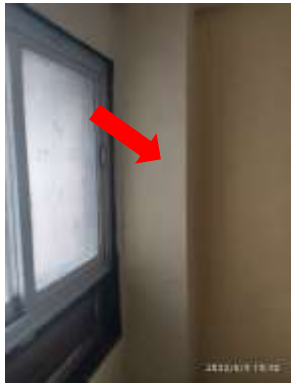
| a) | Bedroom | Column C 24 | | | Column with hollow sound | Refer attachment I : TYPE XVII |

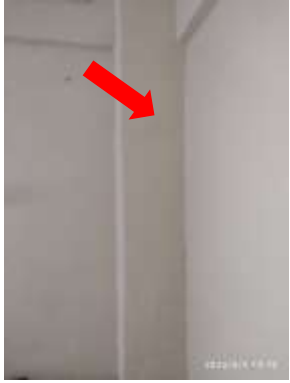
| b) | Bedroom | Column C 25 | | | Column with hollow sound | Refer attachment I : TYPE XVII |

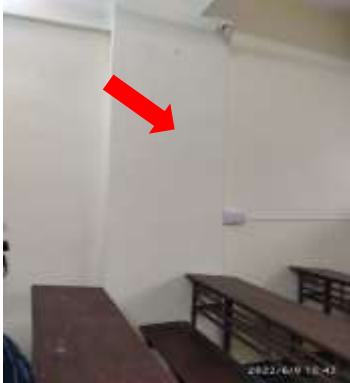
| c) | Living Room | Column C 21 | | | Column with hollow sound | Refer attachment I : TYPE XVII |

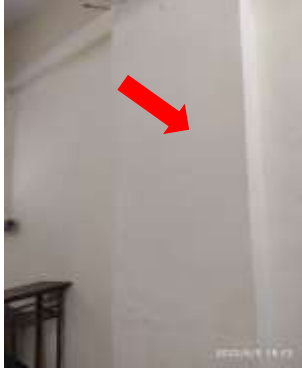
| d) | Living Room | Column C 20 | | | Column with hollow sound | Refer attachment I : TYPE XVII |

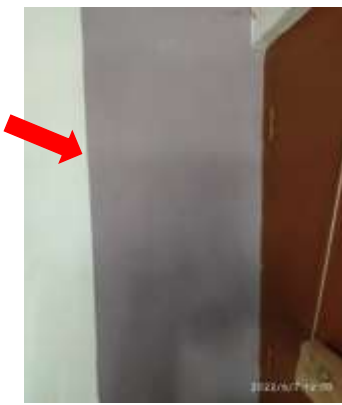
| a) | Living Room | Column C 3 | | | Column with hollow sound | Refer attachment I : TYPE XVII |

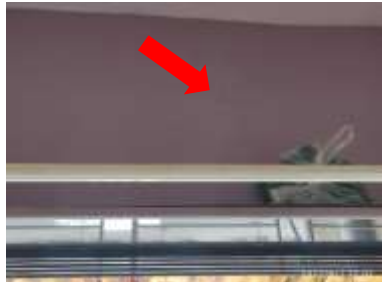
| c) | Living room | Balcony Lintel Beam | | | Window top lintel found with crack | Refer attachment I : TYPE XIX |

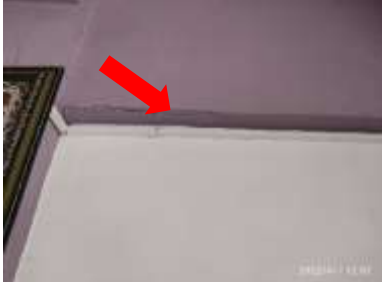
| d) | Living Room | Beam | | | Structural crack | Refer attachment I : TYPE VI |

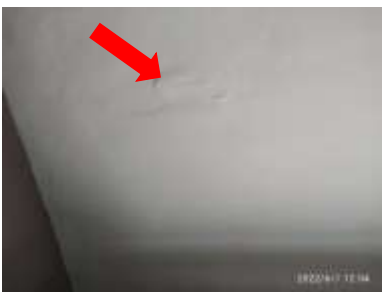
| e) | Living Room<br>Balcony | Ceiling | | | Ceiling cracks | Refer attachment I : TYPE XIII |

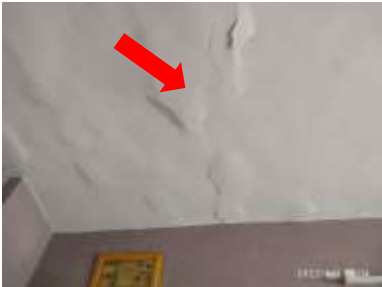
| f) | Living Room | Ceiling | | | Ceiling cracks | Refer attachment I : TYPE XIII |

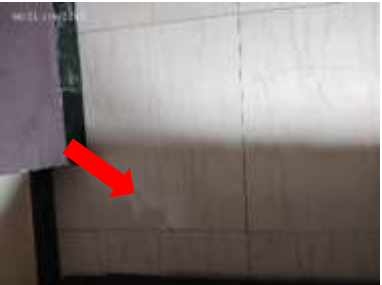
| g) | Living room Balcony | Floor | | | Floor tile uplift | Refer attachment I : TYPE XXVI |

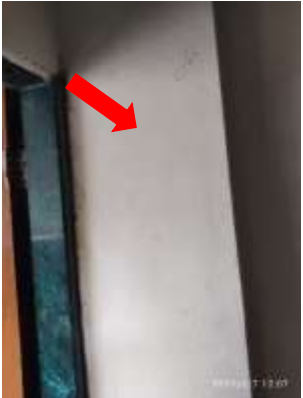
| h) | Bedroom | Column C 6 | | | Plaster crack, column with hollow sound | Refer attachment I : TYPE V, TYPE XVII |

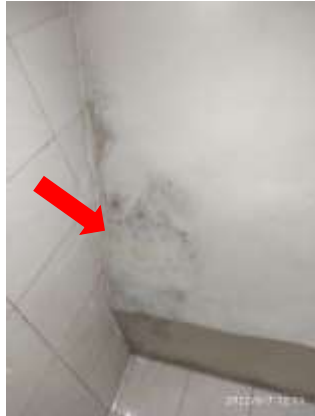
| k) | Toilet | Sunk | | | Seepages<br>from flat no<br>1/9 | Refer attachment<br>I : TYPE XI |

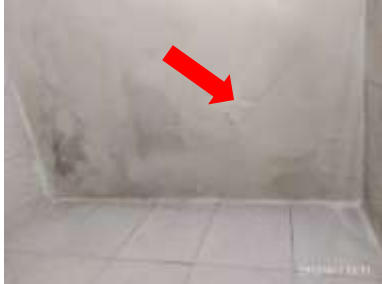
| l) | Bathroom | Ceiling | | | Seepages<br>from flat no<br>1/9, Ceiling<br>cracks | Refer attachment<br>I : TYPE XI |

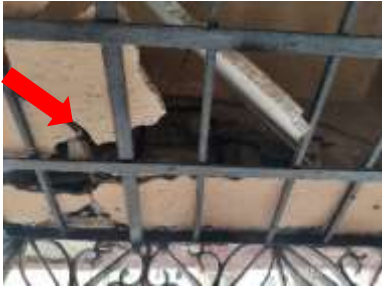
| n) | Kitchen | Chajja | | | Major structural crack, Plaster spall off (reinforcement corroded) | Refer attachment I : TYPE VI, TYPE V |

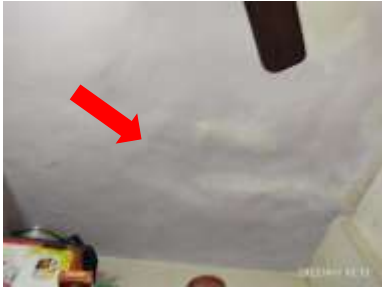
| o) | Kitchen | Ceiling | | | Ceiling cracks | Refer attachment I : TYPES XIII |

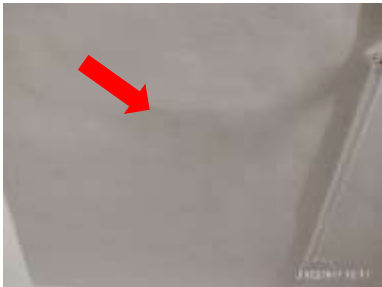
| a) | Living room | Ceiling | | | Ceiling cracks | Refer attachment I : TYPE XIII |

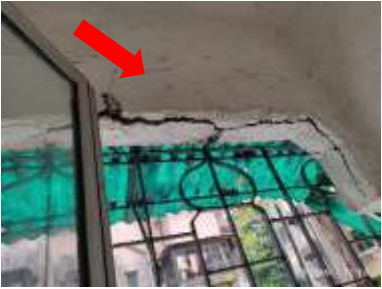
| b) | Kitchen | Chajja | | | Major Structural crack | Refer attachment I : TYPE VI |

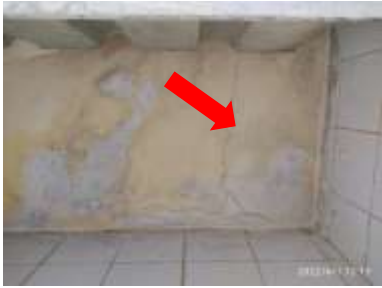
| c) | Bathroom | Ceiling | | | Ceiling cracks, seepage from flat no 1/10 | Refer attachment I : TYPE XIII, TYPE XI |

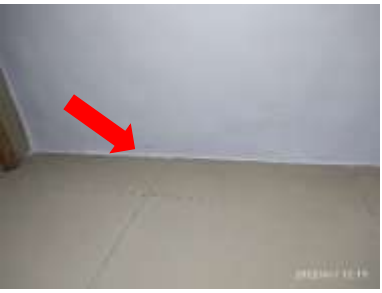
| d) | Passage | Ceiling | | | Ceiling cracks | Refer attachment<br>I : TYPE XIII |

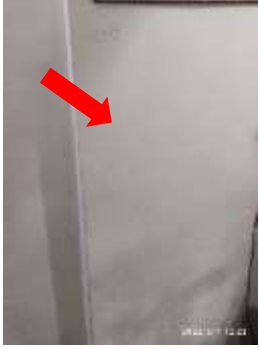
| e) | Bedroom | Column<br>C 13 | | | Plaster crack,<br>Plaster with<br>hollow sound | Refer attachment<br>I : TYPE V, TYPE<br>XVIII |

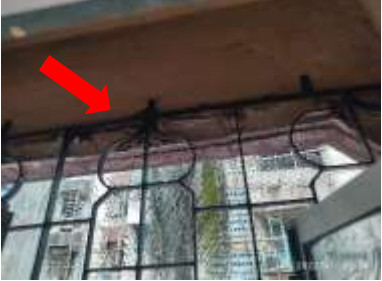
| f) | External | Chajja | | | Structural<br>crack | Refer attachment<br>I : TYPE VI |

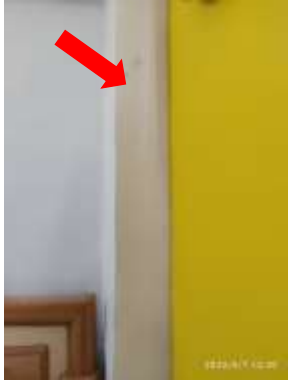
| b) | Bedroom | Column C 15 | | | Column with hollow sound | Refer attachment I : TYPE XVII |

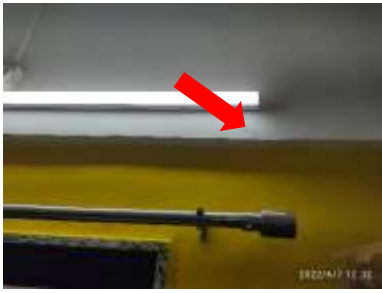
| c) | Bedroom | Beam | | | Structural crack | Refer attachment I : TYPE VI |

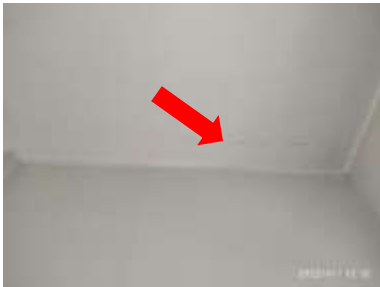
| d) | Bedroom Balcony | Ceiling | | | Ceiling cracks | Refer attachment I : TYPE XIII |

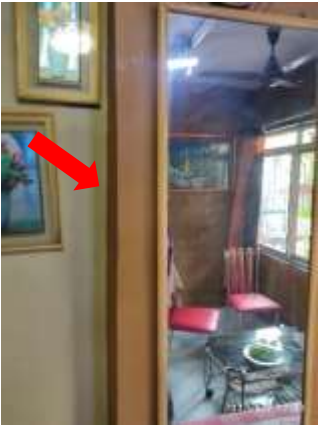
| b) | Living Room | Column C 21 | | | Column with hollow sound | Refer attachment I : TYPE XVII |

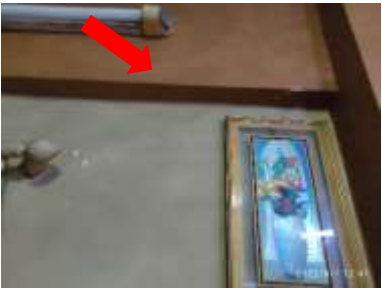
| c) | Living room | Beam | | | Plaster crack | Refer attachment I : TYPE V |

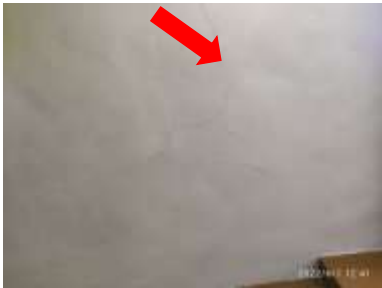
| d) | Living room | Ceiling | | | Ceiling cracks | Refer attachment I : TYPE XIII |

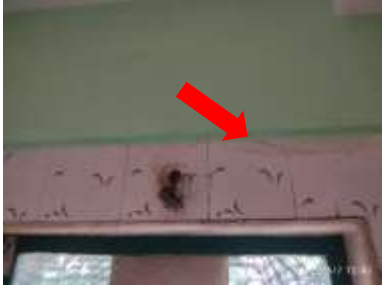
| f) | Kitchen | Beam | | | Plaster crack | Refer attachment<br>I : TYPE V |

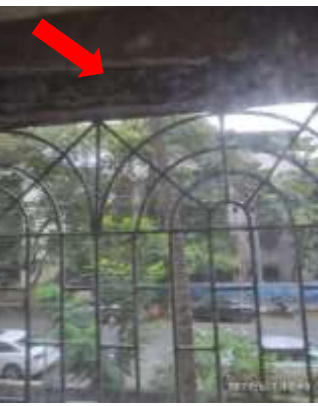
| g) | Kitchen | Chajja | | | Major structural crack<br>(Plaster spall off) | Refer attachment<br>I : TYPE VI |

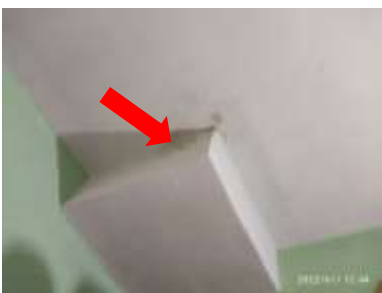
| h) | Kitchen | Sunk | | | Seepages from kitchen sink from flat no 1/12 | Refer attachment<br>I : TYPE XI |

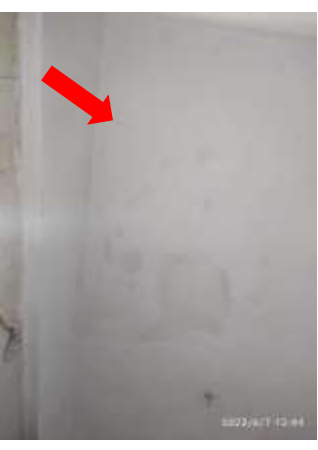
| i) | Bathroom | Ceiling | | | Seepages from flat no 1/12, Ceiling cracks | Refer attachment<br>I : TYPE XI |

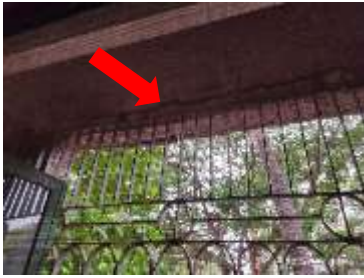
| j) | Bedroom | Chajja | | | Major structural crack | Refer attachment I : TYPE VI |

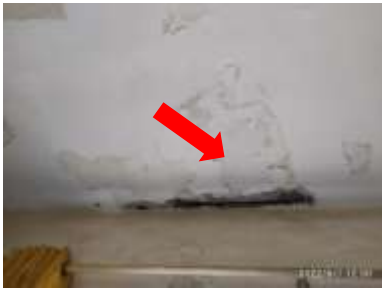
| a) | Living room Balcony | Ceiling | | | Major structural crack (reinforcement corroded, Plaster spall off) | Refer attachment I : TYPE VI |

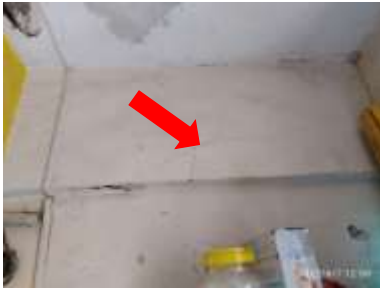
| b) | Living room Beam | Beam | | | Major structural crack, Beam found with crack | Refer attachment I : TYPE VI |

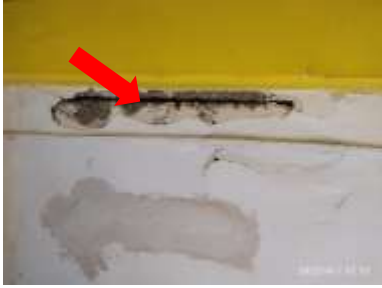
| d) | Living Room | Ceiling | | | Ceiling cracks, Structural crack (Plaster spall off, corroded) Need to support immediately | Refer attachment I : TYPE XIII, TYPE VI |

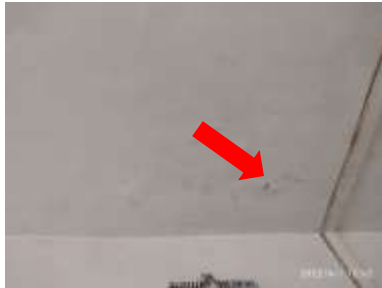
| e) | Living Room | Ceiling | | | Seepages from flat no 1/13 | Refer attachment I : TYPE XI |

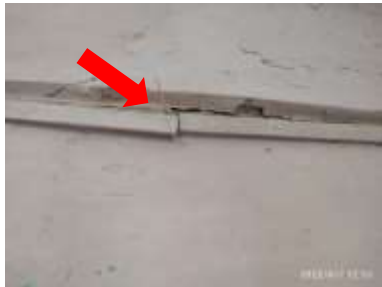
| g) | Bedroom | Beam | | | Structural crack | Refer attachment I : TYPE VI |

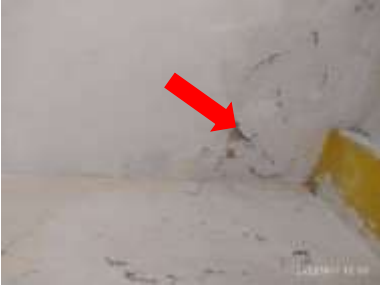
| h) | Bedroom | Ceiling | | | Ceiling cracks | Refer attachment<br>I : TYPE XIII |

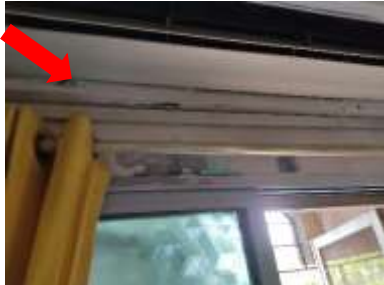
| i) | Bedroom | Lintel Beam | | | Structural crack | Refer attachment<br>I : TYPE VI |

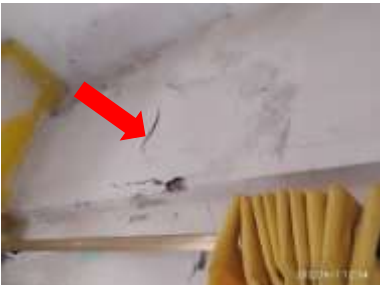
| k) | Bedroom | beam | | | Structural crack, Beam found with crack | Refer attachment<br>I : TYPE VI, TYPE XV |

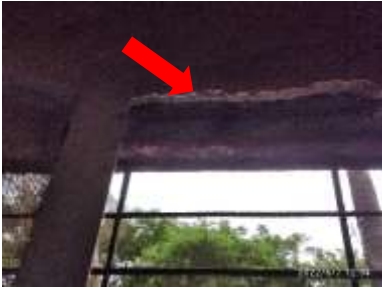
| m) | Bedroom | chajja | | | Major structural crack | Refer attachment I : TYPE VI |

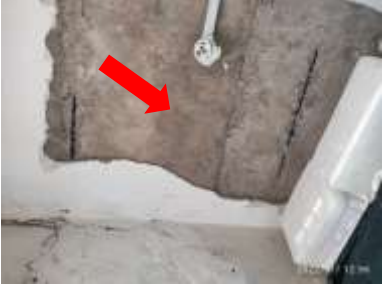
| o) | Bedroom Balcony | Ceiling | | | Ceiling cracks (Plaster spall off, Reinforcement corroded) | Refer attachment I : TYPE XIII |

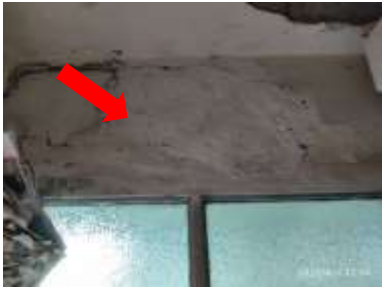
| p) | Bedroom Balcony | Beam | | | Major structural crack, Plaster with hollow sound | Refer attachment I : TYPE VI, TYPE XVIII |

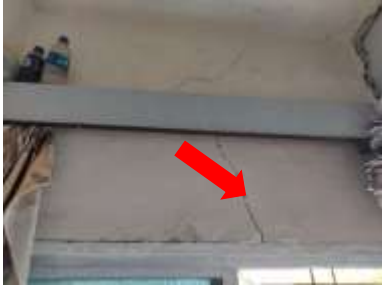
| q) | Bedroom | Lintel Beam | | | Structural crack | Refer attachment I : TYPE VI |

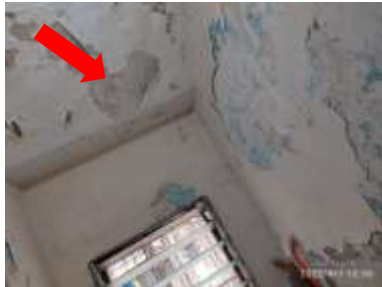
| s) | Toilet | Sunk | | | Major seepages from flat no 1/13 | Refer attachment I : TYPE XI |

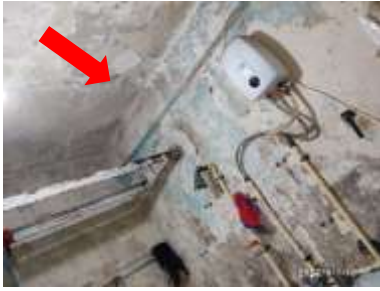
| t) | Bathroom | Ceiling | | | Major seepages from flat no 1/13 | Refer attachment I : TYPE XI |

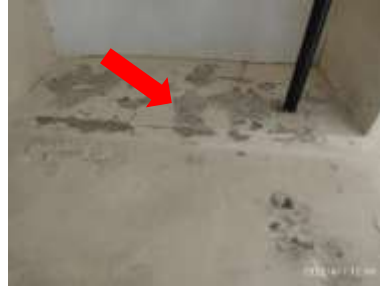
| u) | Passage | Beam | | | Structural crack, Major seepages from flat no 1/13 | Refer attachment I : TYPE VI, TYPE XI |

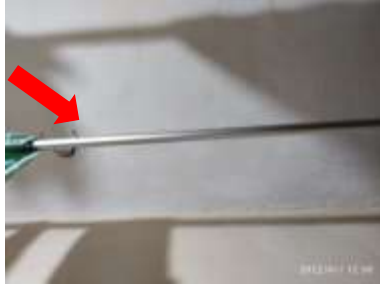
| v) | Passage | Ceiling | | | Ceiling cracks | Refer attachment I : TYPE XIII |

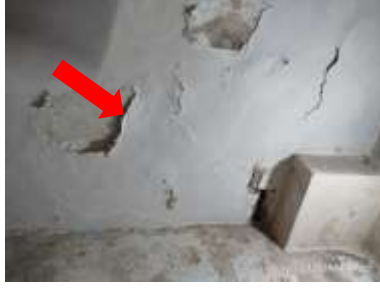
| w) | Kitchen | Ceiling | | | Ceiling cracks, seepages from flat no 1/13 (reinforcement corroded) | Refer attachment I : TYPE XIII, TYPE XI |

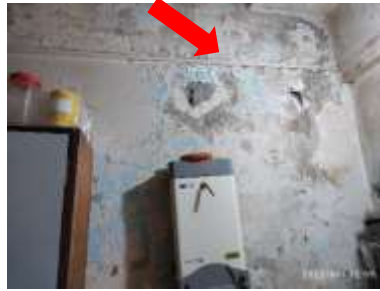
| x) | kitchen | Beam | | | Major structural crack (plaster spall off & corroded) | Refer attachment I : TYPE VI |

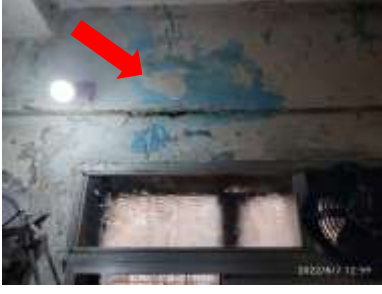
| y) | Kitchen | Beam | | | Major structural crack (corroded & distress) | Refer attachment I : TYPE VI |

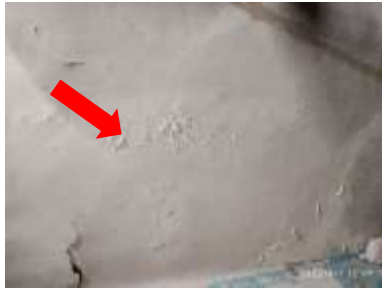
| z) | Kitchen | Ceiling | | | Ceiling cracks, Seepages from flat no 1/13 | Refer attachment I : TYPE XIII, TYPE XI |

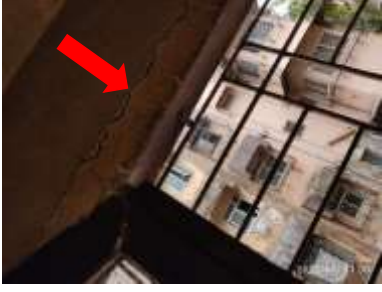
| ab) | Kitchen | Chajja | | | Major structural crack | Refer attachment I : TYPE VI |

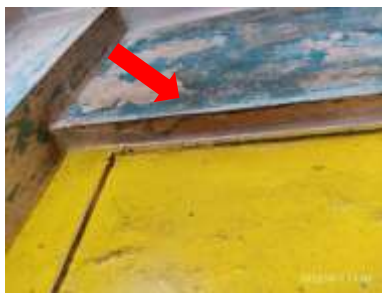
| ac) | kitchen | Beam | | | Structural crack | Refer attachment I : TYPE VI |

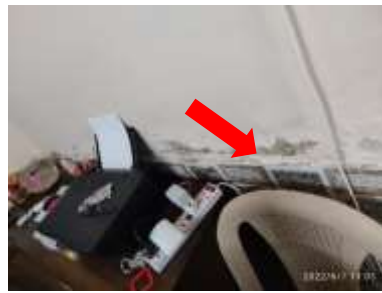
| a) | Living room | Wall | | | Capillary action marks from adjacent bathroom | Refer attachment I : TYPE IV |

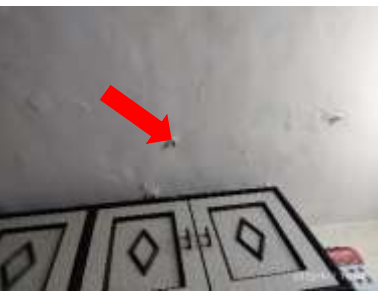
| b) | Kitchen | Ceiling | | | Ceiling cracks & Seepage from flat no 2/14 | Refer attachment I : TYPE XIII, TYPE XI |

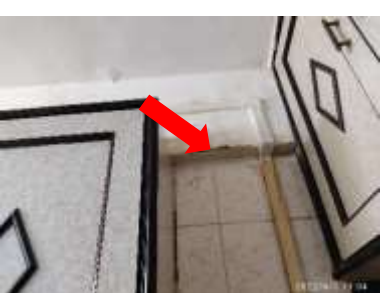
| c) | Kitchen | Beam | | | Seepage from flat no 2/14, Structural crack | Refer attachment I : TYPE XI |

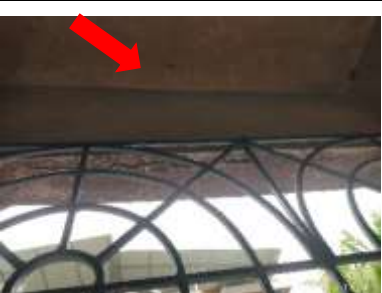
| d) | Kitchen | Chajja | | | Major structural crack | Refer attachment I : TYPE VI |

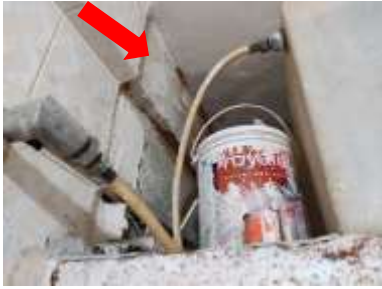
| e) | Bathroom | Ceiling & Beam | | | Major Seepage from flat no 2/14 | Refer attachment I : TYPE XI |

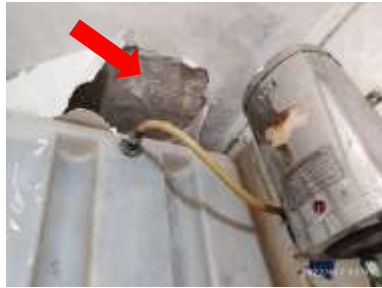
| f) | Bathroom | Ceiling | | | Major Seepage from flat no 2/14 | Refer attachment I : TYPE XI |

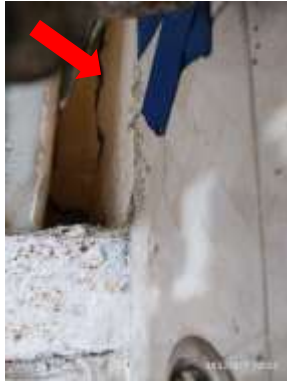
| g) | bathroom | Beam | | | Major structural crack | Refer attachment I : TYPE VI |

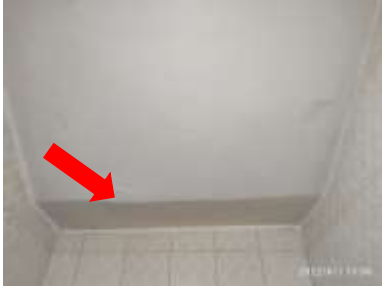
| h) | Toilet | Sunk | | | Plaster crack | Refer attachment I : TYPE V |

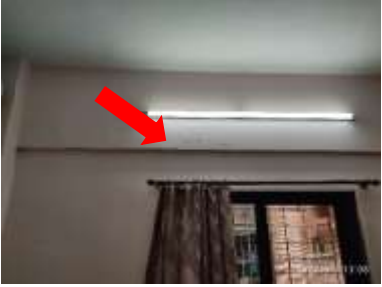
| l) | Bedroom | Beam | | | Structural crack | Refer attachment I : TYPE VI |

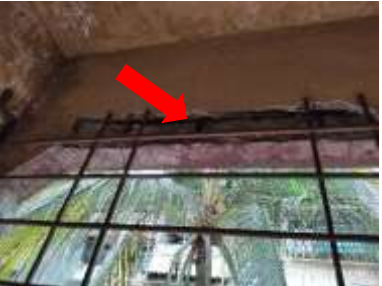
| m) | Bedroom | Chajja | | | Major structural crack<br>(Plaster spall off & corroded) | Refer attachment I : TYPE VI |

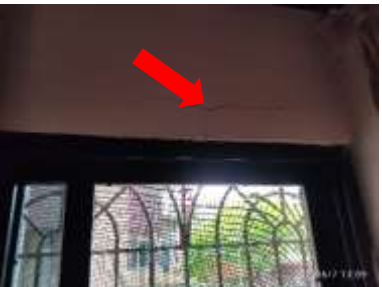
| n) | Bedroom | Balcony | | | Major structural crack,<br>Window top lintel found with crack | Refer attachment I : TYPE VI, TYPE XIX |

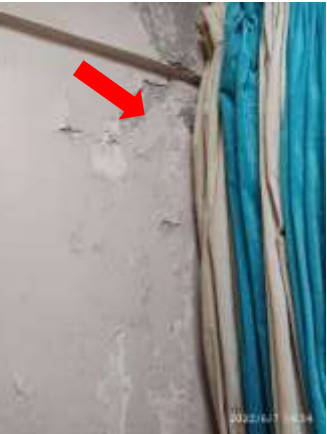
| a) | Living Room | Wall | | | Seepages from external crack | Refer attachment I : TYPE XI |

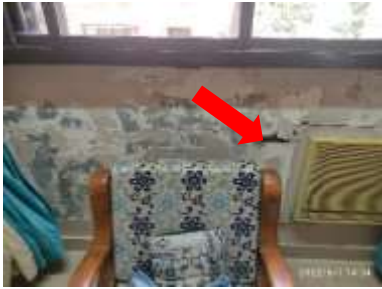
| b) | Living Room balcony | Window sill | | | Major structural cracks, plaster with hollow sound | Refer attachment I : TYPE VI, TYPE XVIII |

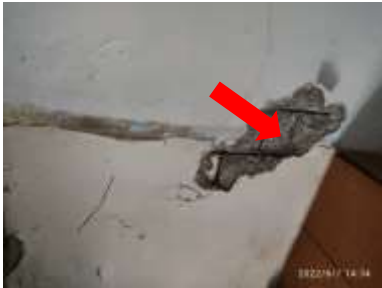
| c) | Kitchen | Ceiling | | | Major structural cracks (Plaster spall off & corroded) | Refer attachment I : TYPE VI |

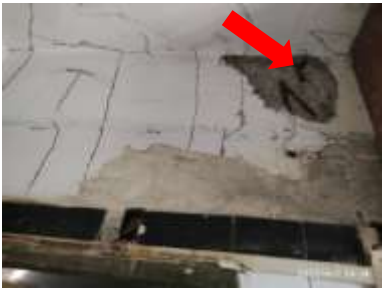
| d) | Kitchen | Beam | | | Major structural crack (Plaster spall off & corroded) | Refer attachment I : TYPE VI |

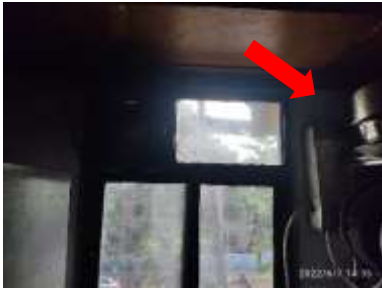
| e) | Kitchen | Lintel Beam | | | Window stopped sliding | Refer attachment I : TYPE VIII |

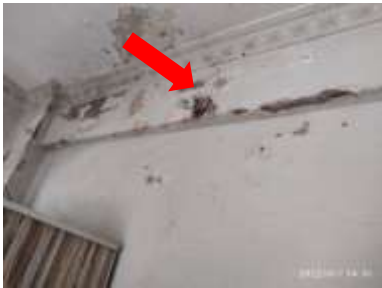
| f) | Bedroom | beam | | | Structural crack, Seepages from flat no 1/15 | Refer attachment I : TYPE VI, TYPE XI |

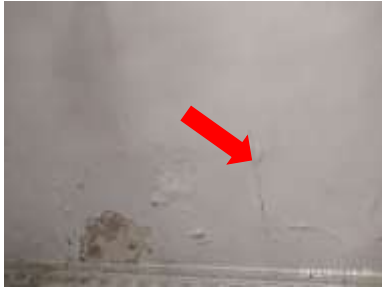
| g) | Bedroom | Ceiling | | | Ceiling cracks,<br>Seepages<br>from flat no<br>1/15 | Refer attachment<br>I : TYPE XIII, TYPE<br>XI |

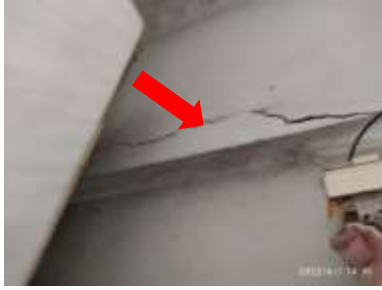
| h) | bedroom | Beam | | | Major<br>structural<br>crack | Refer attachment<br>I : TYPE VI |

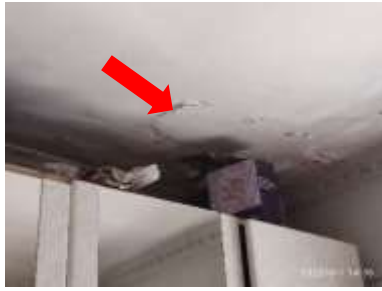
| i) | Bedroom | Ceiling | | | Ceiling cracks<br>(plaster spall<br>off &<br>corroded) | Refer attachment<br>I : TYPE XIII |

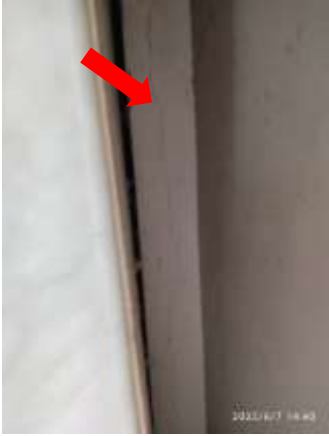
| l) | Bedroom | Column C 15 | | | Structural crack | Refer attachment I : TYPE VI |

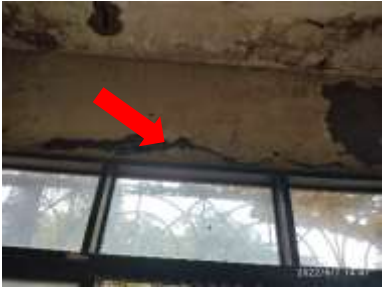
| n) | Bedroom Balcony | Lintel Beam | | | Major structural crack, Window top lintel found with crack | Refer attachment I : TYPE VI, TYPE XIX |

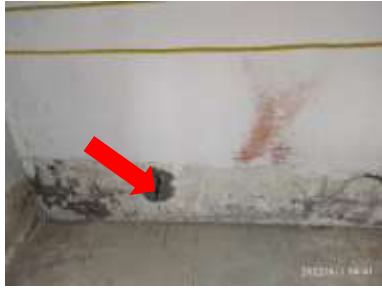
| o) | Bedroom Balcony | Ceiling | | | Ceiling cracks, Structural crack (Plaster spall off & corroded) | Refer attachment I : TYPE XIII, TYPE VI |

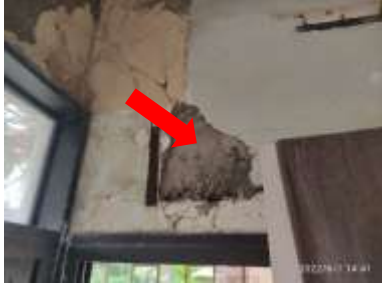
| p) | Bedroom Balcony | Lintel Beam | | | Major structural crack (Plaster spall off) | Refer attachment I : TYPE VI |

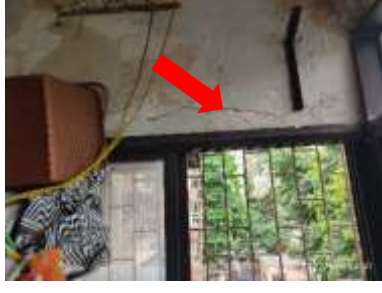
| q) | Bedroom Balcony | Lintel Beam | | | Major structural crack, Window top lintel found with crack | Refer attachment I : TYPE VI, TYPE XIX |

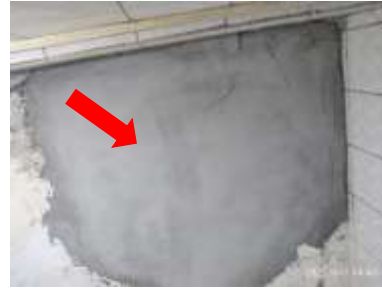
| r) | bathroom | Ceiling | | | Ceiling cracks | Refer attachment I : TYPE XIII |

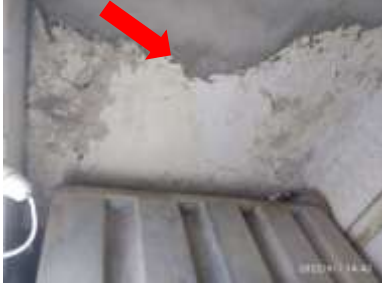
| s) | Bathroom | Ceiling | | | Ceiling cracks | Refer attachment<br>I : TYPE XIII |

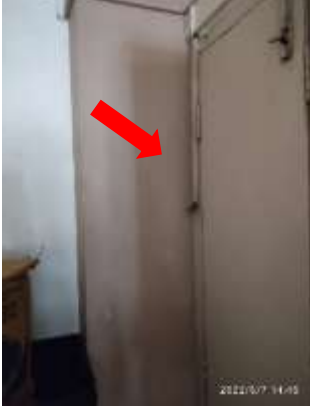
| a) | Living Room | Column C 3 | | | Column with hollow sound | Refer attachment<br>I : TYPE XVII |

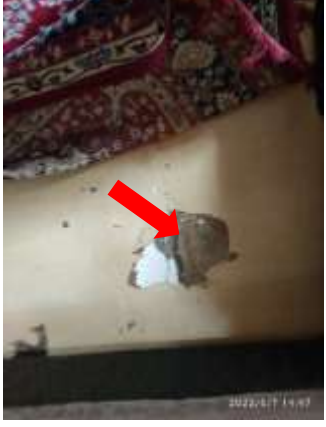
| b) | Living room | Floor | | | Floor Vibrated | |

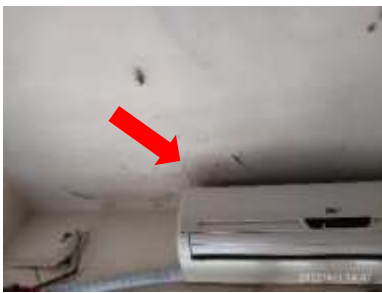
| c) | Living room | Ceiling | | | Ceiling crack | Refer attachment I : TYPE XIII |

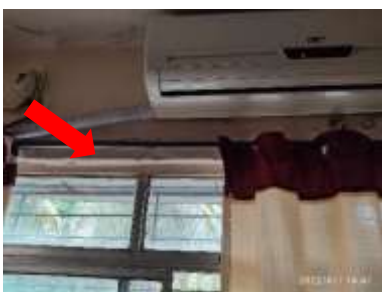
| d) | Living Room | Lintel Beam | | | Structural crack, Window top lintel found with crack | Refer attachment I : TYPE VI, TYPE XIX |

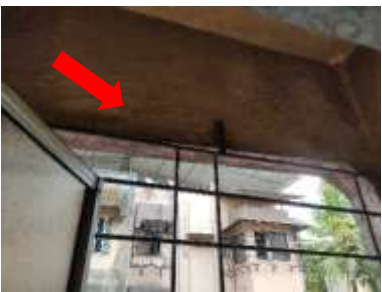
| f) | Kitchen | External chajja | | | Structural crack | Refer attachment I : TYPE VI |

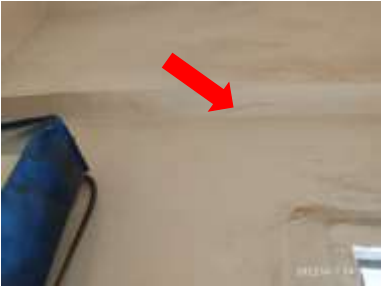
| g) | Kitchen | Beam | | | Plaster crack | Refer attachment<br>I : TYPE V |

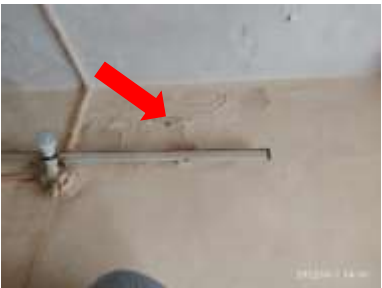
| h) | Kitchen | Beam | | | Seepages<br>from flat no<br>1/17 | Refer attachment<br>I : TYPE XI |

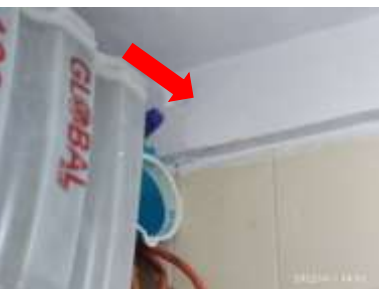
| i) | Bathroom | Beam | | | Structural<br>crack | Refer attachment<br>I : TYPE VI |

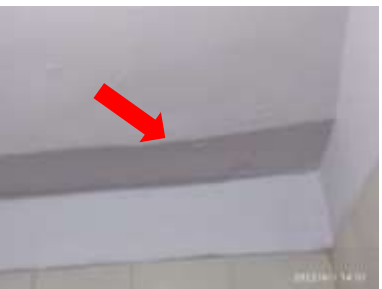
| j) | Toilet | Sunk | | | Plaster crack | Refer attachment<br>I : TYPE V |

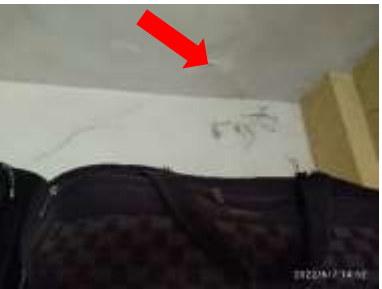
| k) | Bedroom | Ceiling | | | Ceiling cracks | Refer attachment<br>I : TYPE XIII |

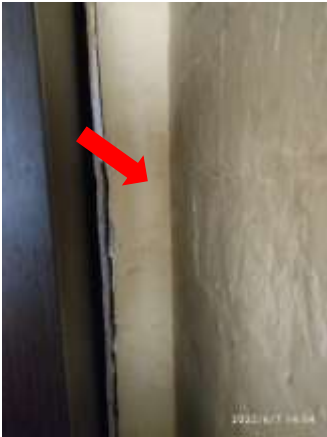
| m) | Bedroom | Column C 8 | | | Tile crack, Structural crack | Refer attachment I : TYPE I, TYPE VI |

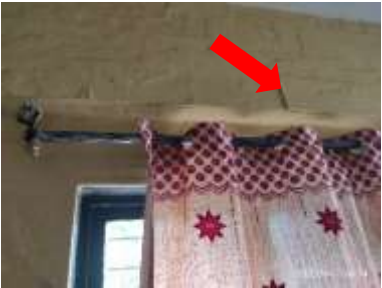
| n) | Bedroom | Lintel Beam | | | Plaster crack | Refer attachment I : TYPE V |

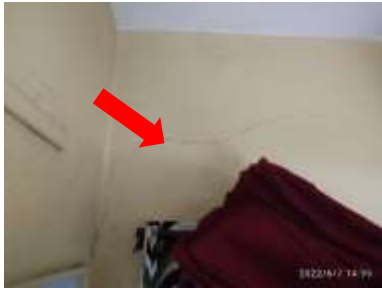
| o) | Bedroom balcony | Beam | | | Structural crack | Refer attachment I : TYPE VI |

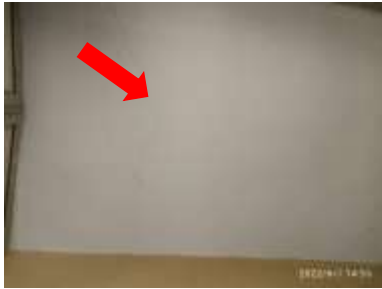
| p) | Bedroom balcony | Wall | | | Plaster crack | Refer attachment I : TYPE V |

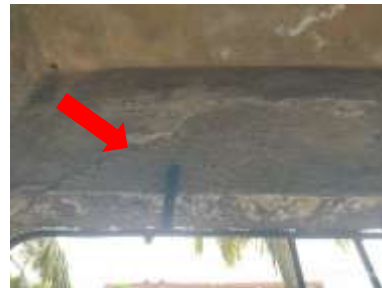
| q) | Bedroom balcony | Chajja | | | Major structural crack | Refer attachment I : TYPE VI |

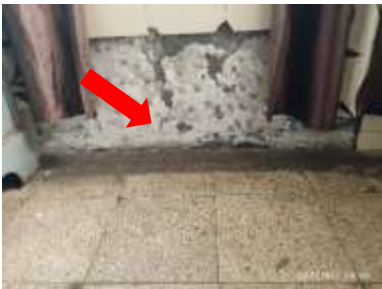
| r) | Bedroom balcony | Floor | | | Floor crack | Refer attachment I : TYPE I |

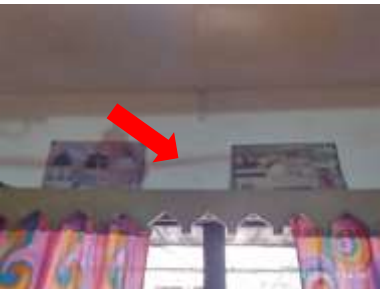
| a) | Living room | Lintel Beam | | | Plaster crack | Refer attachment I : TYPE V |

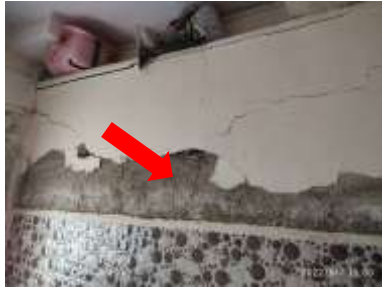
| c) | Kitchen changes to Bedroom | Wall | | | Seepages from adjacent bathroom | Refer attachment I : TYPE XI |

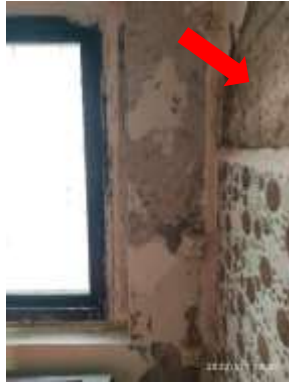
| d) | Kitchen changes to Bedroom | Wall | | | Seepages from adjacent bathroom | Refer attachment I : TYPE XI |

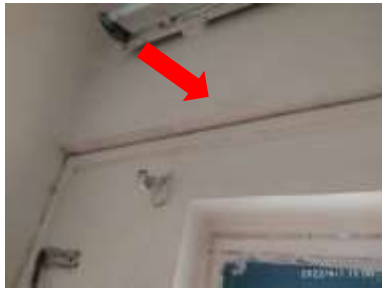
| e) | Kitchen changes to Bedroom | Beam | | | Plaster crack | Refer attachment I : TYPE V |

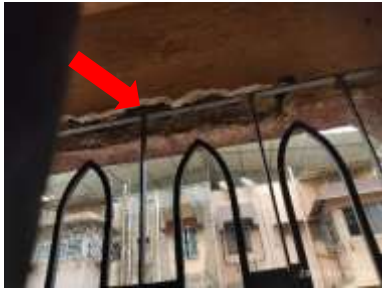
| f) | Kitchen changes to Bedroom | Chajja | | | Major structural crack | Refer attachment I : TYPE VI |

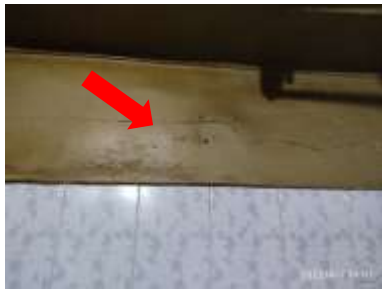
| g) | Passage changes to kitchen | Beam | | | Major structural crack, Beam found with crack | Refer attachment I : TYPE VI, TYPE XV |

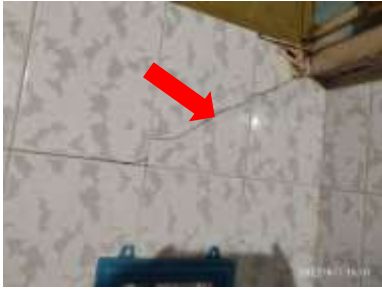
| h) | Passage changes to kitchen | Wall | | | Tile cracks | Refer attachment I : TYPE I |

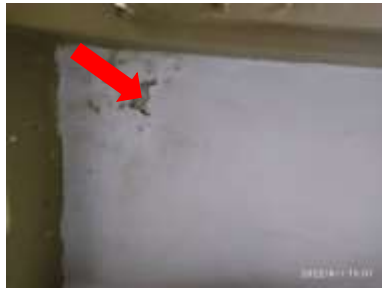
| i) | Passage changes to kitchen | Ceiling | | | Seepages from Flat no | Refer attachment I : TYPE XI |

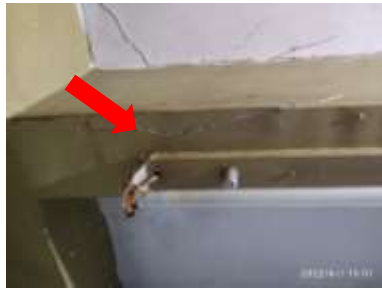
| j) | Passage changes to kitchen | Beam | | | Major structural crack | Refer attachment I : TYPE VI |

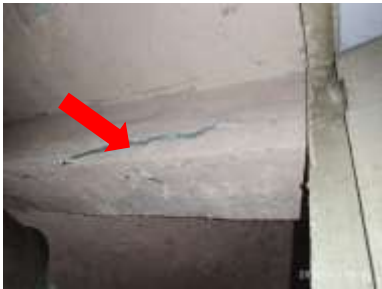
| k) | Passage changes to kitchen | Beam | | | Major Structural crack | Refer attachment I : TYPE VI |

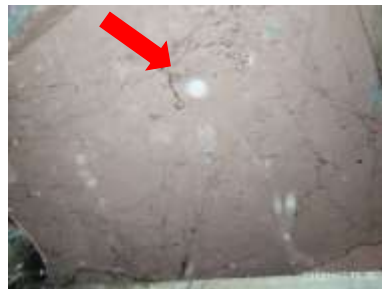
| l) | Toilet | Ceiling | | | Ceiling Crack | Refer attachment I : TYPE XIII |

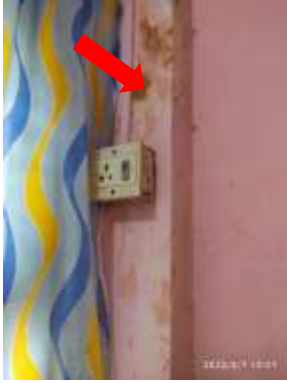
| m) | Bedroom | Column C 12 | | | Seepage from external cracks | Refer attachment I : TYPE XI |

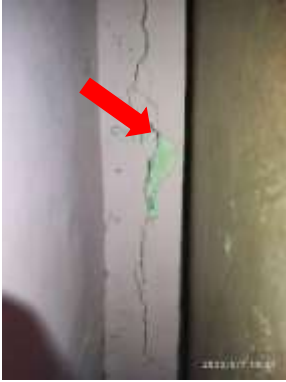
| o) | Bedroom | Column C 11 | | | Major structural crack | Refer attachment I : TYPE VI |

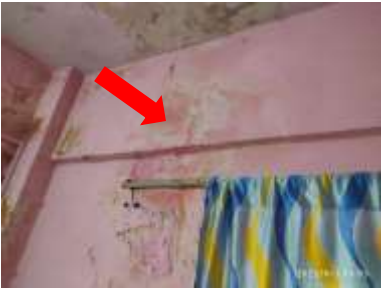
| p) | Bedroom | Beam & Wall | | | Seepages from flat no 1/18 | Refer attachment I : TYPE XI |

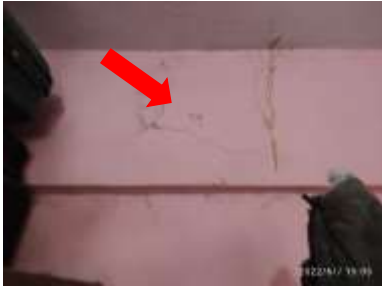
| q) | Bedroom | Beam | | | Plaster crack | Refer attachment I : TYPE V |

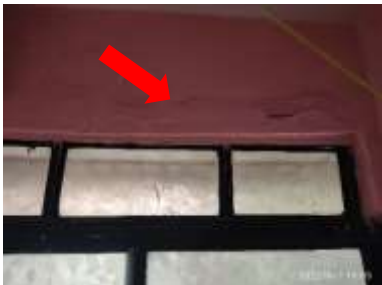
| r) | Bedroom Balcony | Lintel beam | | | Major structural crack,<br>Window top lintel found with crack | Refer attachment I : TYPE VI, TYPE XIX |

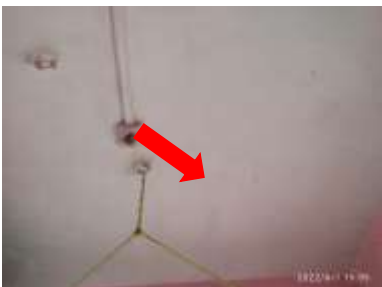
| s) | Bedroom Balcony | Ceiling | | | Ceiling cracks | Refer attachment I : TYPE XIII |

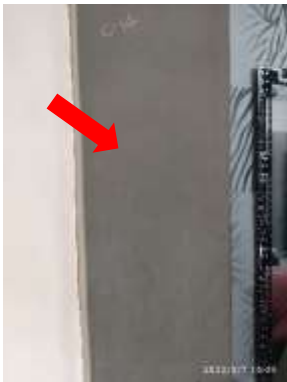
| a) | Living room | Column C 14 | | | Column with hollow sound | Refer attachment I : TYPE XVII |

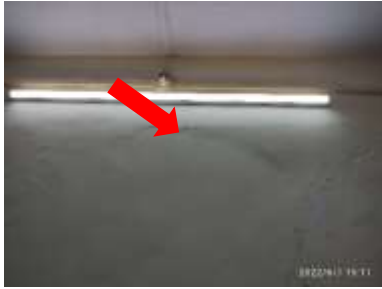
| c) | Kitchen | Beam | | | Structural crack | Refer attachment I : TYPE VI |

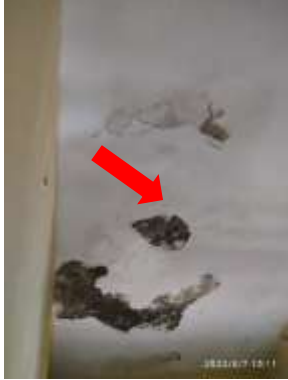
| d) | Bathroom | Ceiling | | | Major seepages from flat no 1/19 Bathroom | Refer attachment I : TYPE XI |

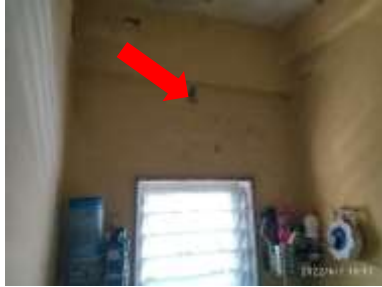
| e) | Bathroom | Beam | | | seepages from flat no 1/19 Bathroom | Refer attachment I : TYPE XI |

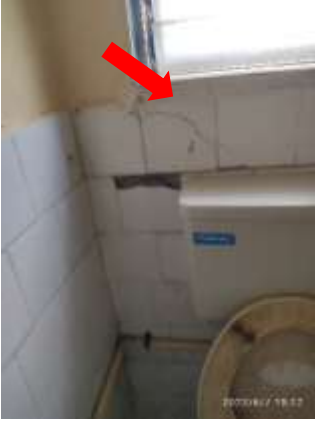
| f) | Toilet | Wall | | | Tile crack | Refer attachment<br>I : TYPE I |

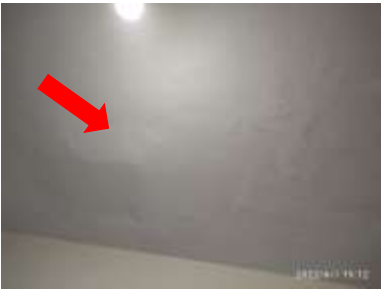
| g) | Passage | Ceiling | | | Ceiling cracks | Refer attachment<br>I : TYPE XIII |

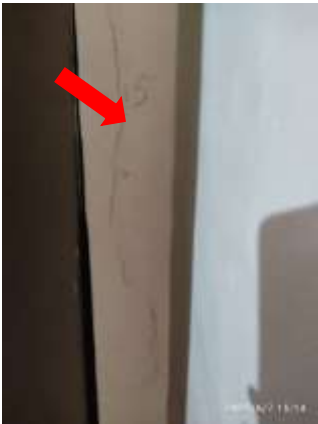
| i) | Bedroom | Column<br>C 15 | | | Structural<br>crack | Refer attachment<br>I : TYPE VI |

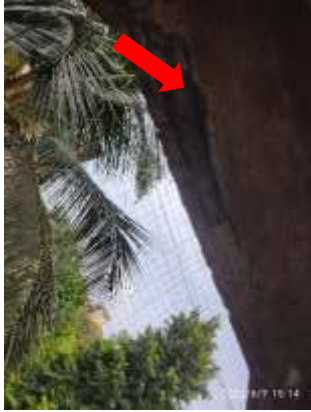
| j) | bedroom | Chajja | | | Major structural crack<br>(Plaster spall off) | Refer attachment<br>I : TYPE VI |

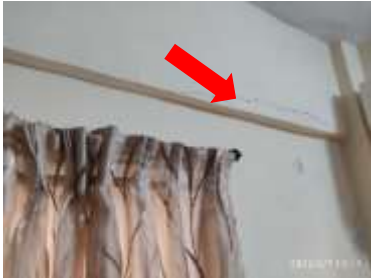
| k) | Bedroom | Lintel Beam | | | Structural crack,<br>Window top Lintel found with crack | Refer attachment<br>I : TYPE VI, TYPE XIX |

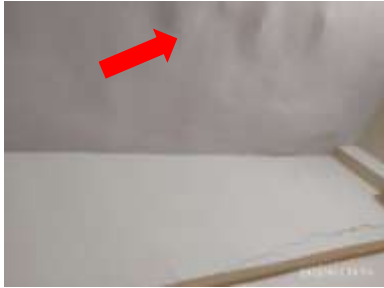
| l) | Bedroom | Ceiling | | | Ceiling cracks | Refer attachment<br>I : TYPE XIII |

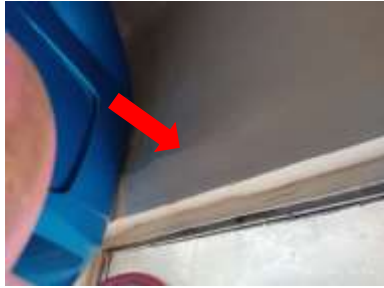
| m) | Bedroom balcony | Lintel Beam | | | Structural crack | Refer attachment<br>I : TYPE VI |

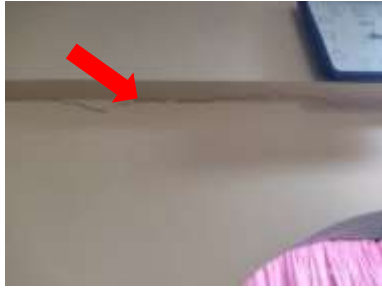
| a) | Living Room | Beam | | | Structural crack | Refer attachment I : TYPE VI |

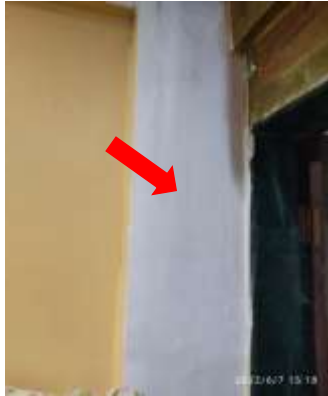
| b) | Bedroom | Column C 23 | | | Column with hollow sound | Refer attachment I : TYPE XVII |

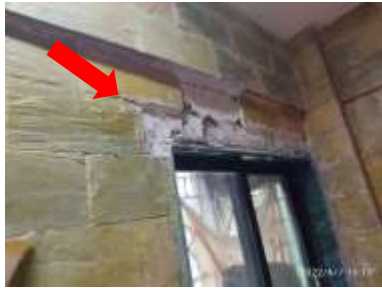
| c) | Bedroom | Lintel Beam | | | Window top lintel found with crack | Refer attachment I : TYPE XIX |

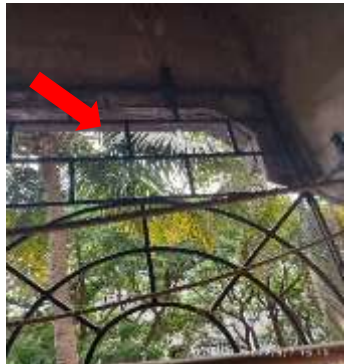
| d) | Bedroom | Chajja | | | Major structural crack | Refer attachment I : TYPE VI |

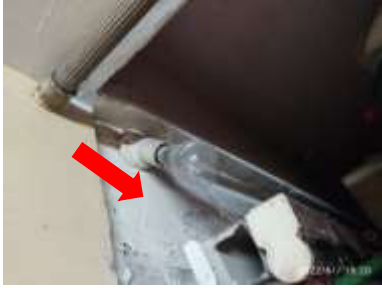
| e) | Passage | Wall | | | Seepage marks | Refer attachment I : TYPE III |

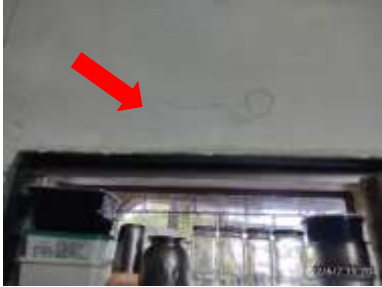
| f) | kitchen | Lintel Beam | | | Structural crack,<br>Window top lintel found with crack | Refer attachment I : TYPE VI, TYPE XIX |

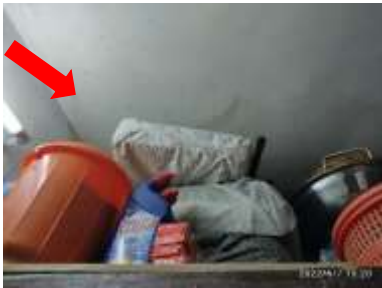
| g) | kitchen | Ceiling | | | Ceiling cracks | Refer attachment I : TYPE XIII |

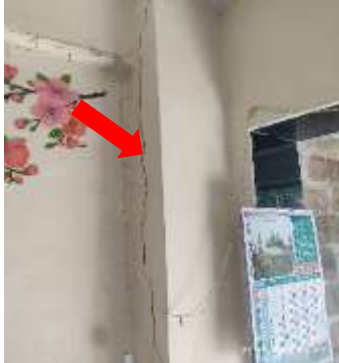
| a) | Living Room | Column C 1 | | | Major structural cracks | Refer attachment I : TYPE VI |

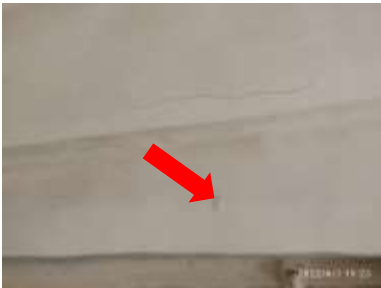
| c) | Living Room | Beam | | | Structural crack | Refer attachment I : TYPE VI |

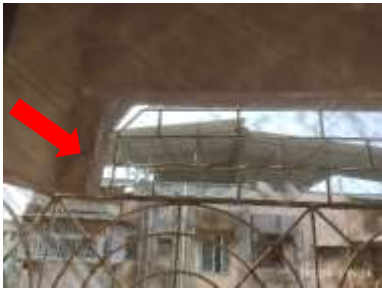
| d) | Kitchen | Chajja | | | Structural crack | Refer attachment I : TYPE VI |

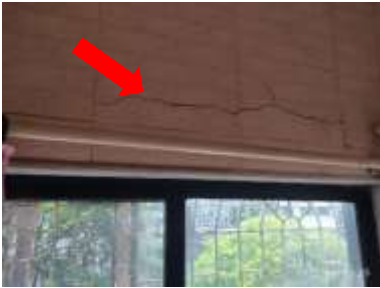
| e) | Bedroom | Lintel Beam | | | Structural crack, Window top lintel found with crack | Refer attachment I : TYPE VI, TYPE XIX |

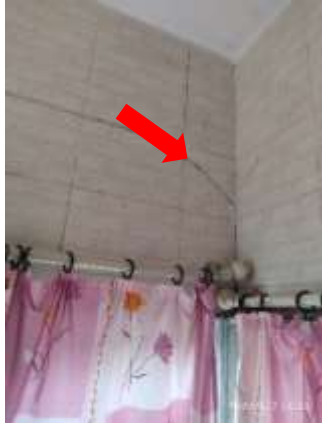
| f) | Bedroom | Beam | | | Tile crack | Refer attachment<br>I : TYPE I |

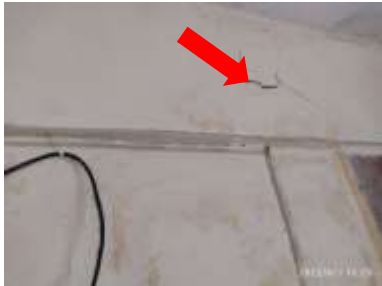
| g) | Bedroom | Beam | | | Plaster crack,<br>Beam found<br>with crack | Refer attachment<br>I : TYPE V, TYPE<br>XV |

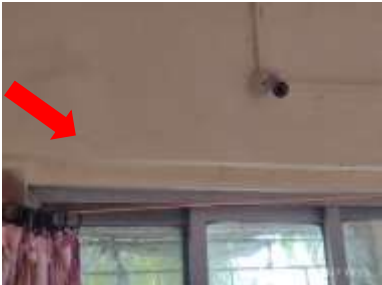
| h) | Bedroom | Beam | | | Plaster crack | Refer attachment<br>I : TYPE V |

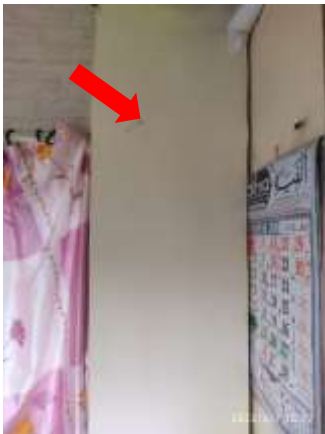
| i) | Bedroom | Column<br>C 6 | | | Plaster crack,<br>Column found<br>with crack | Refer attachment<br>I : TYPE V, TYPE<br>XIV |

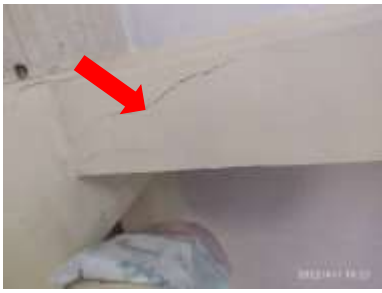
| j) | Bedroom | Beam | | | Major structural crack | Refer attachment I : TYPE VI |

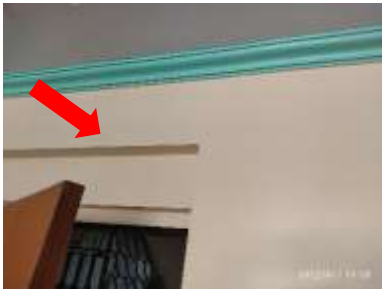
| a) | Living Room | Beam | | | Plaster with hollow sound | Refer attachment I : TYPE XVIII |

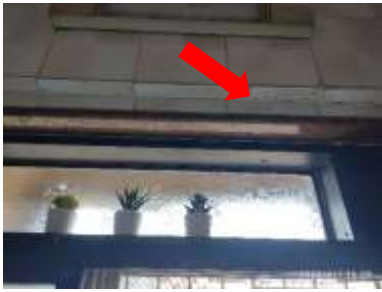
| b) | Kitchen | Beam | | | Structural crack, window top lintel found with crack | Refer attachment I : TYPE VI, TYPE XIX |

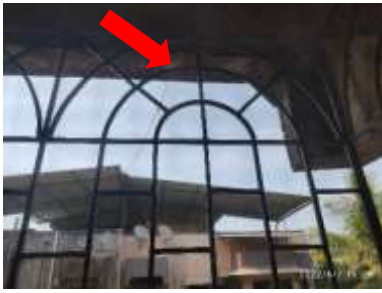
| c) | Kitchen | Chajja | | | Structural crack | Refer attachment I : TYPE VI |

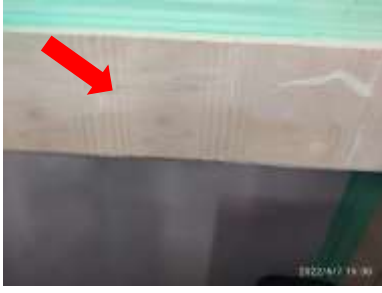
| d) | Bedroom | Beam | | | Structural crack | Refer attachment I : TYPE VI |

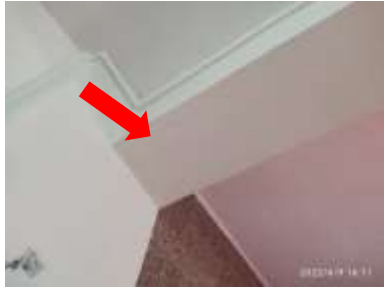
| a) | Living Room | Beam | | | Structural crack | Refer attachment I : TYPE VI |

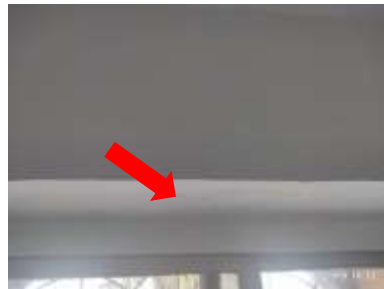
| b) | Kitchen | Lintel Beam | | | Structural crack | Refer attachment I : TYPE VI |

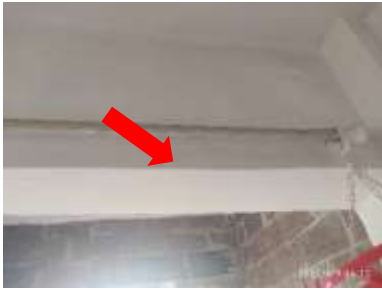
| c) | Kitchen | Beam | | | Structural crack | Refer attachment I : TYPE VI |
