# STRUCTURAL AUDIT REPORT

NOOR CO-OP. HOUSING SOCIETY LTD,

VASHI,

**Taamra Engineering Consultants Private Limited**

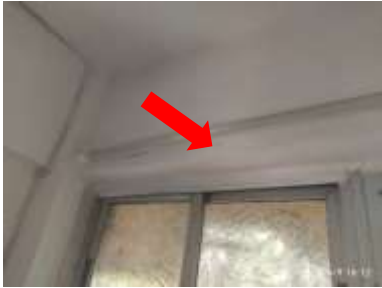
| d) | Bedroom1 | Lintel Beam | | | Major structural crack, Window top lintel found with crack | Refer attachment I : TYPE VI, TYPE XIX |

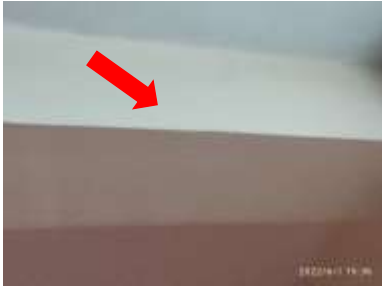
| a) | Living Room | Beam | | | Plaster with hollow sound | Refer attachment I : TYPE XVIII |

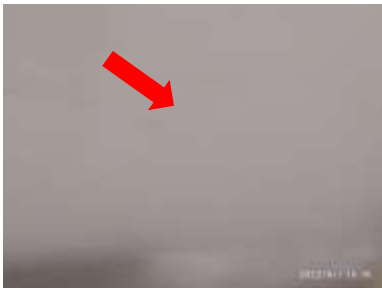
| b) | Living Room | Ceiling | | | Ceiling cracks | Refer attachment I : TYPE XIII |

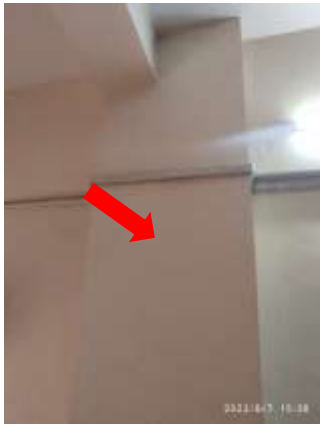
| c) | Living Room | Column C 20 | | | Column with hollow sound | Refer attachment I : TYPE XVII |

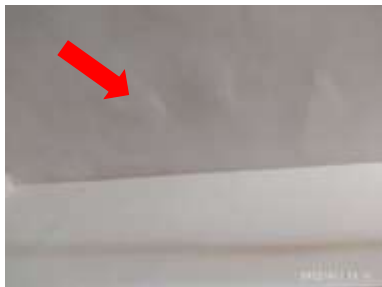
| d) | Living Room | Ceiling | | | Ceiling cracks | Refer attachment I : TYPE XIII |

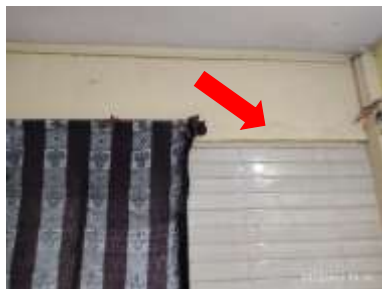
| e) | Bedroom 1 | Beam | | | Plaster crack | Refer attachment I : TYPE V |

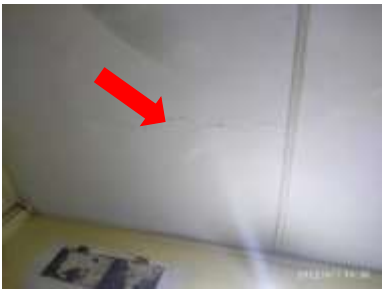
| g) | Bedroom<br>1 | Ceiling | | | Ceiling cracks | Refer attachment<br>I : TYPE XIII |

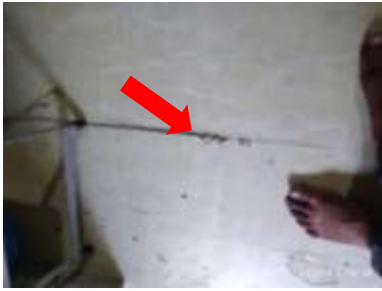
| h) | Bedroom<br>1 | Floor | | | Floor tile<br>uplift | Refer attachment<br>I : TYPE XXVI |

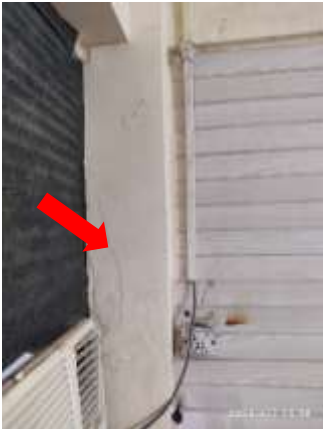
| i) | Bedroom<br>1 | Column<br>C 24 | | | Plaster crack | Refer attachment<br>I : TYPE V |

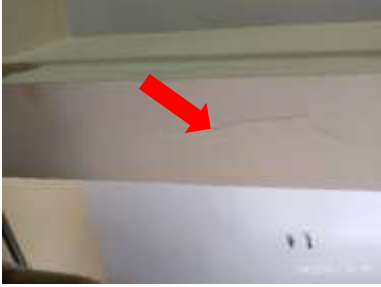
| k) | Living<br>Room | Beam | | | Structural<br>crack | Refer attachment<br>I : TYPE VI |

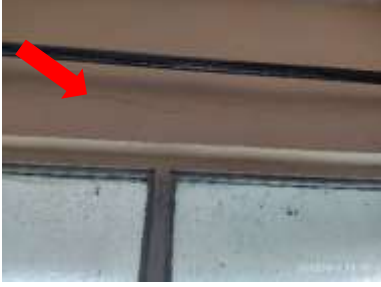
| l) | Living<br>Room<br>Balcony | Lintel Beam | | | Window top<br>Lintel found<br>with crack,<br>Structural<br>crack | Refer attachment<br>I : TYPE XIX, TYPE<br>VI |

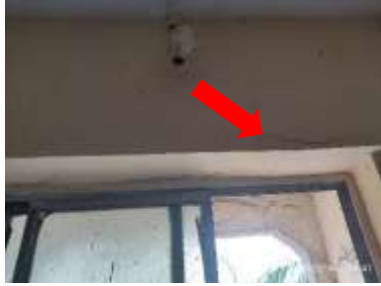
| m) | Living<br>Room<br>Balcony | Lintel Beam | | | Window top<br>Lintel found<br>with crack,<br>Structural<br>crack | Refer attachment<br>I : TYPE XIX TYPE<br>VI |

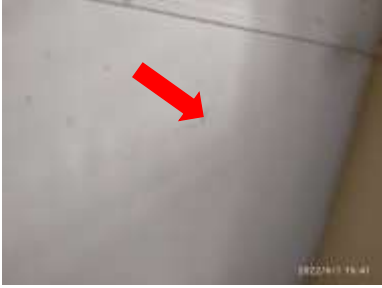
| o) | Kitchen | Ceiling | | | Ceiling cracks | Refer attachment<br>I : TYPE XIII |

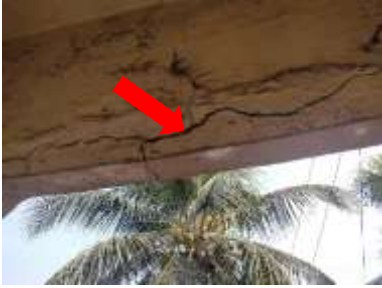
| p) | Kitchen | Chajja | | | Major<br>Structural<br>crack | Refer attachment<br>I : TYPE VI |

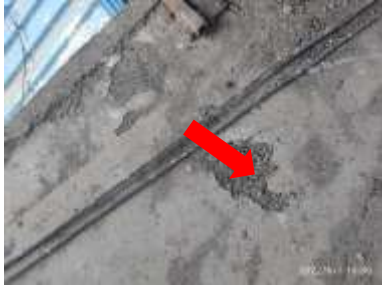
| Sr No. | LOCATION | AREA DESCRIPTION | | PHOTOS | DEFECTS | PROCESS FOR AMELIORATIONS |
|---|---|---|---|---|---|---|
| a) | Water Tank | Floor | | | Surface hair line cracks, Plaster cracks | Refer attachment 1-TYPE XXI, TYPE V |

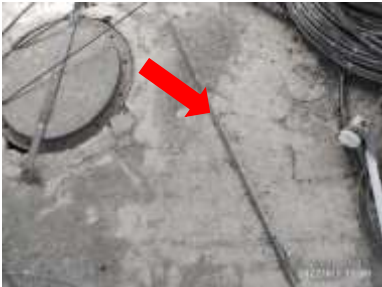
| Sr No. | LOCATION | AREA DESCRIPTION | | PHOTOS | DEFECTS | PROCESS FOR AMELIORATIONS |
|---|---|---|---|---|---|---|
| b) | Water Tank | Floor | | | Surface hair line cracks, Plaster cracks | Refer attachment 1-TYPE XXI, TYPE V |

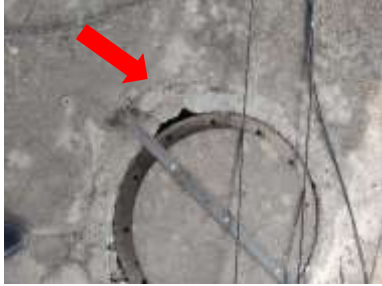
| Sr No. | LOCATION | AREA DESCRIPTION | | PHOTOS | DEFECTS | PROCESS FOR AMELIORATIONS |
|---|---|---|---|---|---|---|
| c) | Water Tank | Floor | | | Surface hair line cracks, Plaster cracks | Refer attachment 1-TYPE XXI, TYPE V |

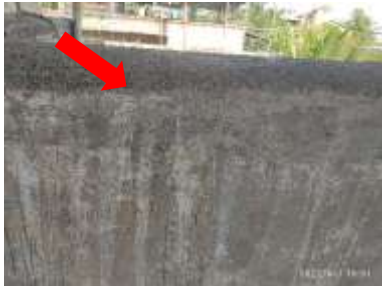
| Sr No. | LOCATION | AREA DESCRIPTION | | PHOTOS | DEFECTS | PROCESS FOR AMELIORATIONS |
|---|---|---|---|---|---|---|
| d) | Terrace | Parapet wall | | | Plaster cracks | Refer attachment 1-TYPE V |

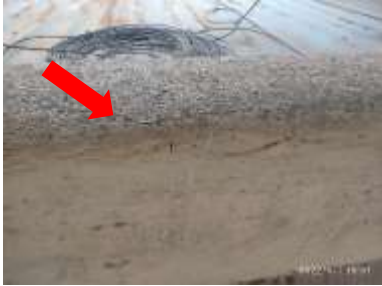
| f) | Terrace | Parapet wall | | | Plaster cracks | Refer attachment 1-TYPE V |

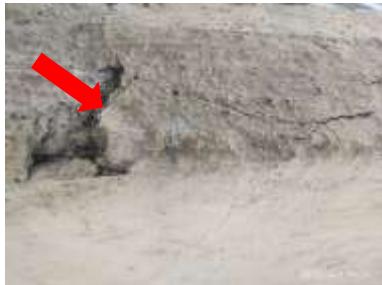
| g) | Terrace | Parapet wall | | | Plaster cracks | Refer attachment 1-TYPE V |

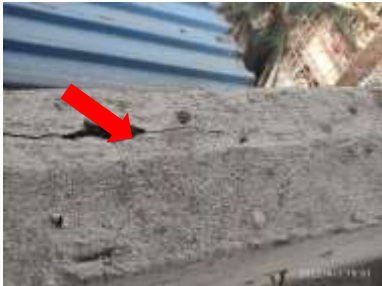
| h) | Terrace | Parapet wall | | | Structural cracks | Refer attachment 1-TYPE VI |

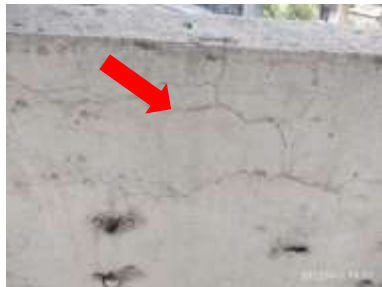
| i) | Terrace | Parapet wall | | | Plaster cracks | Refer attachment 1-TYPE V |

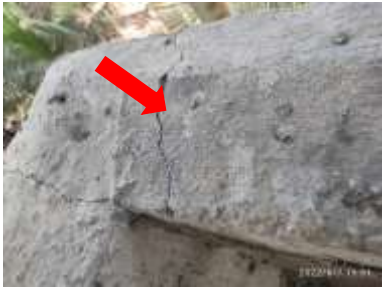
| j) | Terrace | Parapet wall | | | Structural crack | Refer attachment 1-TYPE VI |

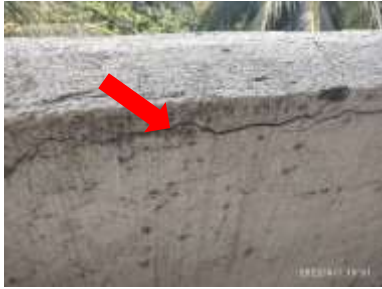
| k) | Terrace | Parapet Wall | | | Structural crack | Refer attachment 1-TYPE VI |

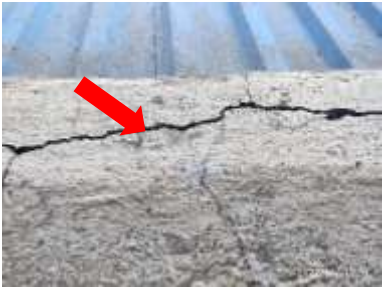
| l) | Terrace | Parapet Wall | | | Structural crack | Refer attachment 1-TYPE VI |

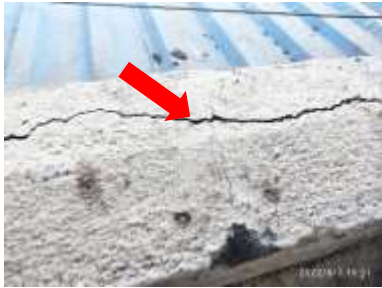
| m) | Terrace | Parapet Wall | | | Structural crack | Refer attachment 1-TYPE VI |

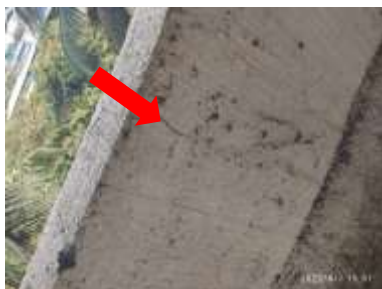
| n) | Terrace | Parapet wall | | | Plaster crack | Refer attachment 1-TYPE V |

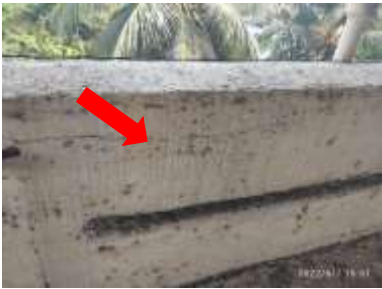
| o) | Terrace | Parapet wall | | | Plaster crack | Refer attachment 1-TYPE V |

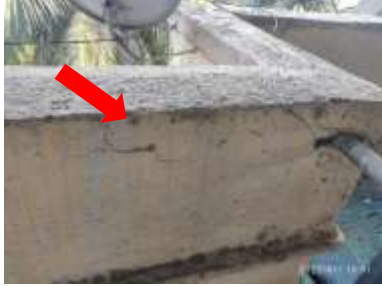
| p) | Terrace | Parapet wall | | | Structural crack | Refer attachment 1-TYPE VI |

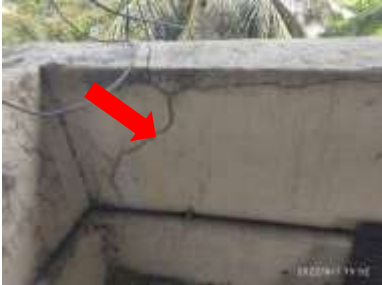
| q) | Terrace | Parapet wall | | | Structural crack | Refer attachment 1-TYPE VI |

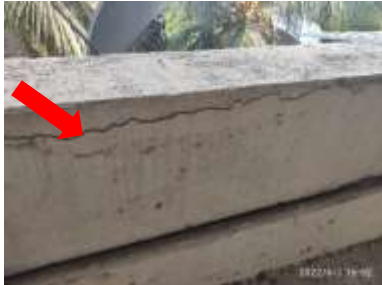
| r) | Terrace | Parapet wall | | | Structural crack | Refer attachment 1-TYPE VI |

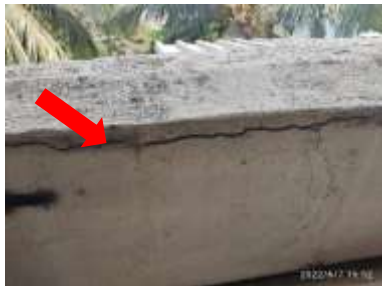
| s) | Terrace | Parapet wall | | | Structural crack | Refer attachment 1-TYPE VI |

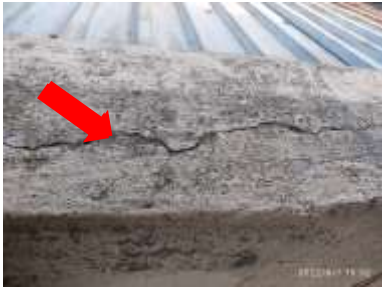
| t) | Terrace | Parapet wall | | | Structural crack | Refer attachment 1-TYPE VI |

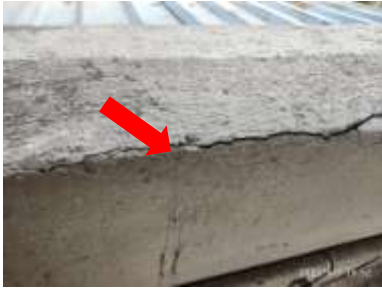
| u) | Terrace | Parapet wall | | | Structural crack | Refer attachment 1-TYPE VI |

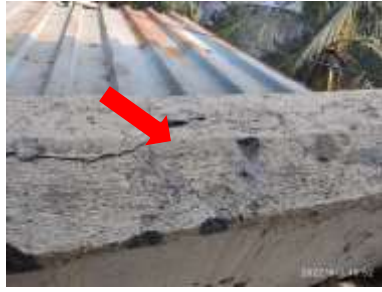
| v) | Terrace | Parapet wall | | | Structural crack | Refer attachment 1-TYPE VI |

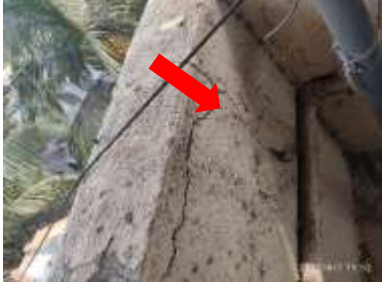
| w) | Terrace | Parapet wall | | | Structural crack | Refer attachment 1-TYPE VI |

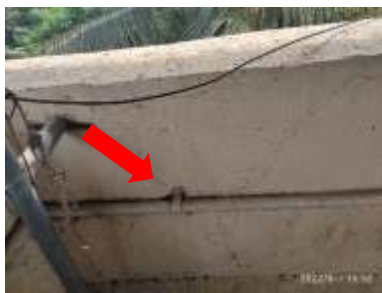
| x) | Terrace | Parapet wall | | | Structural crack | Refer attachment 1-TYPE VI |

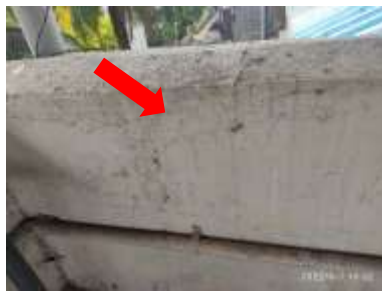
| y) | Terrace | Parapet wall | | | Plaster crack | Refer attachment 1-TYPE V |

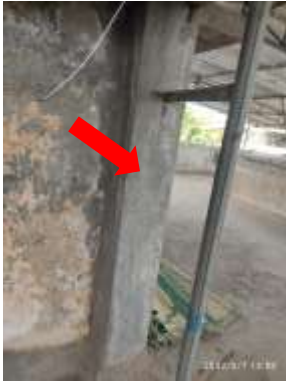
| z) | Water tank | Column | | | Structural crack | Refer attachment 1-TYPE VI |

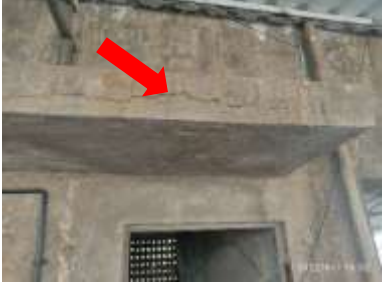
| aa) | Mumpty room | Chajja | | | Structural crack | Refer attachment 1-TYPE VI |

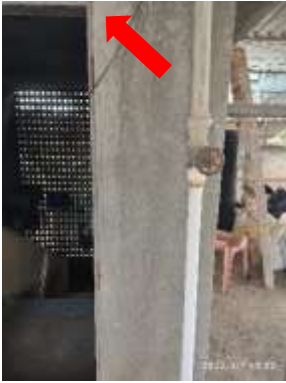
| ab) | Water tank | Column | | | Structural crack | Refer attachment 1-TYPE VI |

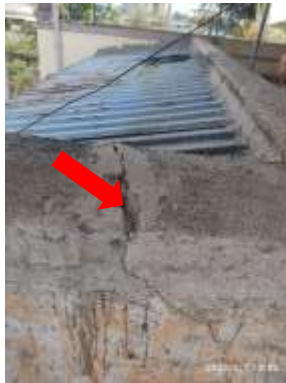
| ac) | Terrace | Parapet wall | | | Structural crack | Refer attachment 1-TYPE VI |

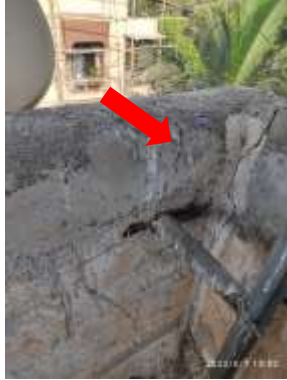
| ad) | Terrace | Parapet wall | | | Structural crack | Refer attachment 1-TYPE VI |

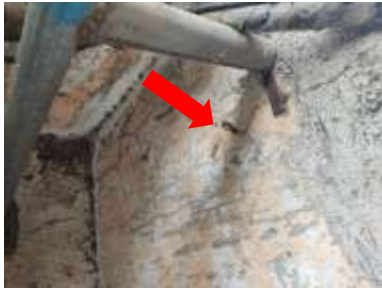
| ae) | Terrace | Parapet wall | | | Structural crack | Refer attachment 1-TYPE VI |

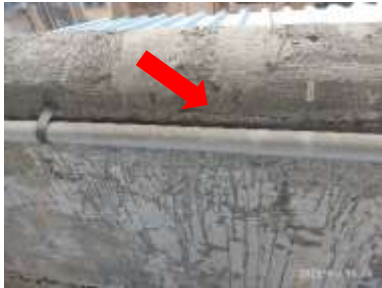
| af) | Terrace | Parapet wall | | | Structural crack | Refer attachment 1-TYPE VI |

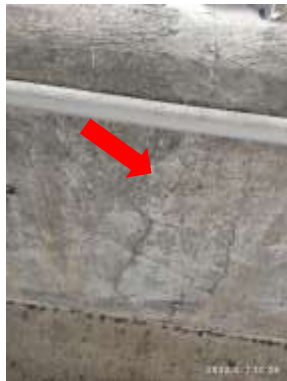
| ag) | Terrace | Parapet wall | | | Structural crack | Refer attachment 1-TYPE VI |

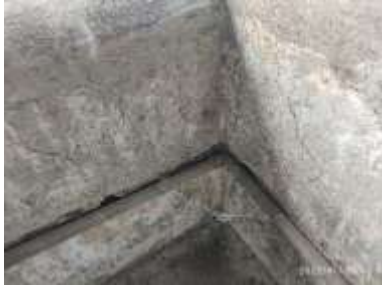
| ah) | Terrace | Parapet wall | | | Plaster crack | Refer attachment<br>1-TYPE V |

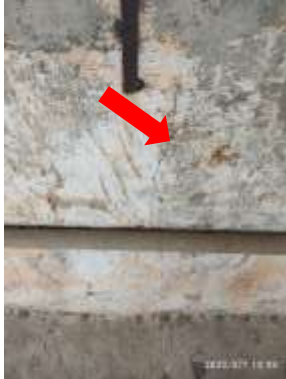
| ai) | Terrace | Parapet wall | | | Plaster crack | Refer attachment<br>1-TYPE V |

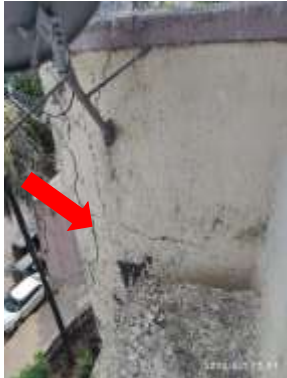
| aj) | External | Wall | | | Major<br>Structural<br>crack | Refer attachment<br>1-TYPE VI |

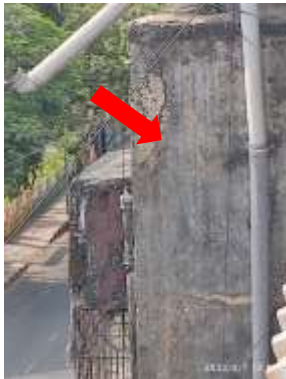
| ak) | External | Wall | | | Major<br>Structural<br>crack | Refer attachment<br>1-TYPE VI |

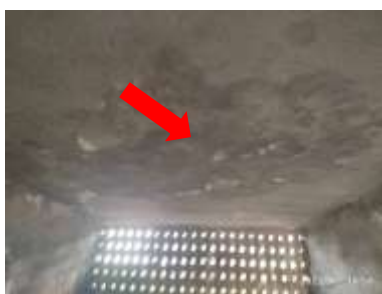
| a) | Mumpty room | Ceiling | | | Seepages from water tank, Ceiling cracks | Refer attachment 1-TYPE XI, TYPE XIII |

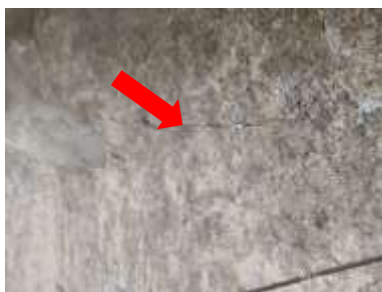
| b) | Mumpty Room | Wall | | | Plaster crack | Refer attachment 1-TYPE V |

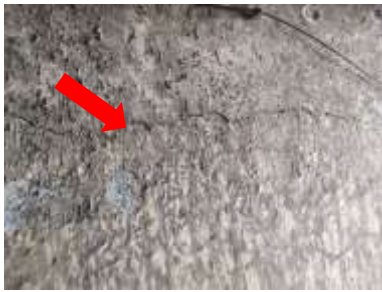
| c) | Mumpty Room | Beam | | | Separation crack | Refer attachment 1-TYPE X |

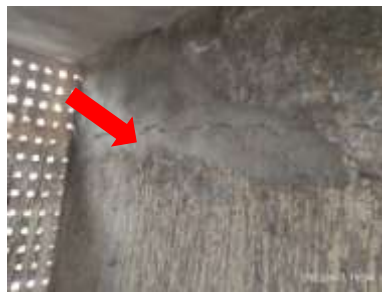
| d) | Mumpty Room | Beam | | | Major structural crack | Refer attachment 1-TYPE VI |

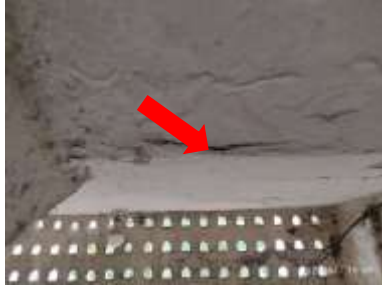
| e) | Staircase 4 <sup>th</sup> Floor | Waist slab | | | Structural crack | Refer attachment 1-TYPE VI |

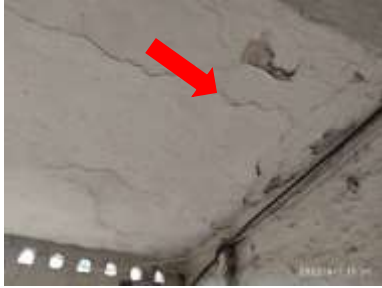
| f) | Staircase<br>4 <sup>th</sup> Floor | Waist slab | | | Structural<br>crack | Refer attachment<br>1-TYPE VI |

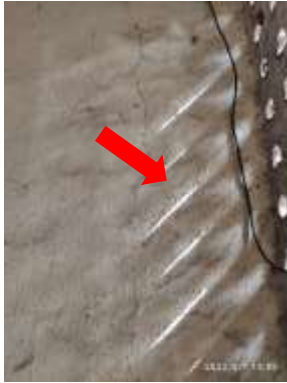
| g) | Staircase<br>4 <sup>th</sup> Floor | Column | | | Structural<br>crack, plaster<br>with hollow<br>sound | Refer attachment<br>1-TYPE VI, TYPE<br>XVIII |

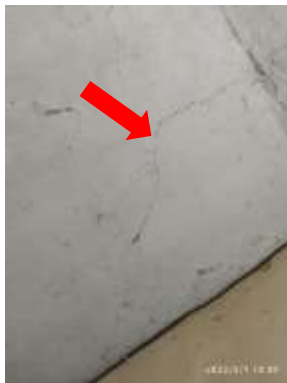
| h) | Staircase<br>4 <sup>th</sup> Floor | Waist slab | | | Structural<br>crack | Refer attachment<br>1-TYPE VI |

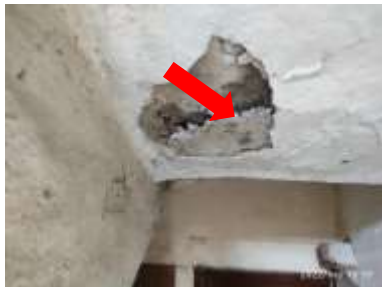
| i) | Staircase<br>4 <sup>th</sup> Floor | Waist slab | | | Major<br>Structural<br>crack | Refer attachment<br>1-TYPE VI |

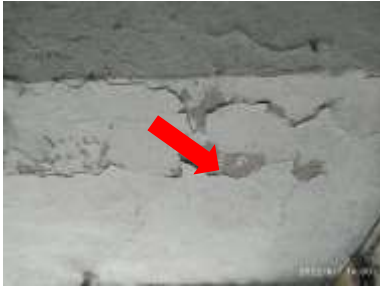
| j) | Staircase<br>3 <sup>rd</sup> Floor | Waist slab | | | Structural<br>crack | Refer attachment<br>1-TYPE VI |

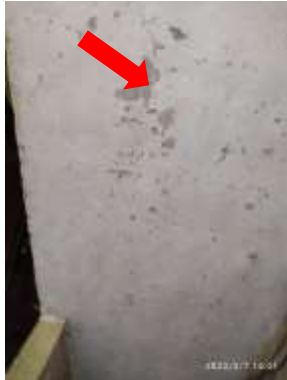
| k) | Staircase<br>1 <sup>st</sup> Floor | Waist slab | | | Plaster with<br>hollow sound | Refer attachment<br>1-TYPE XVIII |

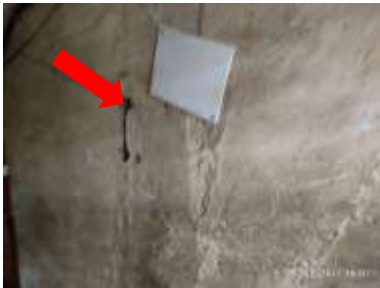
| l) | Staircase<br>1 <sup>st</sup> Floor | Handrail | | | Plaster with<br>hollow sound | Refer attachment<br>1-TYPE XVIII |

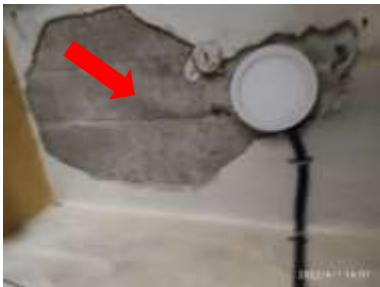
| m) | Staircase<br>1 <sup>st</sup> Floor | Ceiling | | | Ceiling cracks<br>(plaster spall<br>off) | Refer attachment<br>1-TYPE XIII |

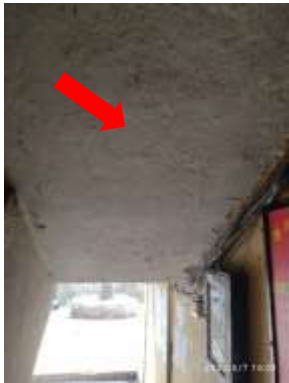
| n) | Staircase<br>1 <sup>st</sup> Floor | Waist slab | | | Plaster with hollow sound | Refer attachment 1-TYPE XVIII |

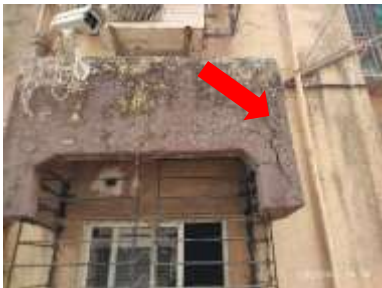
| a) | External | Chajja | | | Structural crack | Refer attachment 1-TYPE VI |

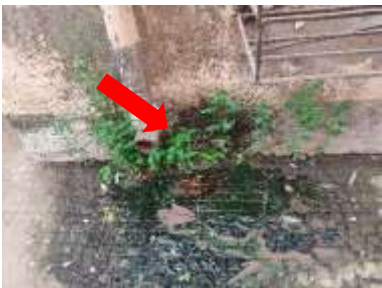
| b) | Plumbing | Vegetation | | | Vegetation, Water dripping | Refer attachment 1-TYPE XXII, TYPE IX |

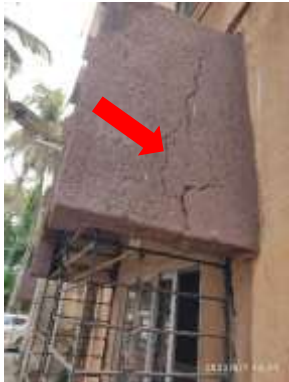
| c) | External | Chajja | | | Structural crack | Refer attachment 1-TYPE VI |

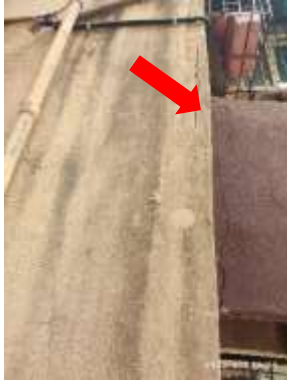
| d) | External | Column | | | Major Structural crack | Refer attachment 1-TYPE VI |

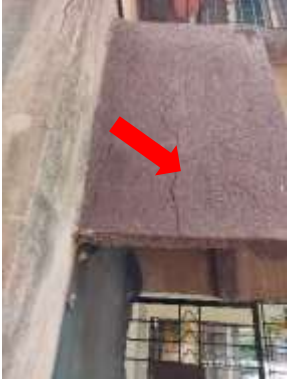
| e) | External | Chajja | | | Structural crack | Refer attachment 1-TYPE VI |

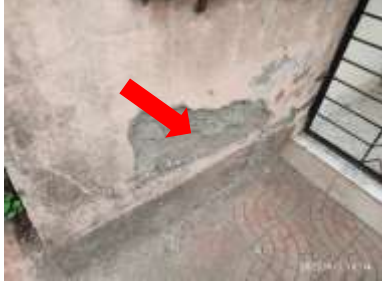
| f) | External | Wall | | | Plaster with hollow sound | Refer attachment 1-TYPE XVIII |

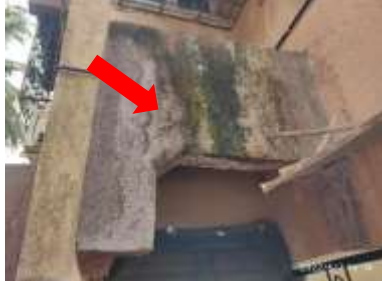
| g) | External | Chajja | | | Structural crack | Refer attachment 1-TYPE VI |

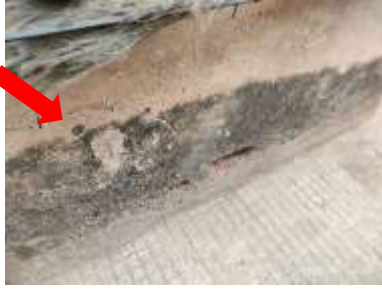
| h) | External | Wall | | | Plaster with hollow sound | Refer attachment 1-TYPE XVIII |

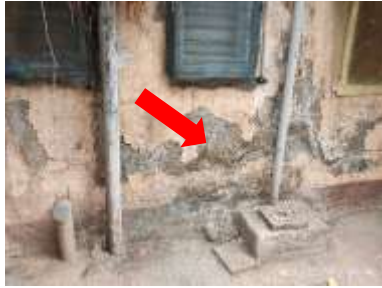
| i) | External | Wall | | | Plaster with hollow sound | Refer attachment 1-TYPE XVIII |

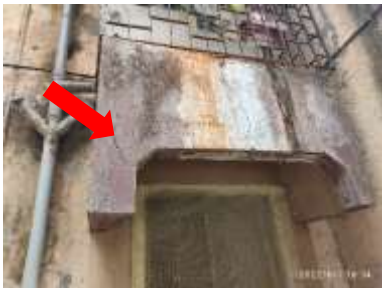
| j) | External | Chajja | | | Structural crack | Refer attachment 1-TYPE VI |

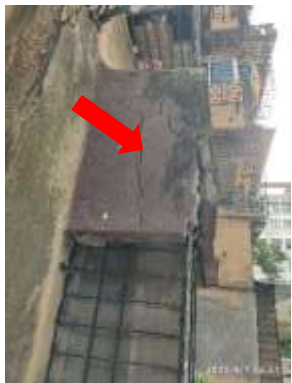
| k) | External | Chajja | | | Structural crack | Refer attachment 1-TYPE VI |

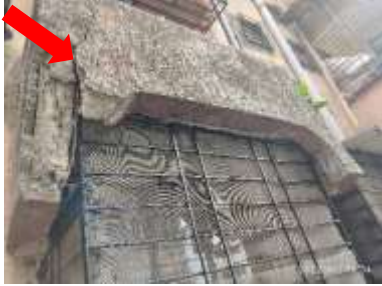
| l) | External | Chajja | | | Structural crack<br>(plaster spall off) | Refer attachment<br>1-TYPE VI |

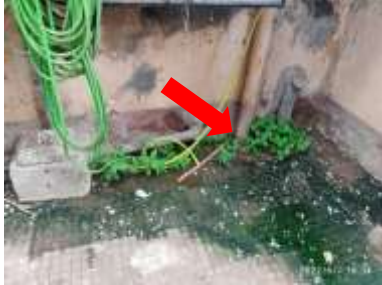
| m) | External | Vegetation | | | Vegetation,<br>water dripping | Refer attachment<br>1-TYPE XXII, TYPE IX |

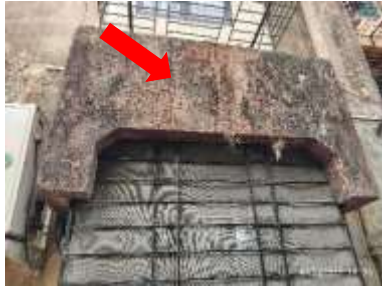
| n) | External | Chajja | | | Structural crack | Refer attachment<br>1-TYPE VI |

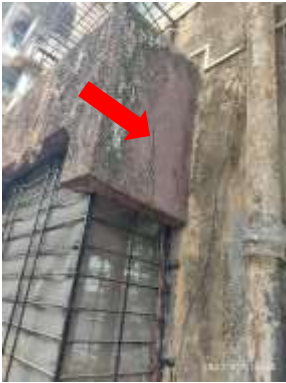
| o) | External | Chajja | | | Structural crack | Refer attachment<br>1-TYPE VI |

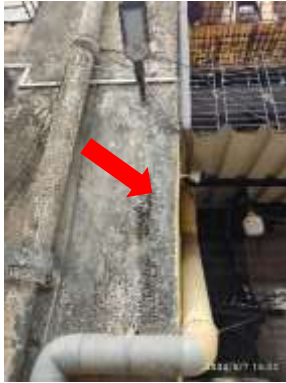
| p) | External | Column | | | Structural crack | Refer attachment 1-TYPE VI |

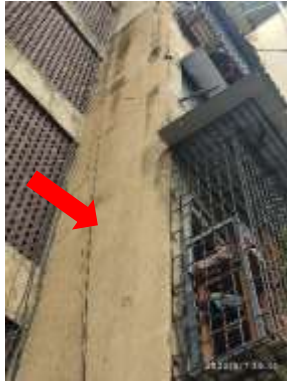
| q) | External | Dead Wall | | | Structural crack, plaster cracks<br>(Source of leakages inside the Flat) | Refer attachment 1-TYPE VI, TYPE V |

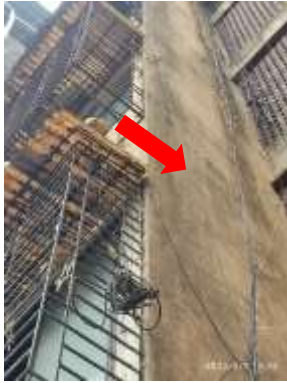
| r) | External | Dead Wall | | | Structural crack, plaster cracks<br>(Source of leakages inside the Flat) | Refer attachment 1-TYPE VI, TYPE V |

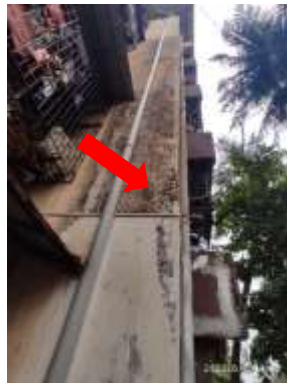
| s) | External | Dead Wall | | | Structural crack, plaster cracks<br>(Source of leakages inside the Flat) | Refer attachment 1-TYPEVI, TYPE V |

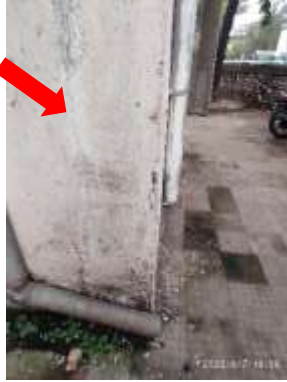
| t) | External | Dead Wall | | | Structural crack | Refer attachment 1-TYPE VI |

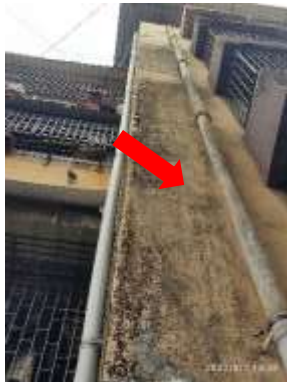
| u) | External | Column | | | Structural crack, plaster cracks<br>(Source of leakages inside the Flat) | Refer attachment 1-TYPE VI, TYPE V |

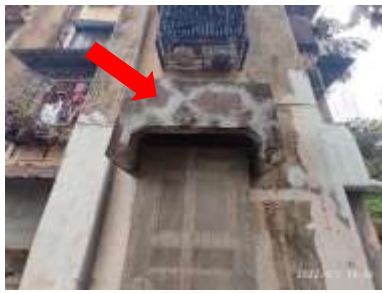
| v) | External | Chajja | | | Structural crack | Refer attachment 1-TYPE VI |

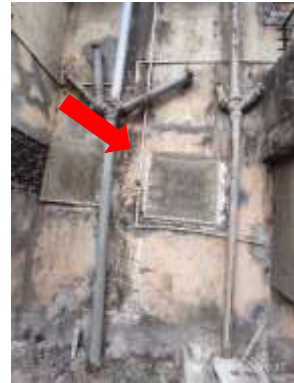
| w) | External | Plumbing line | | | Seepages, water dripping | Refer attachment 1-TYPE XI, TYPE IX |

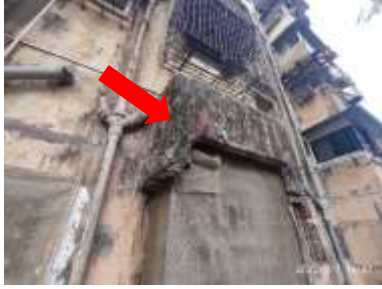
| x) | External | Chajja | | | Structural crack | Refer attachment 1-TYPE VI |

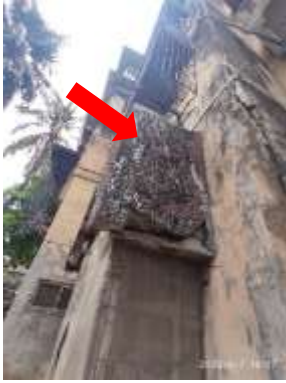
| y) | External | Chajja | | | Structural crack | Refer attachment 1-TYPE VI |

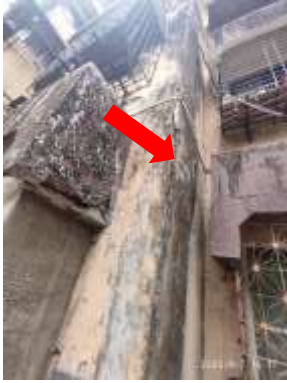
| z) | External | Column | | | Structural crack | Refer attachment 1-TYPE VI |

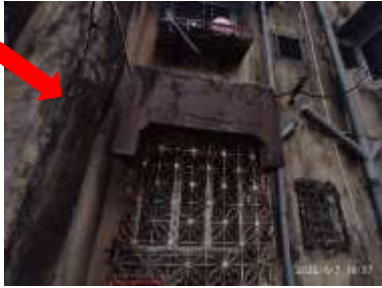
| aa) | External | Column | | | Structural crack | Refer attachment 1-TYPE VI |

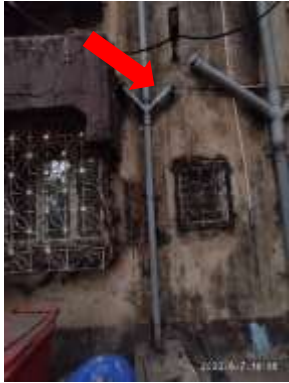
| ab) | External | Plumbing Line | | | Structural crack, plaster cracks<br>(Source of leakages inside the Flat) | Refer attachment 1-TYPE VI, TYPE V |

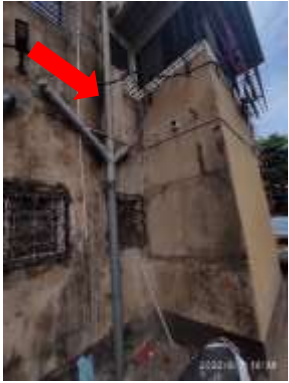
| ac) | External | Plumbing Line | | | Water dripping, seepages | Refer attachment 1-TYPE IX, TYPE XI |

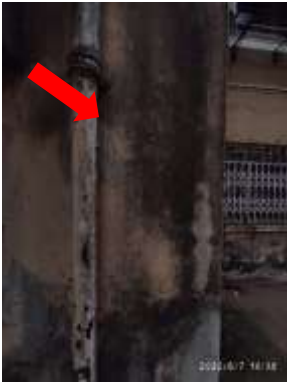
| ad) | External | Plumbing Line | | | Water dripping, seepages | Refer attachment 1-TYPE IX, TYPE XI |

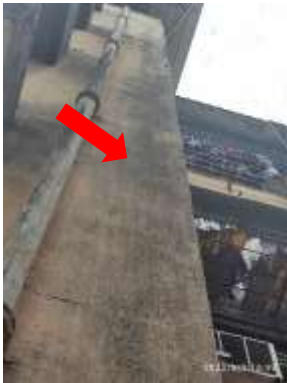
| ae) | External | Dead Wall | | | Water dripping, seepages | Refer attachment 1-TYPE IX, TYPE XI |

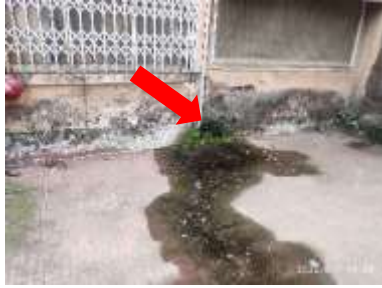
| af) | External | plumbing | | | Water leakages | Refer attachment 1-TYPE IX |

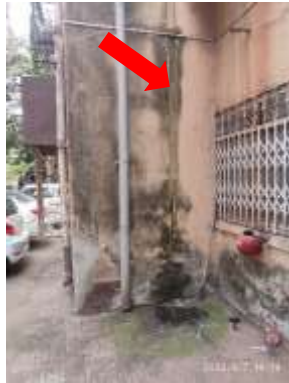
| ag) | External | Dead wall | | | Water dripping, seepages | Refer attachment 1-TYPE IX, TYPE XI |

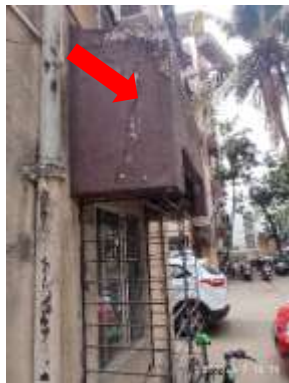
| ah) | External | Chajja | | | Structural crack | Refer attachment 1-TYPE VI |

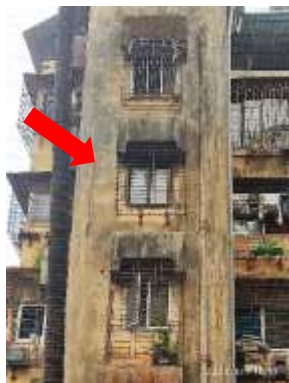
| ai) | External | Column | | | Major structural crack | Refer attachment 1-TYPE VI |

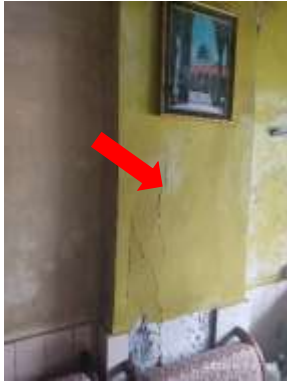
| Sr No. | LOCATION | AREA DESCRIPTION | | PHOTOS | DEFECTS | PROCESS FOR AMELIORATIONS |
|---|---|---|---|---|---|---|
| a) | Living Room | Column C 4 | | | Major structural crack, Column Found with crack | Refer attachment 1-TYPE VI, Type XVII |

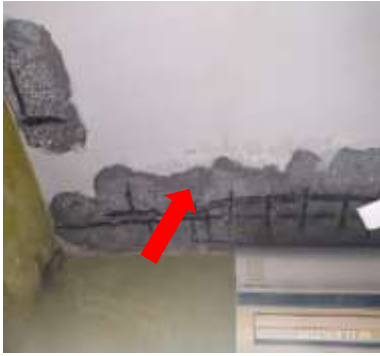
| Sr No. | LOCATION | AREA DESCRIPTION | | PHOTOS | DEFECTS | PROCESS FOR AMELIORATIONS |
|---|---|---|---|---|---|---|
| b) | Living Room Balcony | Ceiling | | | Major Structural crack, Major ceiling crack (reinforcement Corroded, Plaster spall off) | Refer attachment 1-TYPE VI, TYPE XII |

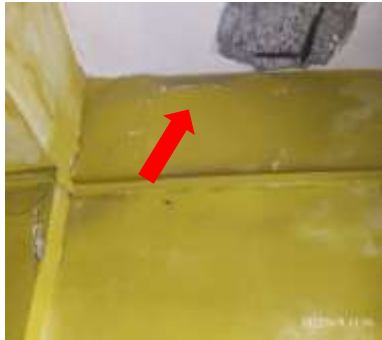
| Sr No. | LOCATION | AREA DESCRIPTION | | PHOTOS | DEFECTS | PROCESS FOR AMELIORATIONS |
|---|---|---|---|---|---|---|
| c) | Living Room Balcony | Beam | | | Major structural crack (Plaster spall off) | Refer attachment 1-TYPE VI |

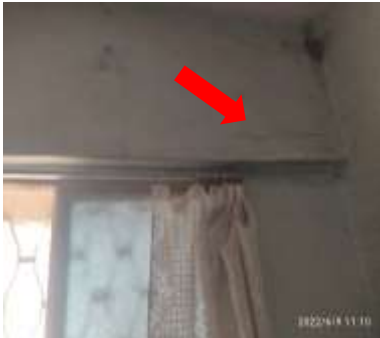
| Sr No. | LOCATION | AREA DESCRIPTION | | PHOTOS | DEFECTS | PROCESS FOR AMELIORATIONS |
|---|---|---|---|---|---|---|
| d) | Kitchen | Beam | | | Structural crack, Beam found with crack | Refer attachment 1-TYPE VI |

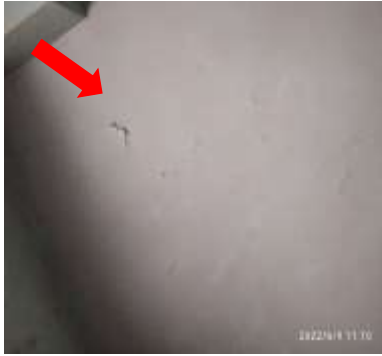
| e) | Kitchen | Ceiling | | | Ceiling cracks | Refer attachment<br>1-TYPE XII |

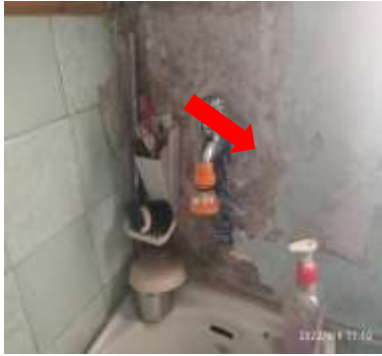
| f) | Kitchen | Wall | | | Seepages<br>through sink<br>Pipeline | Refer attachment<br>1-TYPE XI |

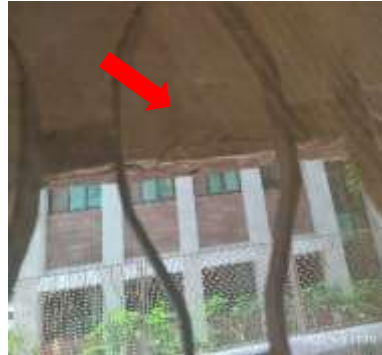
| g) | Kitchen | Chajja | | | Structural<br>crack | Refer attachment<br>1-TYPE VI |

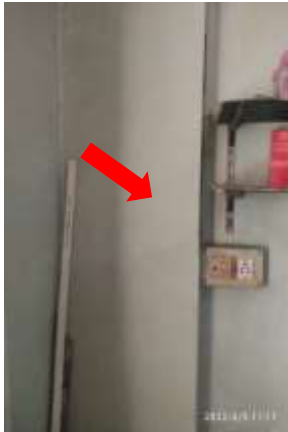
| h) | Kitchen | Column | | | Column with<br>hollow sound | Refer attachment<br>1-TYPE XVII |

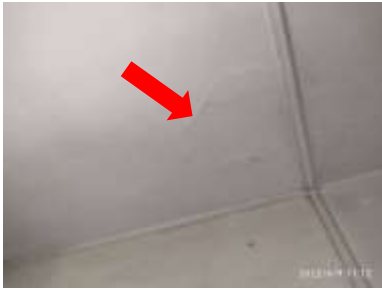
| i) | Bedroom | Ceiling | | | Ceiling cracks | Refer attachment 1-TYPE XII |

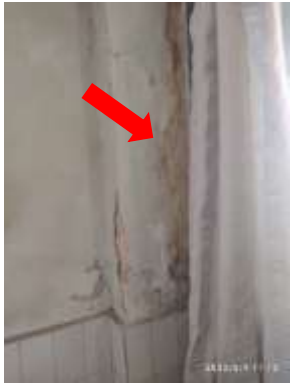
| j) | Bedroom | Column C 8 | | | Seepages from external pipeline | Refer attachment 1-TYPE XI |

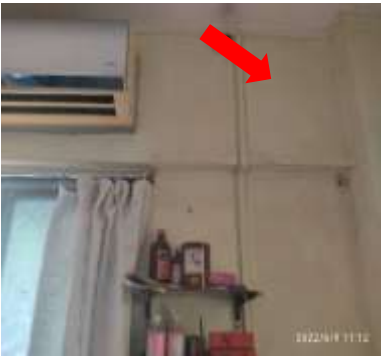
| k) | Bedroom | Beam | | | Plaster crack | Refer attachment 1-TYPE V |

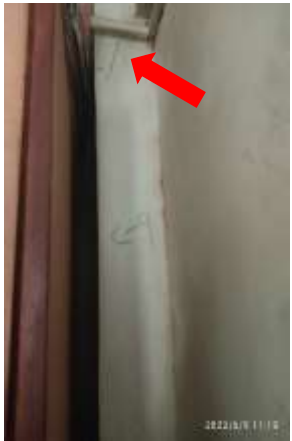
| l) | Bedroom | Column C 9 | | | Structural crack | Refer attachment 1-TYPE VI |

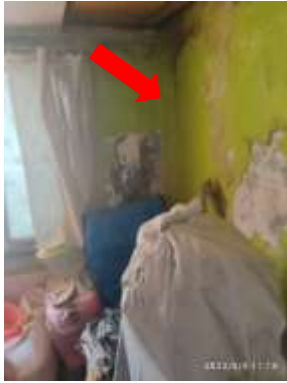
| m) | Bedroom | Wall | | | Major seepages from adjacent Bathroom | Refer attachment 1-TYPE XI |

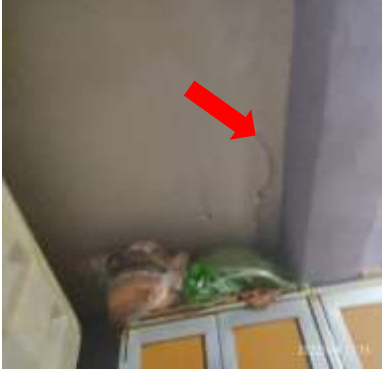
| o) | Passage | Ceiling | | | Ceiling cracks | Refer attachment 1-TYPE XII |

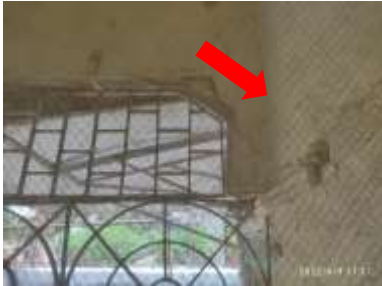
| q) | External | Chajja | | | Plaster crack | Refer attachment 1-TYPE V |

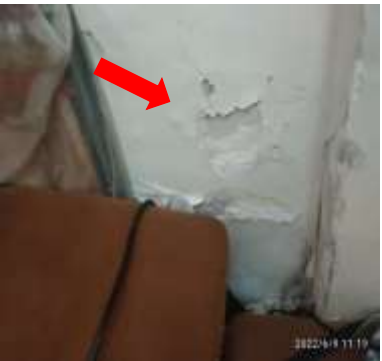
| a) | Living room Balcony | Wall | | | Capillary action marks | Refer attachment 1-TYPE IV |

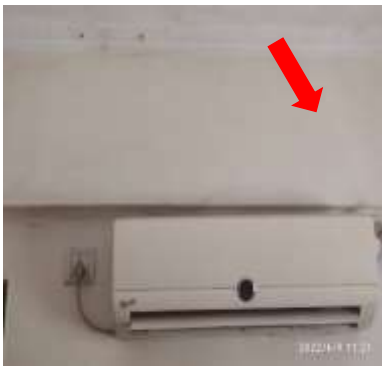
| c) | Bedroom | Beam | | | Plaster crack | Refer attachment 1-TYPE V |

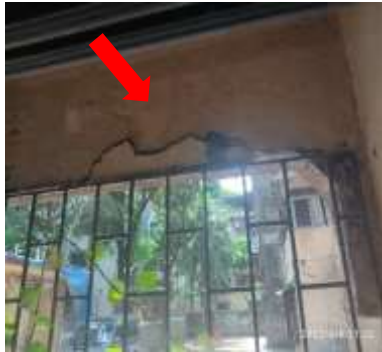
| e) | Bedroom | Chajja | | | Major structural crack | Refer attachment 1-TYPE VI |

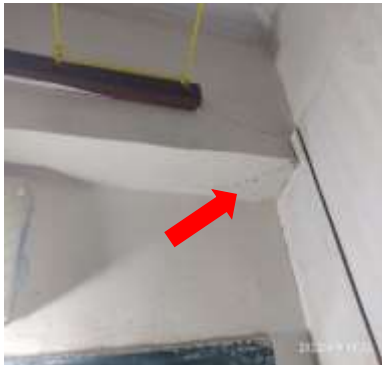
| f) | Passage | Beam | | | Structural crack, Beam Found with crack | Refer attachment 1-TYPE VI |

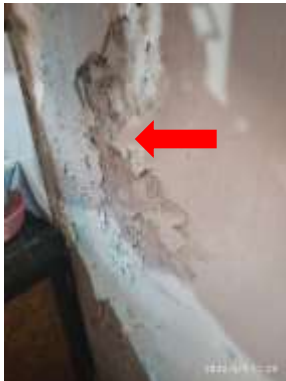
| g) | Kitchen | Wall | | | Seepages from sink Pipeline | Refer attachment 1-TYPE XI |

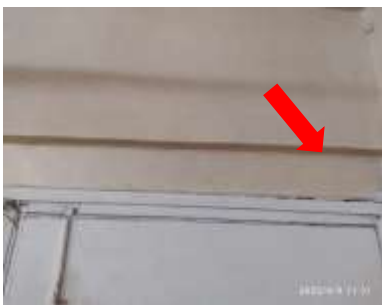
| a) | Living Room | Beam | | | Separation crack | Refer attachment 1-TYPE X |

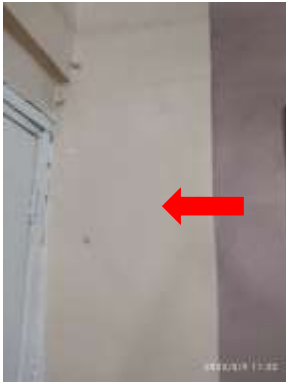
| b) | Living room | Column C 19 | | | Column with hollow sound | Refer attachment 1-TYPE XVII |

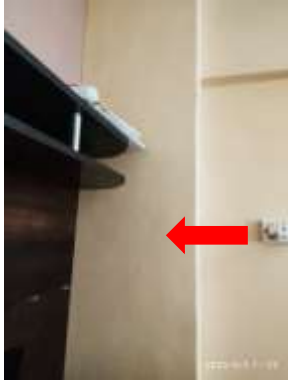
| c) | Living room | Column C 20 | | | Column with hollow sound | Refer attachment 1-TYPE XVII |

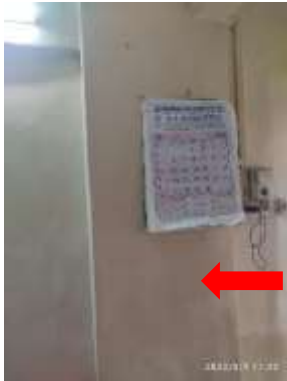
| d) | Living room | Column C 21 | | | Column with hollow sound | Refer attachment 1-TYPE XVII |

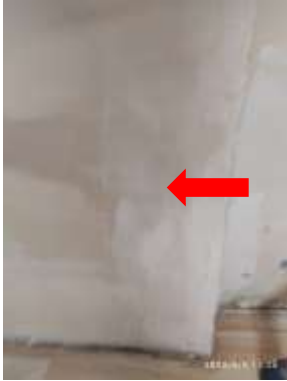
| e) | Living room | Column C 22 | | | Column with hollow sound. Structural crack at bottom | Refer attachment 1-TYPE XVII, TYPE VI |

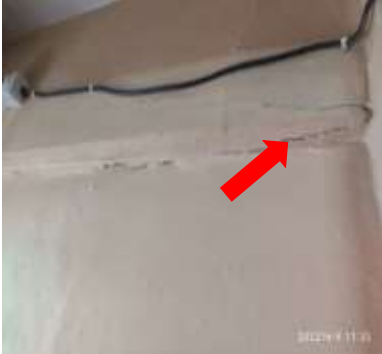
| f) | Living Room Balcony | Beam | | | Major structural crack, Beam Found with crack | Refer attachment 1-TYPE VI |

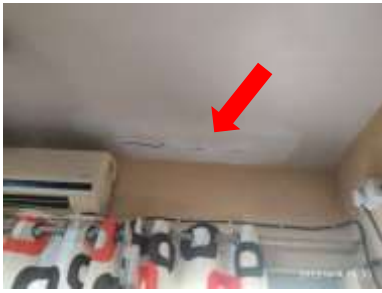
| g) | Living Room Balcony | Ceiling | | | Ceiling cracks | Refer attachment 1-TYPE XIII |

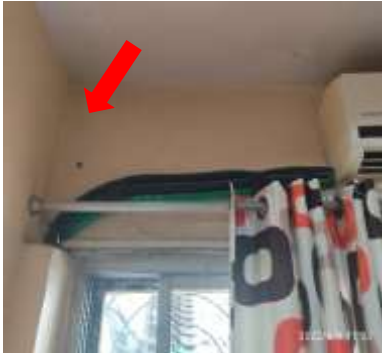
| h) | Living Room Balcony | Lintel Beam | | | Plaster cracks | Refer attachment 1-TYPE V |

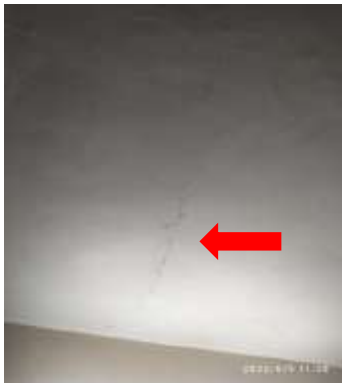
| i) | Living Room Balcony | Ceiling | | | Ceiling cracks | Refer attachment 1-TYPE XIII |

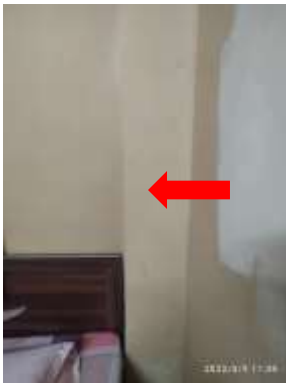
| j) | Living Room Balcony | Beam | | | Plaster crack, Beam found with crack | Refer attachment 1-TYPE V |

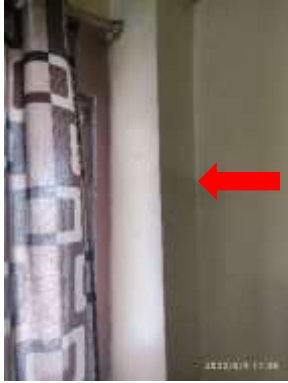
| k) | Bedroom | Column C 24 | | | Column with hollow sound | Refer attachment 1-TYPE XVII |

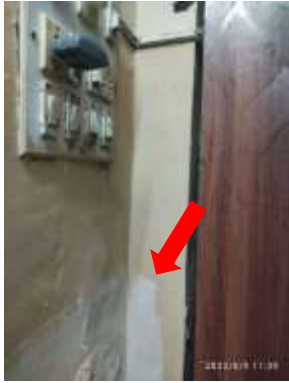
| l) | Bedroom | Column C 25 | | | Plaster crack, Column with hollow sound | Refer attachment 1-TYPE V, TYPE XVII |

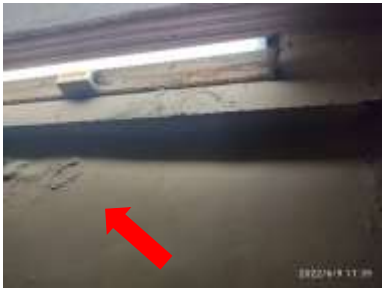
| m) | Bedroom | Beam | | | Seepages from flat no 2/8 & Plaster crack | Refer attachment 1-TYPE XI, TYPE V |

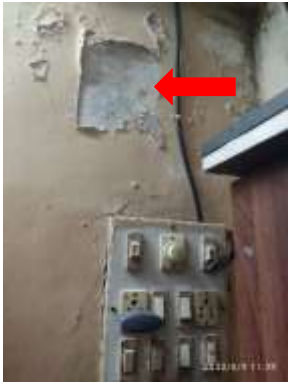
| n) | Bedroom | Wall | | | Seepages from flat no 2/8 & Plaster crack | Refer attachment 1-TYPE XI, TYPE V |

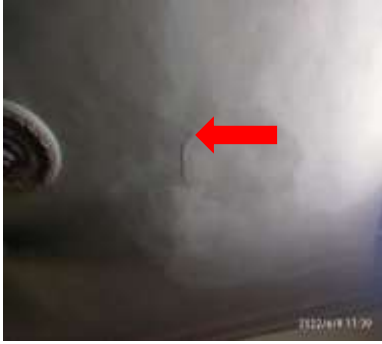
| o) | Bedroom | Ceiling | | | Ceiling cracks | Refer attachment<br>1-TYPE XIII |

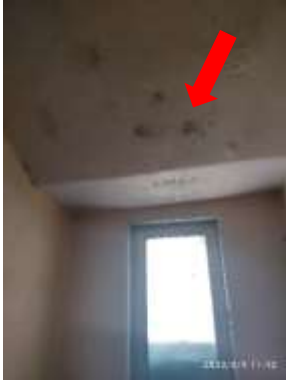
| p) | Toilet | Sunk | | | Seepages<br>from flat no<br>2/8, Plaster<br>crack | Refer attachment<br>1-TYPE XI |

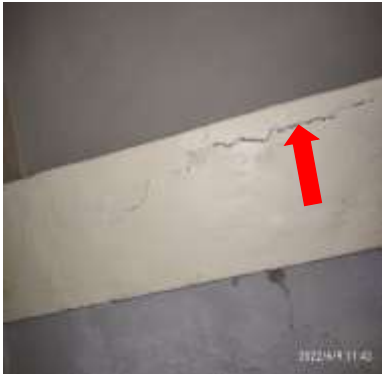
| q) | Passage | Beam | | | Structural<br>crack | Refer attachment<br>1-TYPE VI |

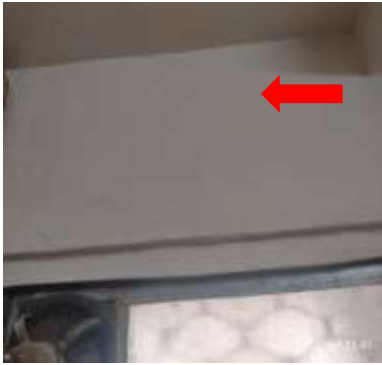
| s) | Kitchen | Beam | | | Plaster crack,<br>Plaster with<br>hollow sound | Refer attachment<br>1-TYPE V, TYPE<br>XVIII |

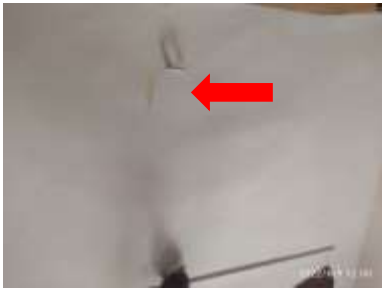
| b) | Bedroom | Ceiling | | | Plaster with<br>hollow sound | Refer attachment<br>1-TYPE XVIII |

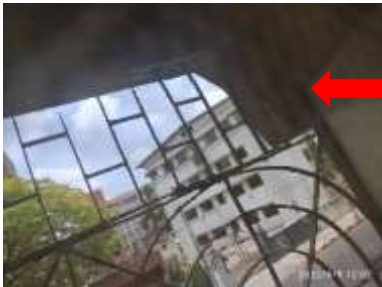
| e) | External | Chajja | | | Structural crack | Refer attachment 1-TYPE VI |

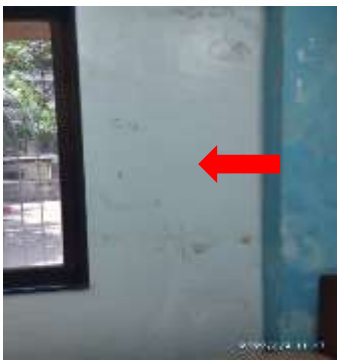
| b) | Bedroom | Wall | | | Seepages from external wall crack | Refer attachment 1-TYPE XI |

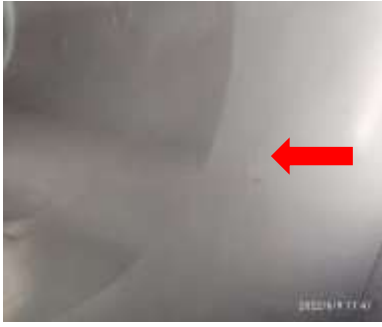
| d) | Bedroom | Ceiling | | | Ceiling crack | Refer attachment<br>1-TYPE XIII |

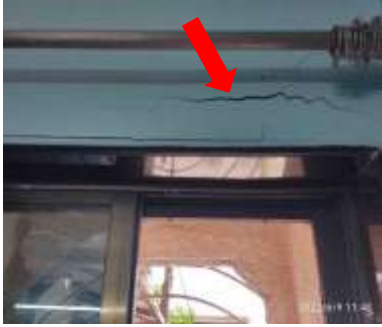
| f) | Bedroom | Lintel Beam | | | Major<br>structural<br>crack,<br>Window top<br>lintel found<br>with crack | Refer attachment<br>1-TYPE VI, TYPE<br>XIX |

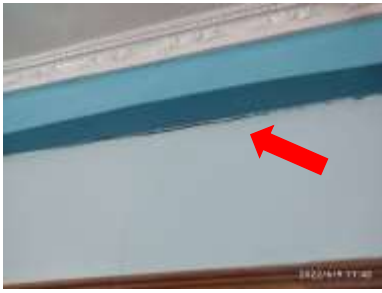
| g) | Bedroom | Beam | | | Separation crack | Refer attachment 1-TYPE X |

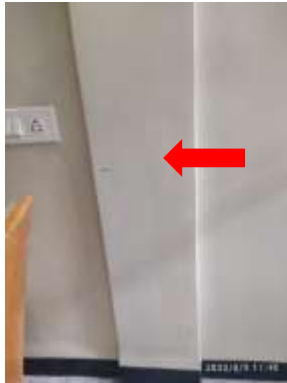
| h) | Kitchen | Column C 2 | | | Plaster crack at bottom, Plaster with hollow sound at bottom | Refer attachment 1-TYPE V, TYPEXVIII |

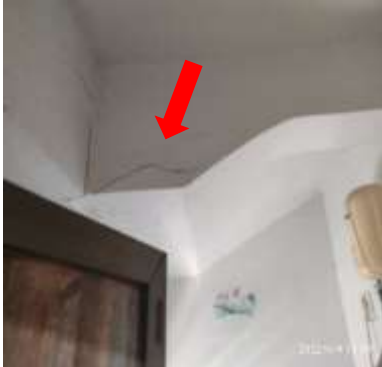
| i) | Toilet | Sunk | | | Structural crack | Refer attachment 1-TYPE VI |

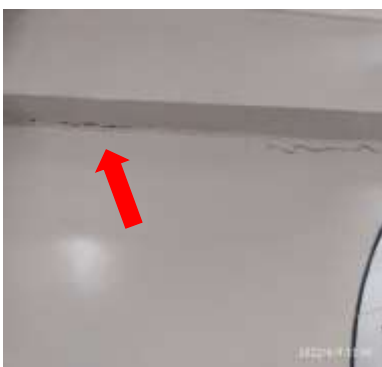
| a) | Living Room | Beam | | | Separation crack | Refer attachment 1-TYPE X |

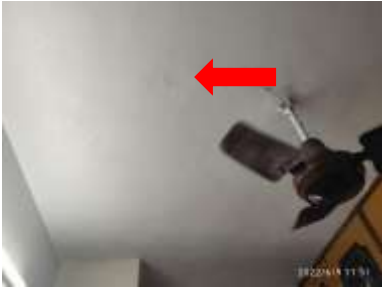
| b) | Kitchen | Ceiling | | | Ceiling cracks | Refer attachment<br>1-TYPE XIII |

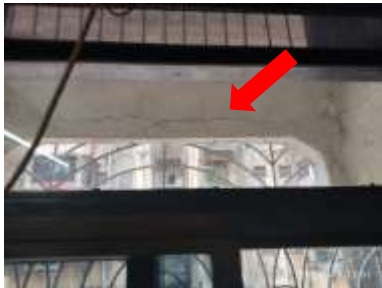
| c) | Kitchen | Chajja | | | Structural<br>crack | Refer attachment<br>1-TYPE VI |

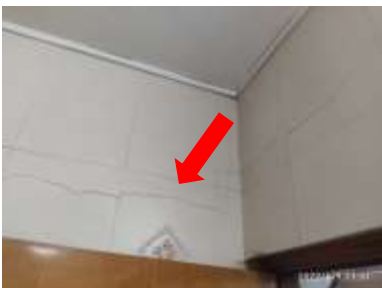
| d) | Kitchen | Wall | | | Tile crack on<br>the wall | Refer attachment<br>1-TYPE I |

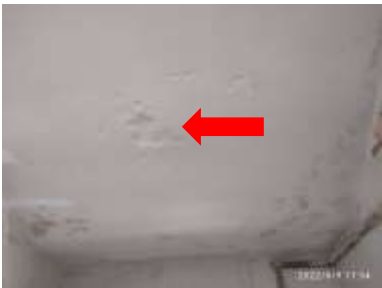
| e) | Toilet | Ceiling | | | Seepages<br>from flat 2/11 | Refer attachment<br>1-TYPE XI |

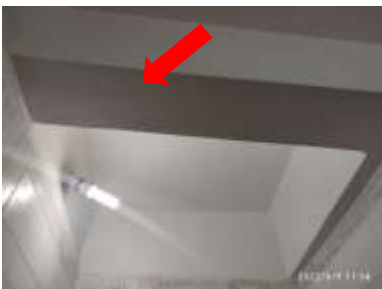
| f) | Passage | Beam | | | Structural<br>crack, Plaster<br>with hollow<br>sound | Refer attachment<br>1-TYPE VI, TYPEX<br>VIII |

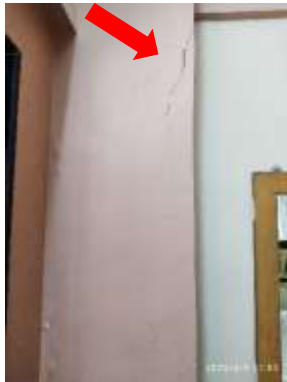
| g) | Bedroom | Column C 18 | | | Major structural crack | Refer attachment 1-TYPE VI |

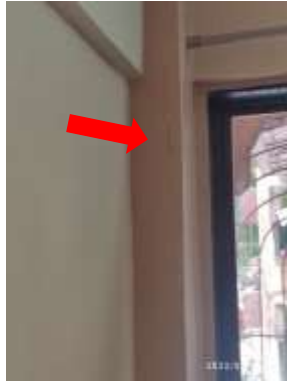
| h) | Bedroom | Column C 19 | | | Major structural crack | Refer attachment 1-TYPE VI |

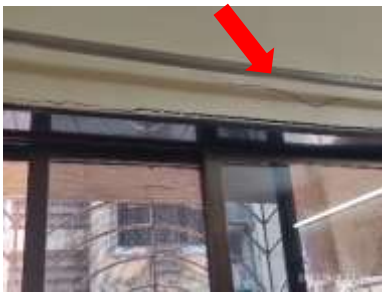
| i) | Bedroom | Lintel Beam | | | Major structural crack, Window top lintel found with crack | Refer attachment 1-TYPE VI, TYPE XIX |

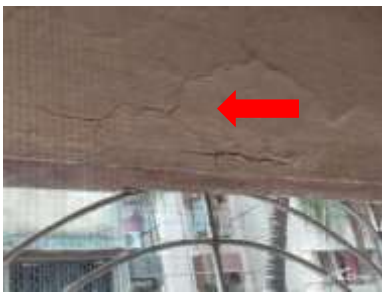
| j) | Bedroom | Chajja | | | Structural crack | Refer attachment 1-TYPE VI |

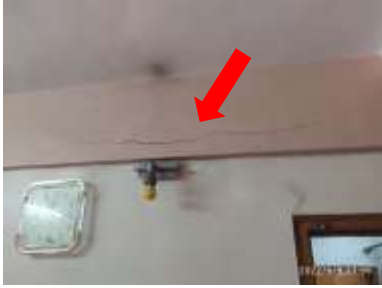
| k) | Bedroom Balcony | Beam | | | Major structural crack | Refer attachment 1-TYPE VI |

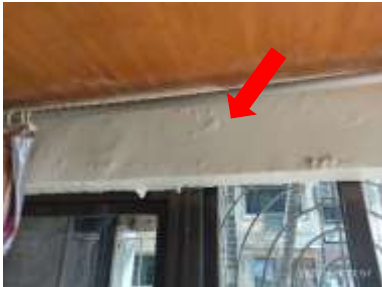
| l) | Bedroom Balcony | Lintel Beam | | | Seepages from external chajja crack | Refer attachment 1-TYPE XU |

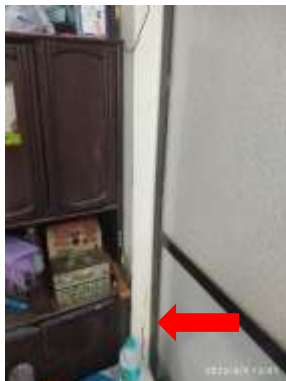
| b) | Living Room | Column C 20 | | | Structural crack at bottom | Refer attachment 1-TYPE VI |

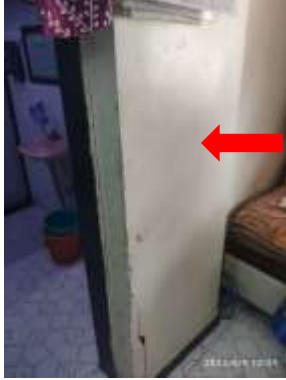
| c) | Living Room | Column C 21 | | | Major structural crack at bottom | Refer attachment 1-TYPE VI |
