# STRUCTURAL AUDIT REPORT

NOOR CO-OP. HOUSING SOCIETY LTD,

VASHI,

**Taamra Engineering Consultants Private Limited**

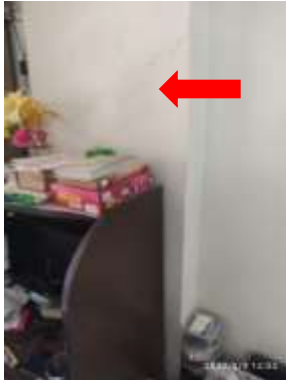
| d) | Living Room | Column C 22 | | | Structural crack at bottom | Refer attachment 1-TYPE VI |

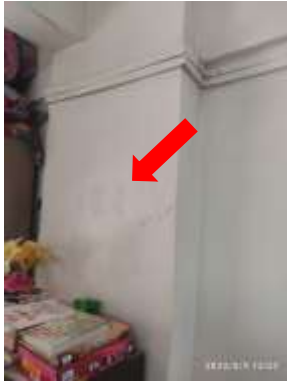
| e) | Living Room | Column C 22 | | | Structural crack | Refer attachment 1-TYPE VI |

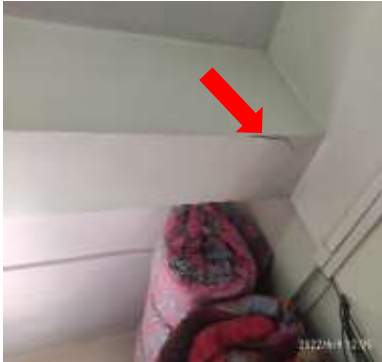
| f) | Living Room | Beam | | | Structural crack | Refer attachment 1-TYPE VI |

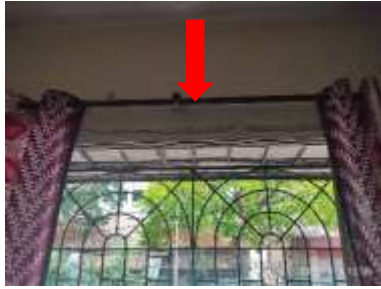
| g) | Living Room | Lintel beam | | | Window top lintel found with crack | Refer attachment 1-TYPE XIX |

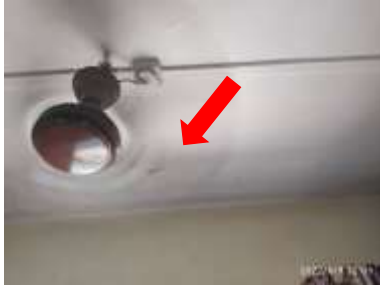
| h) | Living room Balcony | Ceiling | | | Ceiling cracks | Refer attachment 1-TYPE XIII |

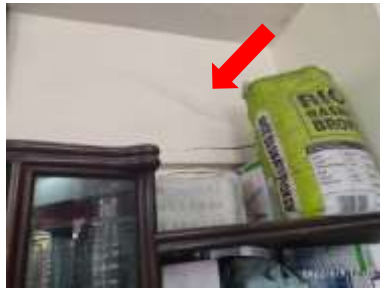
| i) | Living Room Balcony | Beam | | | Major structural crack | Refer attachment 1-TYPE VI |

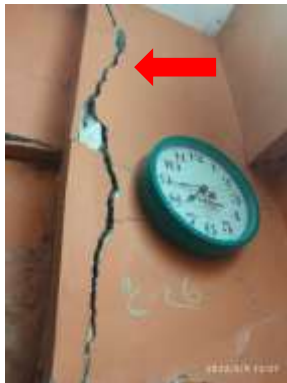
| j) | Kitchen | Column C 26 | | | Major structural crack, Structural distress (Need to add support immediately) | Refer attachment 1-TYPE VI |

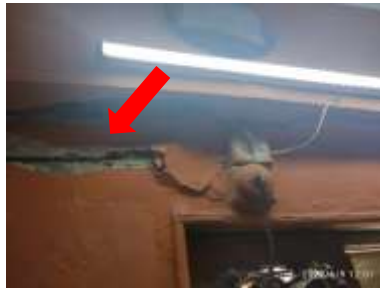
| k) | Kitchen | Beam | | | Major Structural crack (Reinforcement corroded & Plaster spall off) (Need support immediately) | Refer attachment 1-TYPE VI |

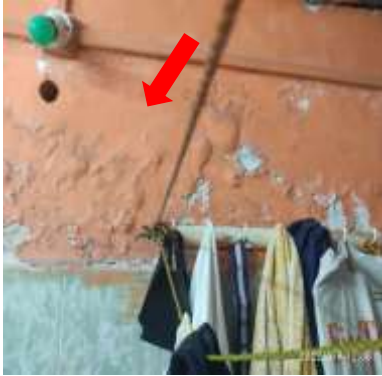
| l) | Kitchen | Wall | | | Capillary action marks from adjacent Bathroom | Refer attachment 1-TYPE IV |

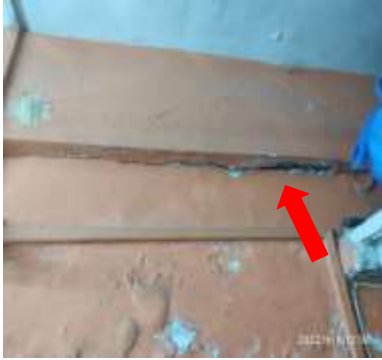
| m) | Kitchen | Beam | | | Major structural crack (Need support immediately) | Refer attachment 1-TYPE VI |

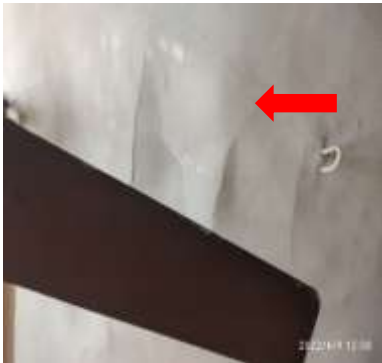
| n) | Kitchen | Ceiling | | | Ceiling cracks | Refer attachment 1-TYPE XIII |

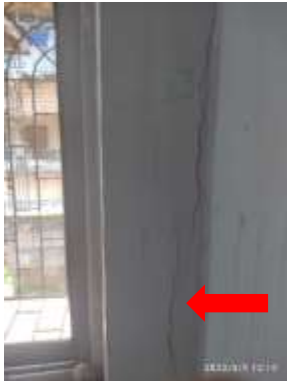
| o) | Bedroom | Column C 23 | | | Structural crack | Refer attachment 1-TYPE VI |

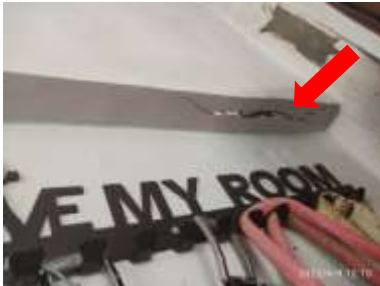
| q) | Bedroom | Beam | | | Major<br>structural<br>crack | Refer attachment<br>1-TYPE VI |

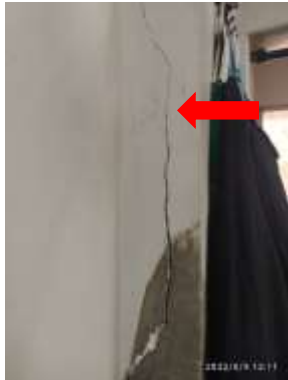
| r) | Bedroom | Column<br>C 25 | | | Major<br>Structural<br>crack | Refer attachment<br>1-TYPE VI |

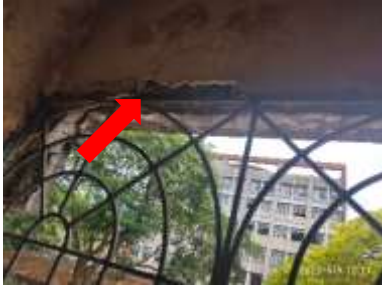
| t) | Bedroom | Chajja | | | Major structural crack<br>(Plaster spall off) | Refer attachment<br>1-TYPE VI |

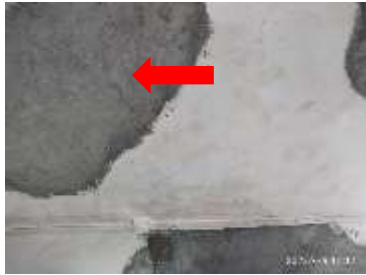
| u) | Bedroom | Ceiling | | | Ceiling cracks | Refer attachment<br>1-TYPE XIII |

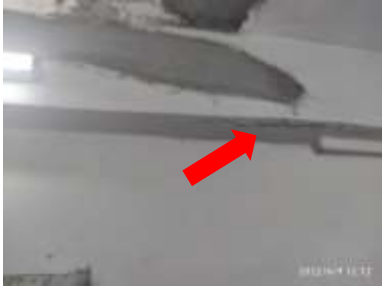
| v) | Bedroom | Beam | | | Major structural crack | Refer attachment<br>1-TYPE VI |

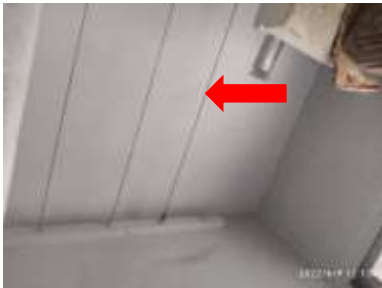
| w) | Bedroom Balony | Ceiling | | | Ceiling cracks | Refer attachment<br>1-TYPE XIII |

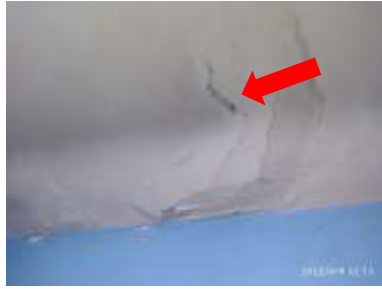
| x) | Kitchen | Ceiling | | | Ceiling cracks | Refer attachment<br>1-TYPE XIII |

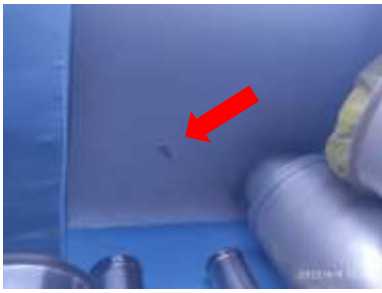
| y) | Kitchen | Ceiling | | | Ceiling cracks | Refer attachment 1-TYPE XIII |

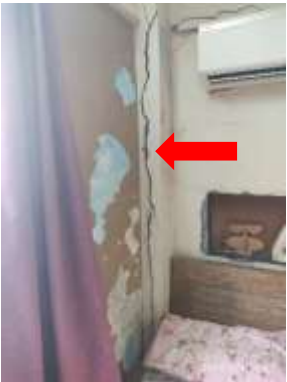
| a) | Bedroom | Column C 8 | | | Major structural crack (need to add support immediately) | Refer attachment 1-TYPE VI |

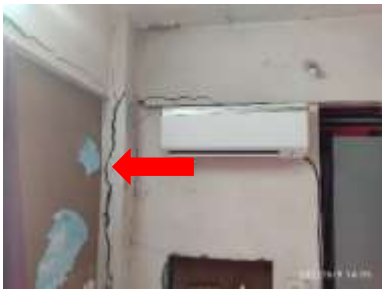
| b) | Bedroom | Beam | | | Major Structural cracks (need to add support immediately) | Refer attachment 1-TYPE VI |

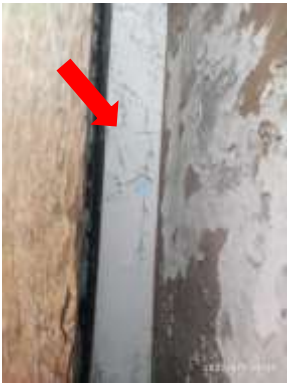
| c) | Bedroom | Wall | | | Seepage from adjacent Bathroom | Refer attachment 1-TYPE XI |

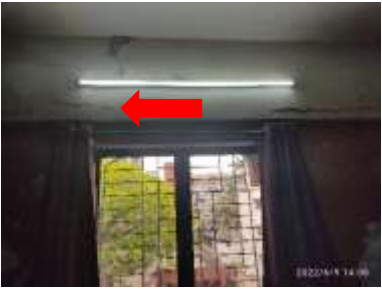
| d) | Bedroom | Lintel Beam | | | Major Structural crack, Window top lintel found with crack | Refer attachment 1-TYPE VI |

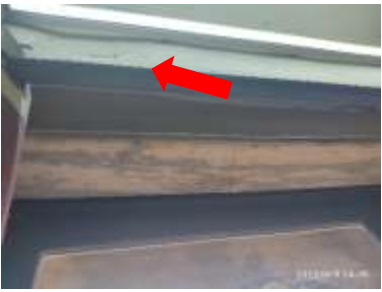
| e) | Bedroom | Lintel Beam | | | Major Structural crack, Window top lintel found with crack | Refer attachment 1-TYPE VI, TYPE XIX |

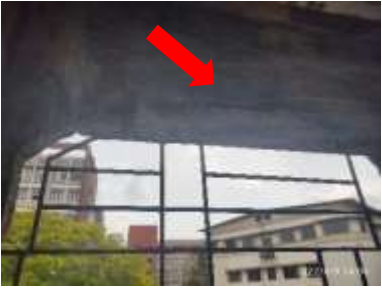
| f) | Bedroom | External chajja | | | Major structural crack | Refer attachment 1-TYPE VI |

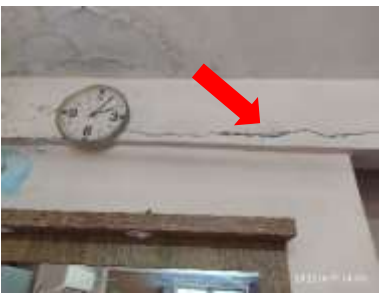
| g) | Bedroom | Beam | | | Major structural crack, Beam found with crack | Refer attachment 1-TYPE VI |

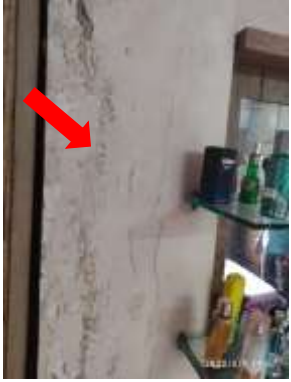
| h) | Bedroom | Column C 7 | | | Structural crack, Column with hollow sound | Refer attachment 1-TYPE VI, TYPE XVII |

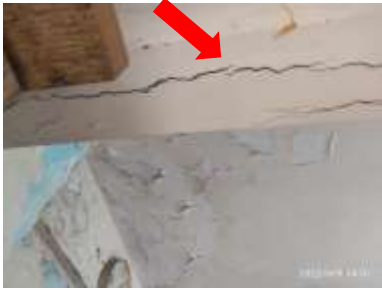
| i) | Bedroom | Beam | | | Major Structural crack | Refer attachment 1-TYPE VI |

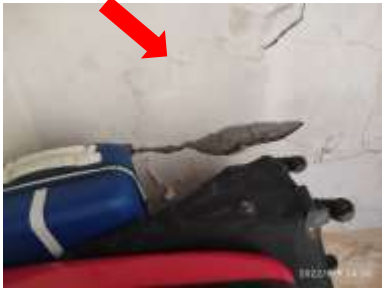
| j) | Bedroom | Balcony | | | Ceiling cracks (plaster spall off) | Refer attachment 1-TYPE XIII |

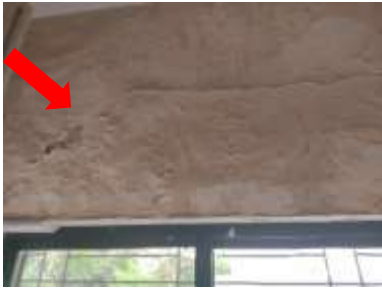
| k) | Bedroom Balcony | Beam | | | Seepages from external, plaster crack | Refer attachment 1-TYPE XI |

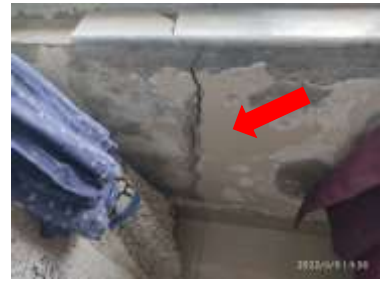
| l) | Bedroom Balcony | Window Sill | | | Major structural crack | Refer attachment 1-TYPE VI |

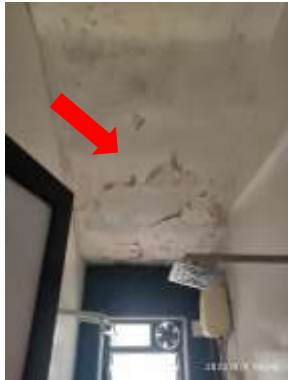
| m) | Toilet | Ceiling | | | Seepages from flat no 2/13 | Refer attachment 1-TYPE XI |

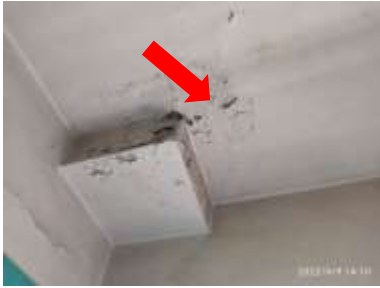
| n) | Kitchen | Sunk | | | Seepages from flat no 2/13 sink | Refer attachment 1-TYPE XI |

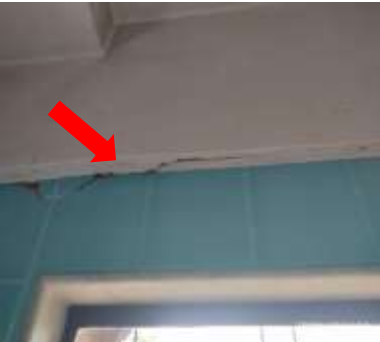
| o) | Kitchen | Beam | | | Major Structural crack | Refer attachment 1-TYPE VI |

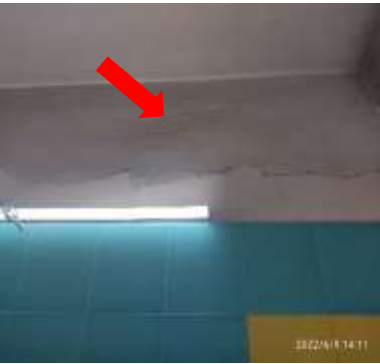
| p) | Kitchen | Beam | | | Structural crack, Plaster with hollow sound | Refer attachment 1-TYPE VI, TYPEVIII |

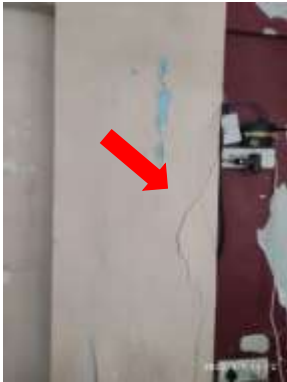
| q) | Living Room | Column C 4 | | | Structural crack, Plaster with hollow sound | Refer attachment 1-TYPE VI, TYPE XVIII |

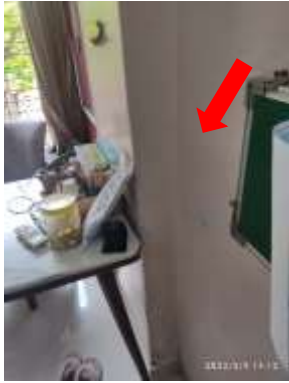
| r) | Living Room | Column C 3 | | | Structural crack at bottom | Refer attachment 1-TYPE VI |

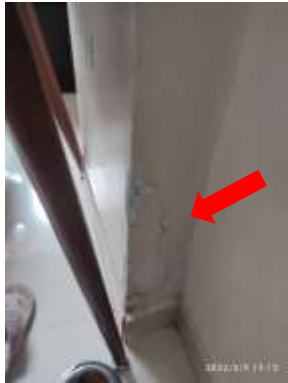
| s) | Living Room | Column C 3 | | | Structural crack at bottom | Refer attachment 1-TYPE VI |

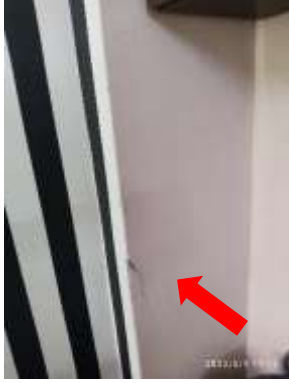
| t) | Living Room | Column C 2 | | | Plaster crack, column with hollow sound | Refer attachment 1-TYPE V, TYPEXVII |

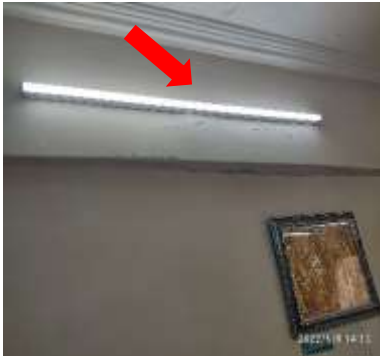
| u) | Living Room | Beam | | | Major Structural crack | Refer attachment 1-TYPE VI |

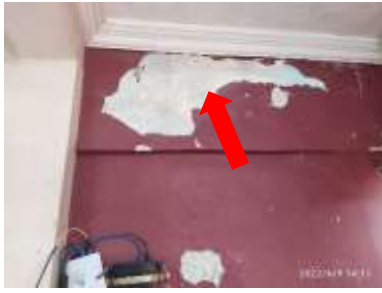
| v) | Living room<br>Balcony | Beam | | | Plaster with hollow sound | Refer attachment 1-TYPE XVIII |

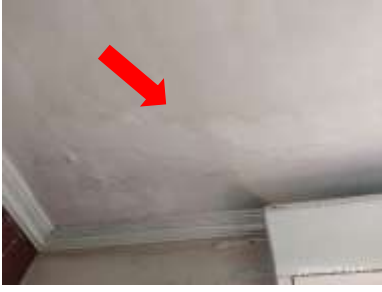
| w) | Living room<br>Balcony | Ceiling | | | Ceiling cracks | Refer attachment 1-TYPE XII |

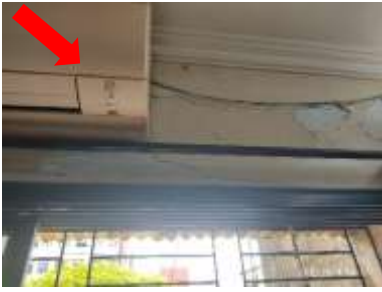
| x) | Living room<br>Balcony | Lintel Beam | | | Structural crack,<br>Window Top Lintel Found with crack | Refer attachment 1-TYPE VI, TYPE XIX |

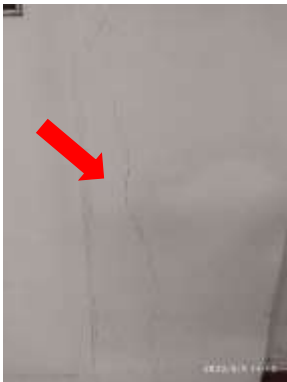
| a) | Living room | Column C 11 | | | Structural crack, Column found with crack | Refer attachment 1-TYPE VI, TYPE XVII |

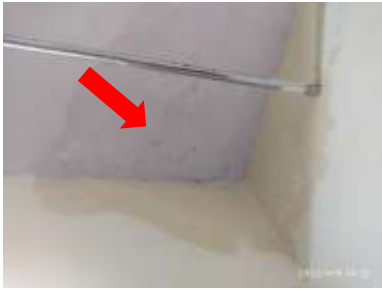
| c) | Passage | Ceiling | | | Water dripping (Live leakages from Flat no 2/14) | Refer attachment 1-TYPE XI |

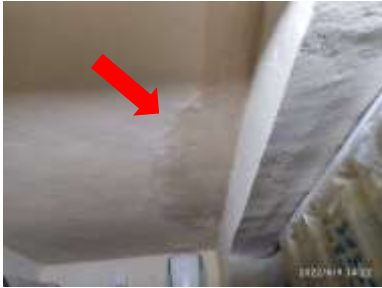
| d) | Bathroom | Ceiling | | | Water dripping (Live leakages from Flat no 2/14) | Refer attachment 1-TYPE XI |

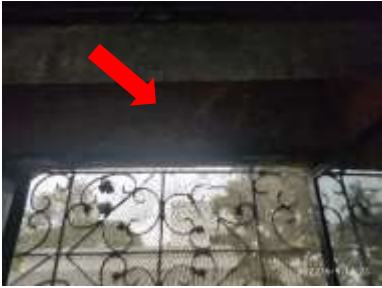
| e) | External | Chajja | | | Structural crack | Refer attachment 1-TYPE VI |

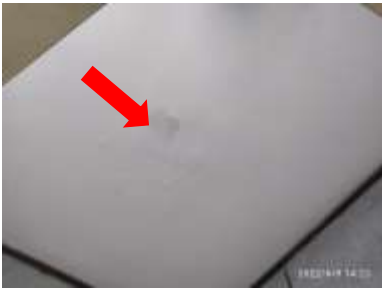
| f) | Bedroom | Ceiling | | | Seepage Marks | Refer attachment 1-TYPE III |

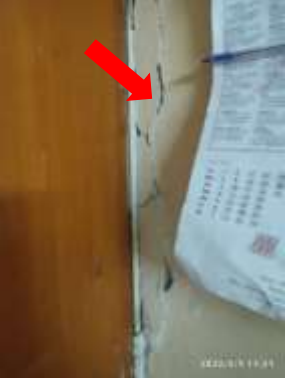
| b) | Living Room | Wall | | | Plaster crack | Refer attachment 1-TYPE V |

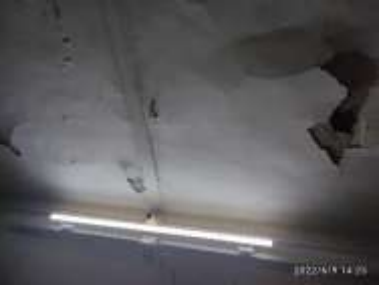
| c) | Living room | Ceiling | | | Ceiling cracks | Refer attachment 1-TYPE XIII |

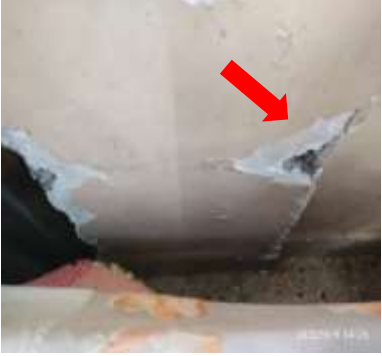
| d) | Living Room | Column C 10 | | | Major Structural crack | Refer attachment 1-TYPE VI |

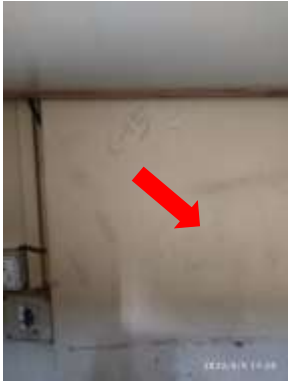
| e) | Living Room | Column C 15 | | | Column with hollow sound | Refer attachment 1-TYPE XVII |

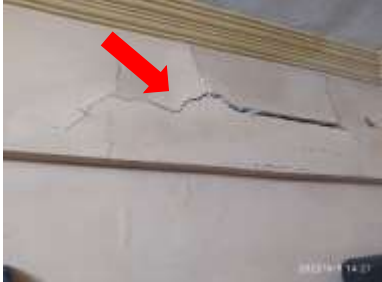
| f) | Bedroom | Beam | | | Major structural crack | Refer attachment 1-TYPE VI |

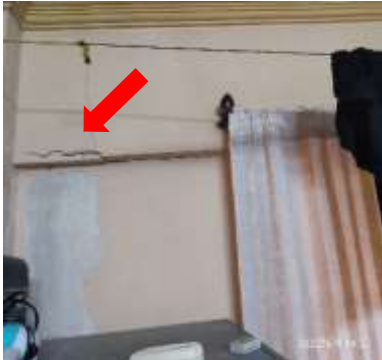
| g) | Bedroom | Beam | | | Major structural crack | Refer attachment 1-TYPE VI |

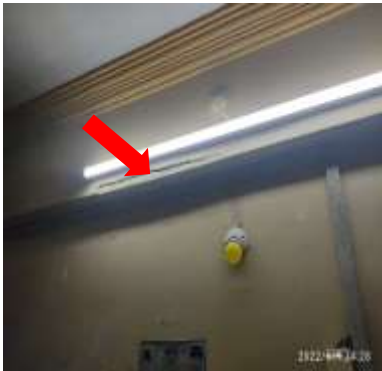
| h) | Bedroom | Beam | | | Major structural crack | Refer attachment 1-TYPE VI |

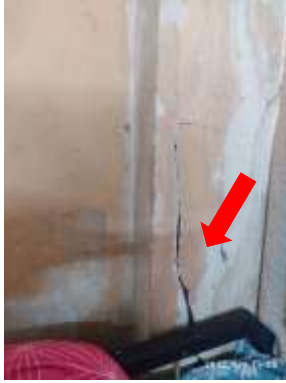
| i) | Bedroom | Column C 17 | | | Major structural crack, Column found with crack | Refer attachment 1-TYPE VI, TYPE XVII |

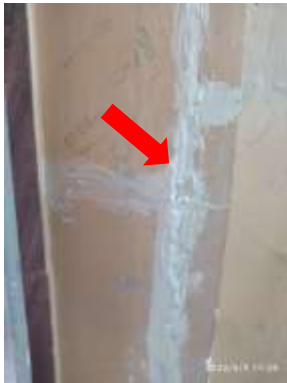
| j) | Bedroom | Column C 18 | | | Major structural crack, Column found with crack | Refer attachment 1-TYPE VI, TYPE XVII |

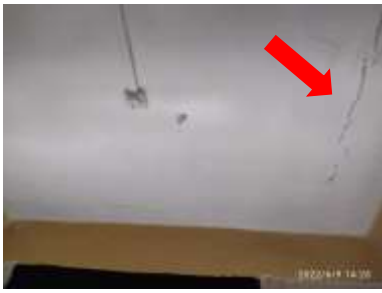
| k) | Bedroom Balcony | Ceiling | | | Ceiling cracks | Refer attachment 1-TYPE XI |

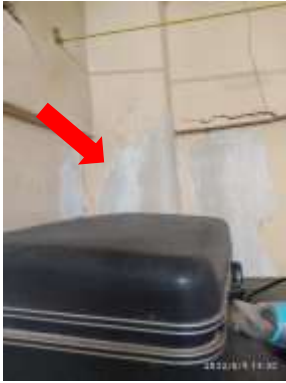
| m) | Bedroom<br>Balcony | Beam | | | Structural<br>crack | Refer attachment<br>1-TYPE VI |

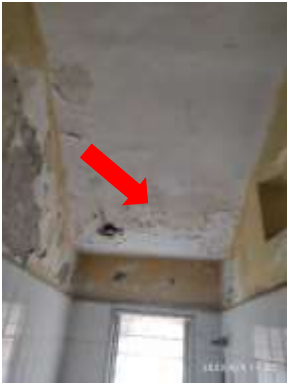
| n) | Toilet | Ceiling | | | Ceiling crack,<br>Seepages<br>from Flat no<br>2/15 | Refer attachment<br>1-TYPE XIII |

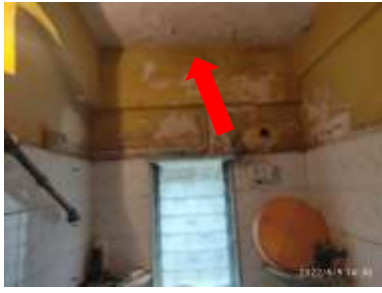
| p) | Bathroom | Ceiling | | | Seepages<br>from Flat no<br>2/15 | Refer attachment<br>1-TYPE XI |

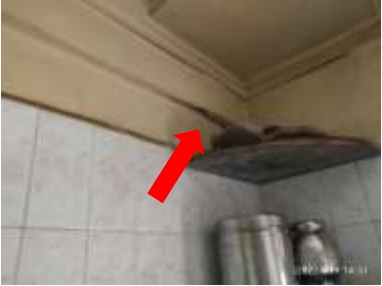
| q) | Kitchen | Beam | | | Major Structural crack | Refer attachment 1-TYPE VI |

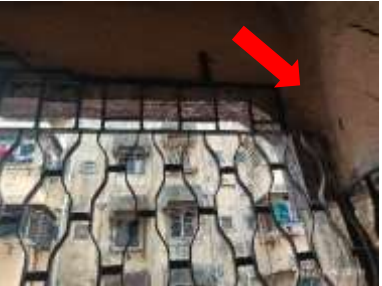
| s) | External | Chajja | | | Major Structural crack | Refer attachment 1-TYPE VI |

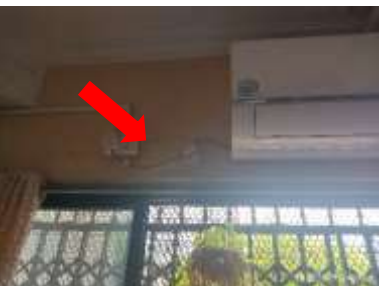
| a) | Living Room | Lintel Beam | | | Major structural crack, Window Top Lintel Found with crack | Refer attachment 1-TYPE VI, TYPE XIX |

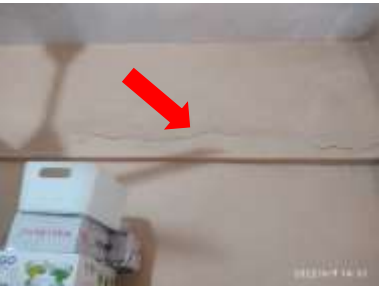
| b) | Kitchen | Beam | | | Structural crack, beam Found with crack | Refer attachment 1-TYPE VI |

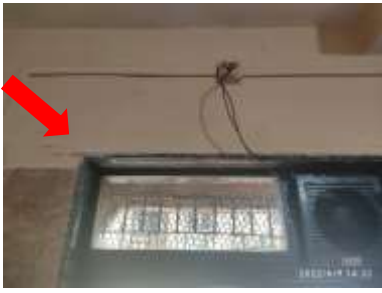
| c) | Kitchen | Lintel Beam | | | Separation crack, plaster crack | Refer attachment 1-TYPE X, TYPE V |

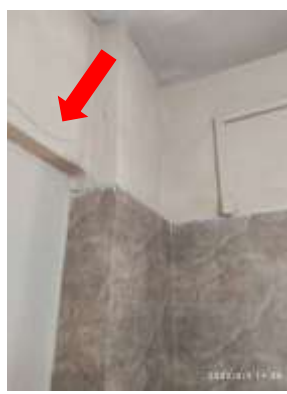
| d) | Kitchen | Column C 26 | | | Structural crack | Refer attachment 1-TYPE VI |

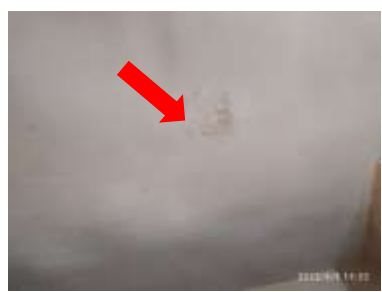
| e) | Kitchen | Ceiling | | | Seepage marks | Refer attachment 1-TYPE III |

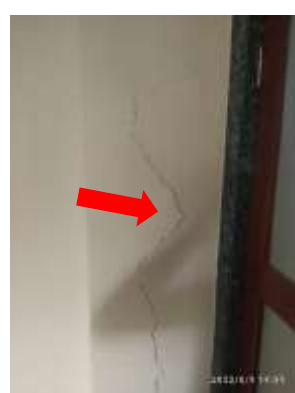
| f) | Bedroom | Column C 25 | | | Major Structural crack, Column found with crack | Refer attachment 1-TYPE VI, TYPE XVII |

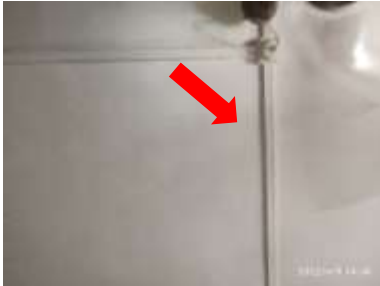
| g) | Bedroom | Ceiling | | | Ceiling cracks | Refer attachment<br>1-TYPE XIII |

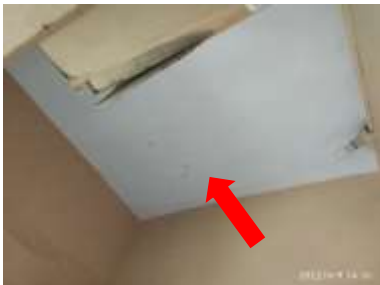
| h) | Bedroom<br>Balcony | Ceiling | | | Ceiling cracks | Refer attachment<br>1-TYPE XIII |

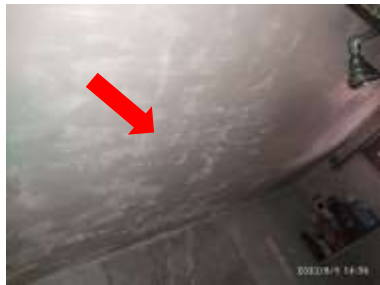
| i) | Bathroom | Loft | | | Seepage<br>Marks | Refer attachment<br>1-TYPE III |

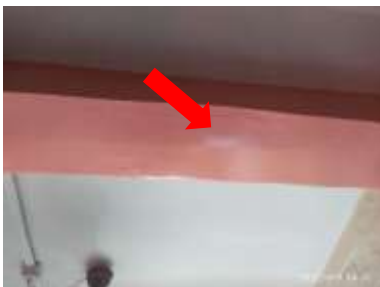
**Flat 2-13**

| a) | Living<br>room | Beam | | | Plaster crack,<br>Beam With<br>hollow sound | Refer attachment<br>1-TYPE V |

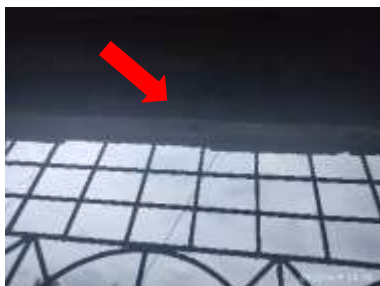
| b) | External | Chajja | | | Structural<br>crack | Refer attachment<br>1-TYPE VI |

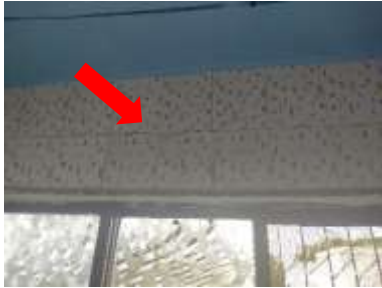
| c) | Bedroom<br>Balcony | Lintel Beam | | | Tile cracks | Refer attachment<br>1-TYPE I |

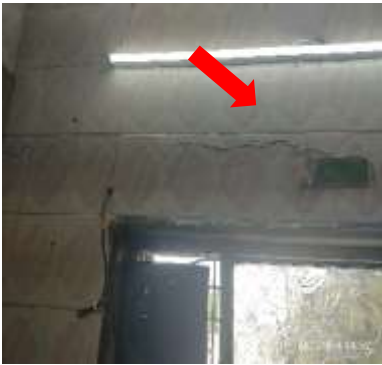
**Flat 2-14**

| a) | Kitchen | Lintel Beam | | | Window Top<br>lintel found<br>with crack,<br>Tile crack | Refer attachment<br>1-TYPE XIX, TYPE<br>I |

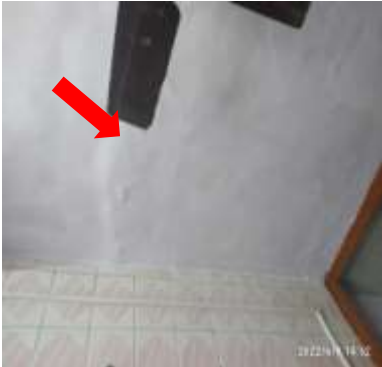
| b) | Kitchen | Ceiling | | | Ceiling cracks | Refer attachment<br>1-TYPE XIII |

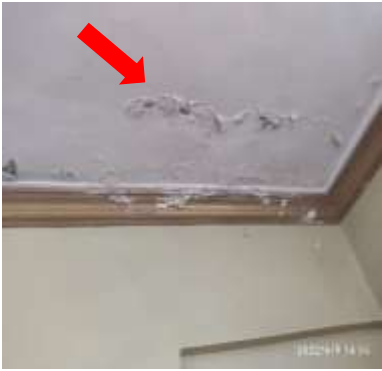
**Flat 2-15 (floor vibrate)**

| a) | Living room | Ceiling | | | Seepages from flat no 2/19 | Refer attachment 1-TYPE XI |

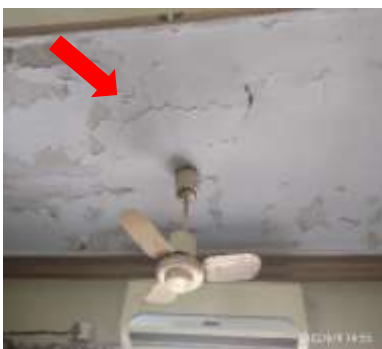
| b) | Living room | Ceiling | | | Ceiling cracks | Refer attachment 1-TYPE XIII |

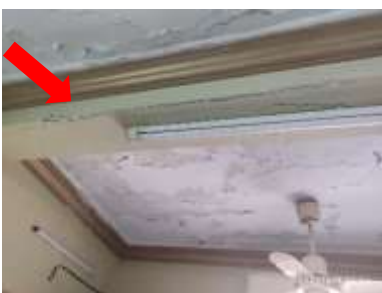
| c) | Living Room | Beam | | | Major Structural crack | Refer attachment 1-TYPE VI |

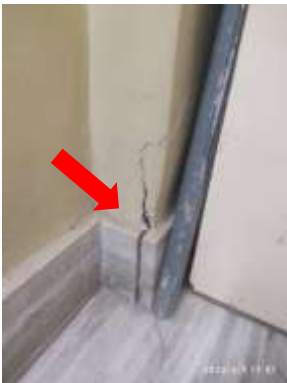
| d) | Living room | Column C 10 | | | Structural crack at bottom | Refer attachment 1-TYPE VI |

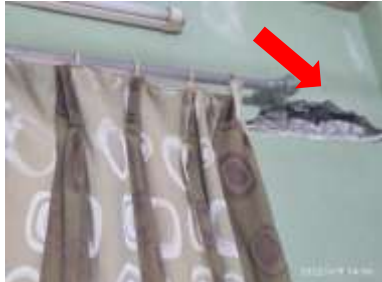
| e) | Bedroom | Beam | | | Major Structural crack<br>(Reinforcement corroded & Plaster spall off) | Refer attachment<br>1-TYPE VI |

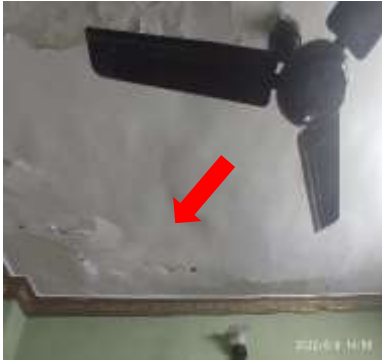
| f) | Bedroom | Ceiling | | | Ceiling cracks | Refer attachment<br>1-TYPE XIII |

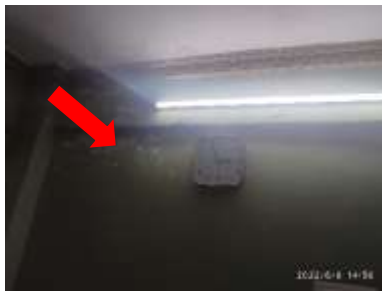
| g) | Bedroom | Beam | | | Plaster crack | Refer attachment<br>1-TYPE V |

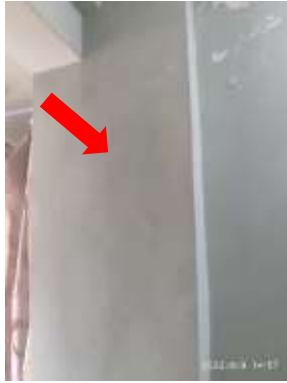
| i) | Bedroom | Column C 18 | | | Structural crack | Refer attachment 1-TYPE VI |

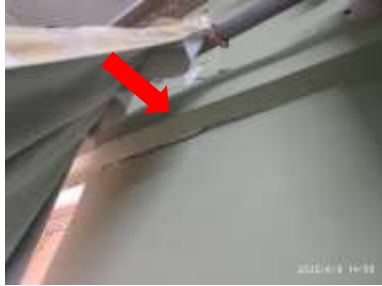
| j) | Bedroom Balcony | Beam | | | Structural crack | Refer attachment 1-TYPE VI |

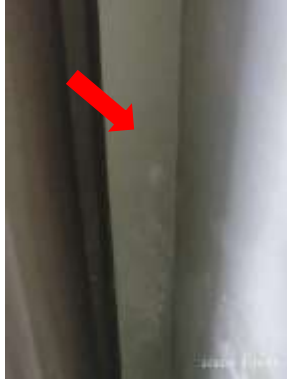
| k) | Bedroom | Column C 16 | | | Seepages | Refer attachment 1-TYPE XI |

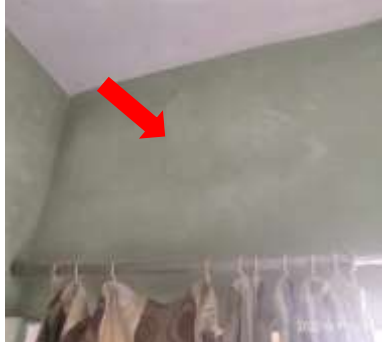
| l) | Bedroom Balcony | Beam | | | Plaster crack, Plaster with hollow sound | Refer attachment 1-TYPE V, TYPE XVIII |

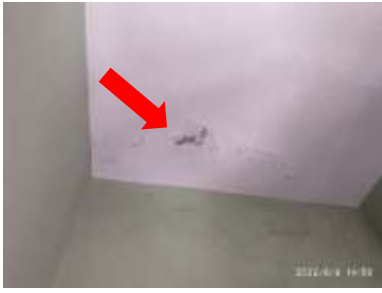
| m) | Balcony | Celing | | | Seepages from external cracks | Refer attachment 1-TYPE XI |

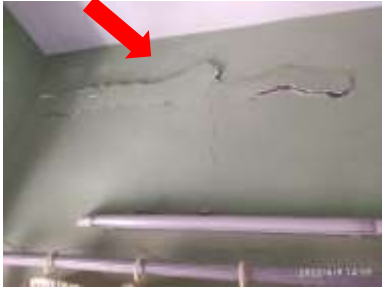
| n) | Bedroom Balcony | Beam | | | Structural crack, Beam Found with crack | Refer attachment 1-TYPE VI |

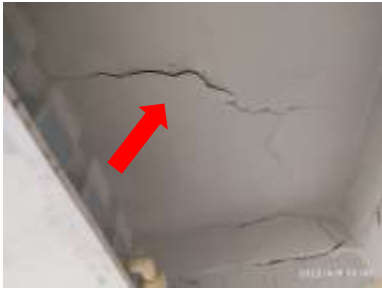
| o) | Bathroom | Ceiling | | | Ceiling cracks | Refer attachment 1-TYPE XIII |

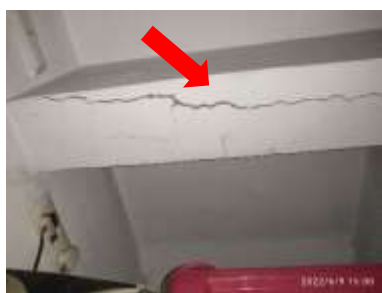
| p) | Passage | Beam | | | Major Structural crack | Refer attachment 1-TYPE VI |

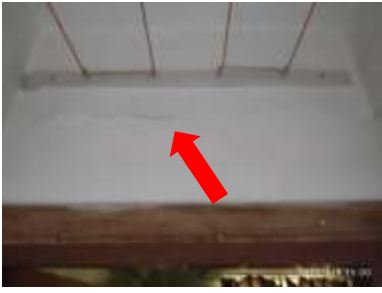
| q) | Passage | Beam | | | Structural crack | Refer attachment 1-TYPE VI |

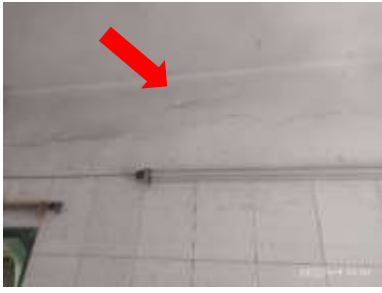
| r) | Kitchen | Beam | | | Structural crack, Beam found with crack | Refer attachment 1-TYPE VI |

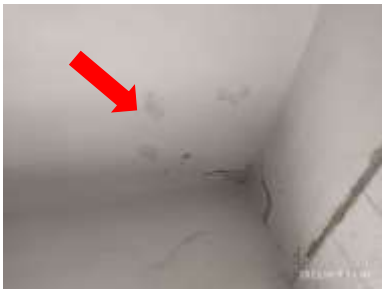
| s) | Kitchen | Ceiling | | | Ceiling cracks | Refer attachment 1-TYPE XIII |

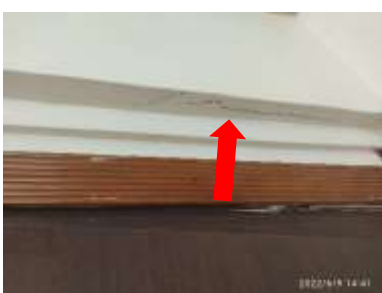
| <b>Flat 2-16</b> | | | | | | |

| a) | Living Room | Beam | | | Structural crack | Refer attachment 1-TYPE VI |

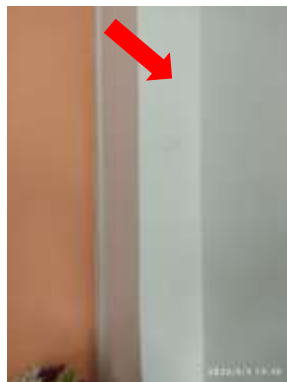
| b) | Living Room | Column C 20 | | | Plaster crack | Refer attachment 1-TYPE V |

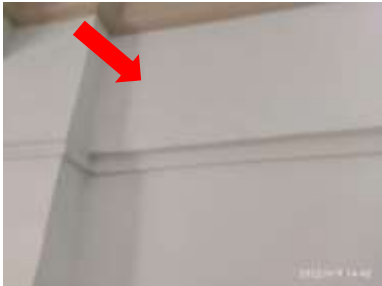
| c) | Living Room | Beam | | | Plaster crack | Refer attachment 1-TYPE V |

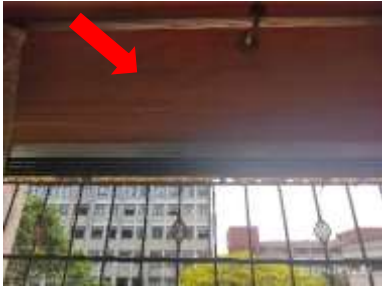
| d) | Living Room | Lintel Beam | | | Window top lintel found with crack, Plaster cracks | Refer attachment 1-TYPE XIX, TYPE V |

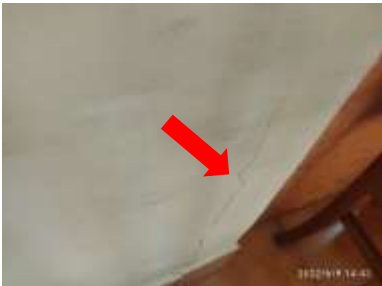
| e) | Living room | Wall | | | Plaster crack | Refer attachment 1-TYPE V |

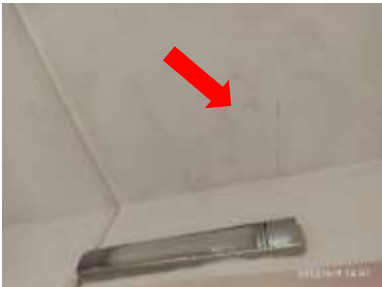
| h) | Bedroom | Ceiling | | | Ceiling cracks | Refer attachment<br>1-TYPE XIII |

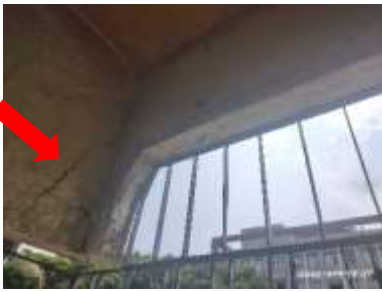
| i) | Bedroom | Chajja | | | Plaster crack | Refer attachment<br>1-TYPE V |

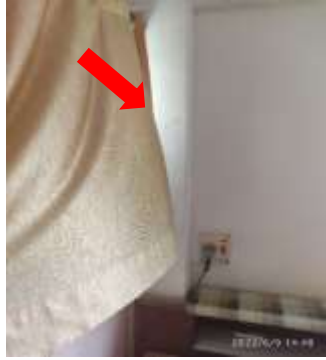
| j) | Bedroom | Column<br>C 23 | | | Column with<br>hollow sound | Refer attachment<br>1-TYPE XVII |

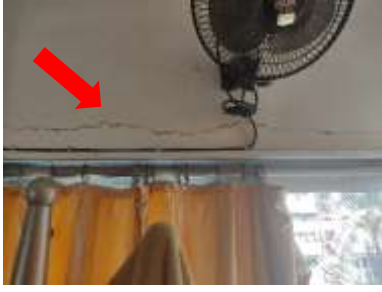
| k) | Bedroom<br>Balcony | Lintel Beam | | | Major<br>Structural<br>crack,<br>Window top<br>lintel found<br>with crack | Refer attachment<br>1-TYPE VI, TYPE<br>XIX |

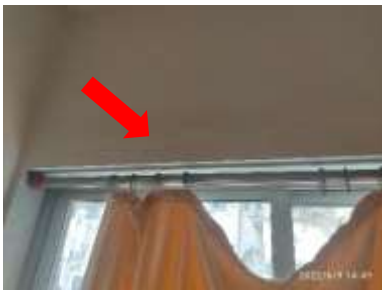
| l) | Bedroom<br>Balcony | Lintel Beam | | | Structural<br>crack,<br>Window top<br>lintel found<br>with crack | Refer attachment<br>1-TYPE VI, TYPE<br>XIX |

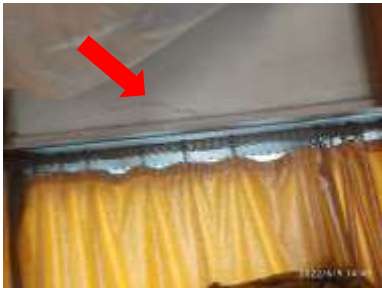
| m) | Bedroom<br>Balcony | Lintel Beam | | | Structural crack,<br>Window top lintel found with crack | Refer attachment<br>1-TYPE VI, TYPE<br>XIX |

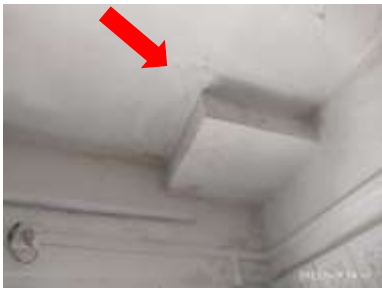
| n) | Kitchen | Ceiling | | | Seepage marks | Refer attachment<br>1-TYPE III |

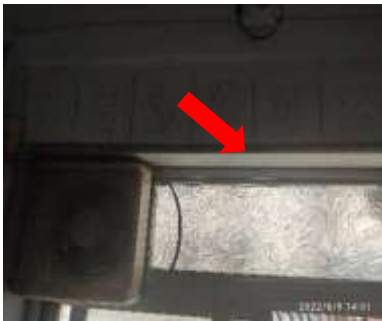
| o) | Kitchen | Lintel beam | | | Window top lintel found with crack | Refer attachment<br>1-TYPE XIX |

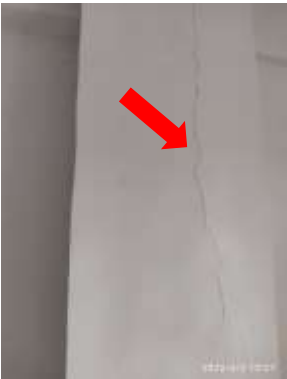
| a) | Living Room | Column C 4 | | | Major structural crack | Refer attachment<br>1-TYPE VI |

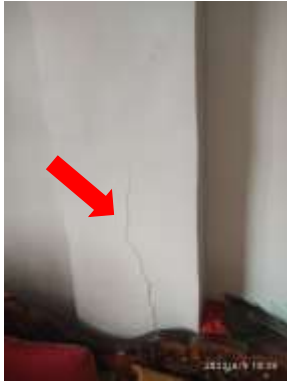
| b) | Living Room | Column C 3 | | | Structural crack, Column with hollow sound | Refer attachment 1-TYPE VI, TYPE XVII |

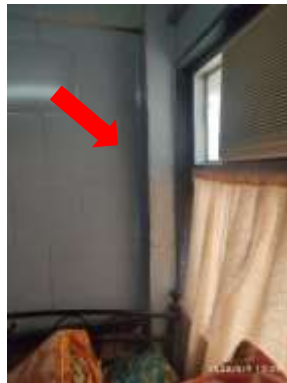
| c) | Bedroom | Column C 8 | | | Structural crack | Refer attachment 1-TYPE VI |

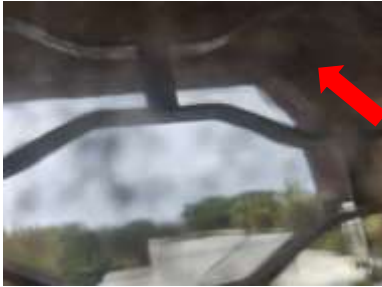
| d) | Kitchen | Chajja | | | Major Structural crack | Refer attachment 1-TYPE VI |

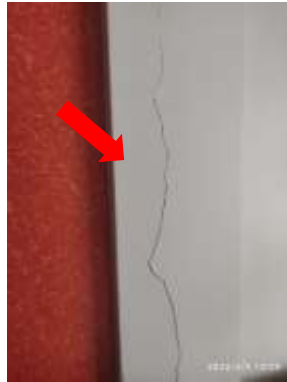
| a) | Living Room | Column C 11 | | | Major Structural crack, Column with hollow sound | Refer attachment 1-TYPE VI, XVII |

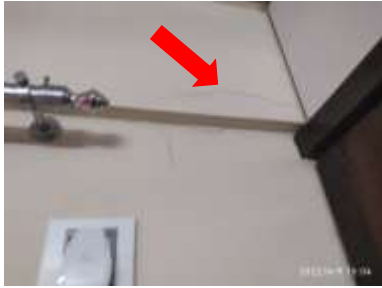
| b) | Bedroom | Beam | | | Structural crack | Refer attachment 1-TYPE VI |

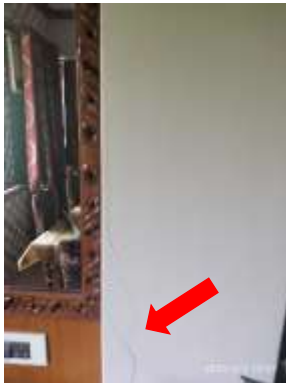
| a) | Living Room | Column C 15 | | | Plaster crack | Refer attachment 1-TYPE V |

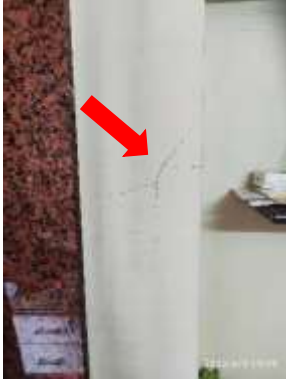
| b) | Bedroom | Column C 18 | | | Structural crack, column with hollow sound | Refer attachment 1-TYPE VI, TYPE XVII |

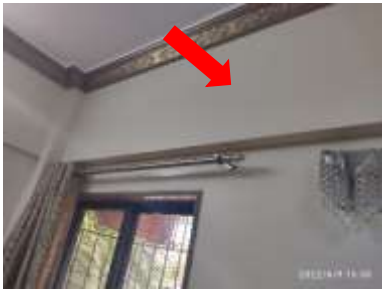
| c) | Bedroom | Beam | | | Plaster crack, Plaster with hollow sound | Refer attachment 1-TYPE V, TYPE XVIII |

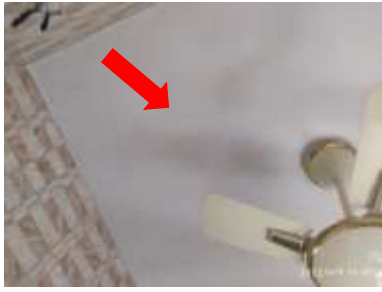
| d) | Bedroom Balcony | Ceiling | | | Ceiling cracks | Refer attachment 1-TYPE XIII |

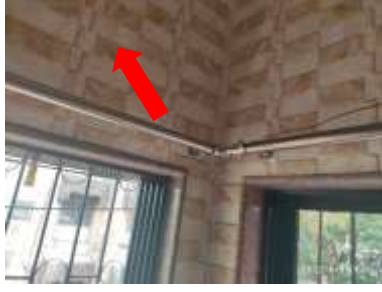
| e) | Bedroom Balcony | Lintel Beam | | | Tile crack | Refer attachment 1-TYPE I |

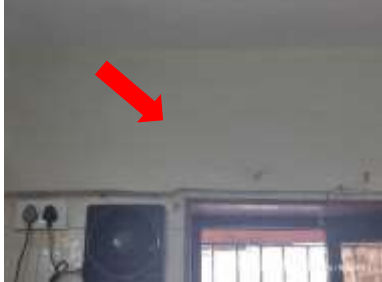
| f) | Kitchen | Beam | | | Plaster crack | Refer attachment 1-TYPE V |

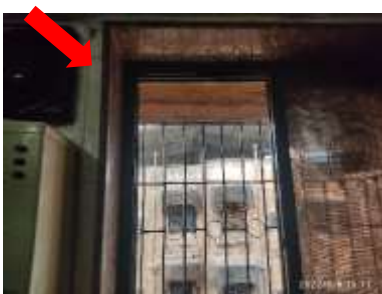
| g) | Kitchen | Chajja | | | Structural crack | Refer attachment 1-TYPE VI |

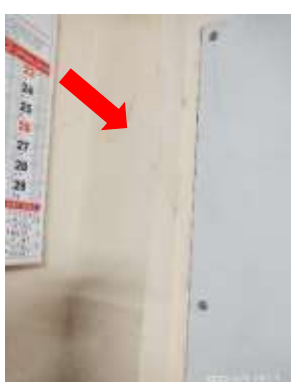
| c) | Living Room | Column C 20 | | | Column with hollow sound | Refer attachment 1-TYPE XVII |

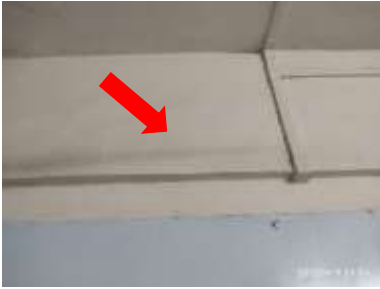
| d) | Living Room | Beam | | | Plaster with hollow sound | Refer attachment 1-TYPE XVIII |

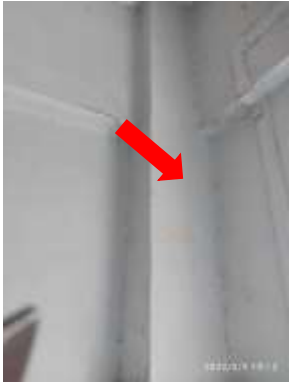
| e) | Kitchen | Column C 26 | | | Column with hollow sound | Refer attachment 1-TYPE XVII |

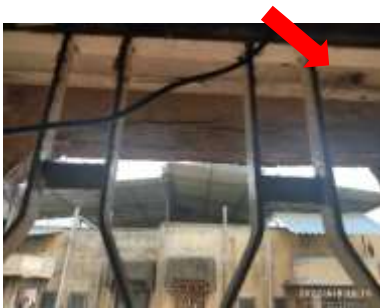
| f) | Kitchen | Chajja | | | Major structural crack | Refer attachment 1-TYPE VI |

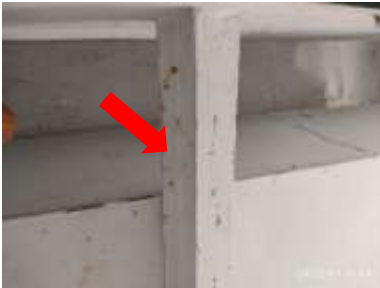
| g) | Toilet | Ceiling | | | Seepage Marks | Refer attachment 1-TYPE III |

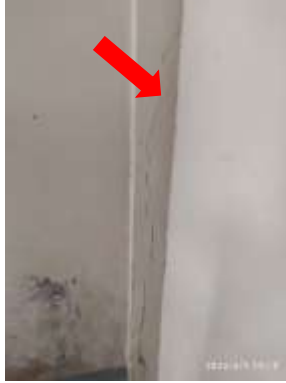
| h) | Bedroom<br>1 | Column<br>C 25 | | | Structural<br>crack | Refer attachment<br>1-TYPE VI |

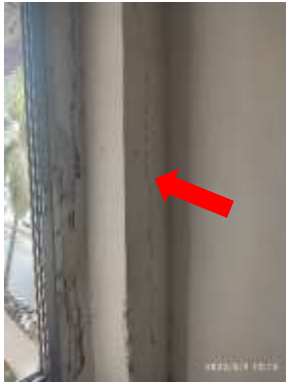
| i) | Bedroom<br>1 | Column<br>C 24 | | | Major<br>Structural<br>crack | Refer attachment<br>1-TYPE VI |

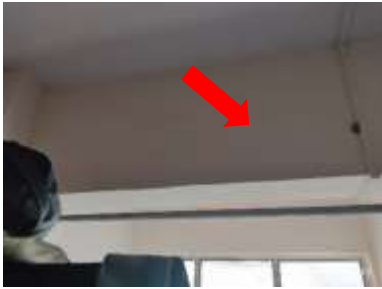
| j) | Bedroom<br>1 | Beam | | | Plaster crack | Refer attachment<br>1-TYPE V |

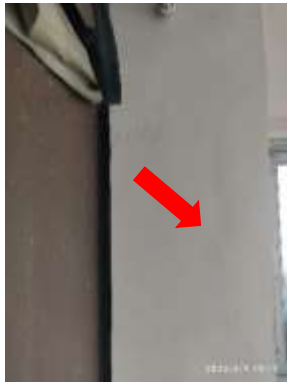
| k) | Bedroom<br>1 | Column<br>C 23 | | | Column with<br>hollow sound | Refer attachment<br>1-TYPE XVII |

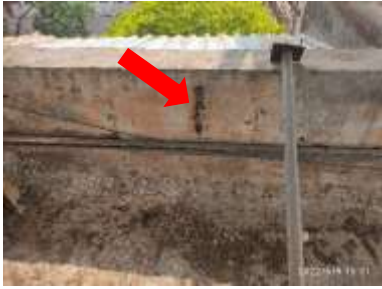
| Sr No. | LOCATION | AREA DESCRIPTION | | PHOTOS | DEFECTS | PROCESS FOR AMELIORATIONS |
|---|---|---|---|---|---|---|
| a) | Building 2 Terrace | Parapet wall | | | Plaster cracks | Refer attachment 1-TYPE V |

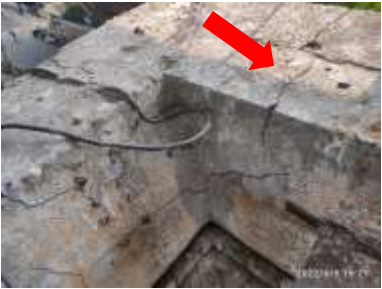
| Sr No. | LOCATION | AREA DESCRIPTION | | PHOTOS | DEFECTS | PROCESS FOR AMELIORATIONS |
|---|---|---|---|---|---|---|
| b) | Building 2 Terrace | Parapet wall | | | Structural cracks | Refer attachment 1-TYPE VI |

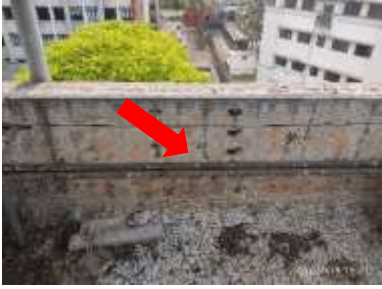
| Sr No. | LOCATION | AREA DESCRIPTION | | PHOTOS | DEFECTS | PROCESS FOR AMELIORATIONS |
|---|---|---|---|---|---|---|
| c) | Building 2 Terrace | Parapet wall | | | Plaster cracks, plaster with hollow sound | Refer attachment 1-TYPE V, Type XVIII |

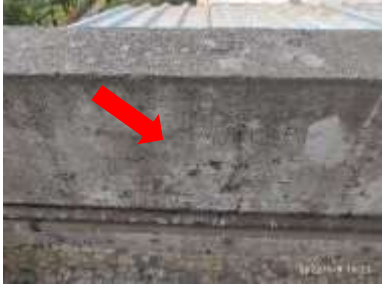
| Sr No. | LOCATION | AREA DESCRIPTION | | PHOTOS | DEFECTS | PROCESS FOR AMELIORATIONS |
|---|---|---|---|---|---|---|
| d) | Building 2 Terrace | Parapet wall | | | Plaster cracks | Refer attachment 1-TYPE V |

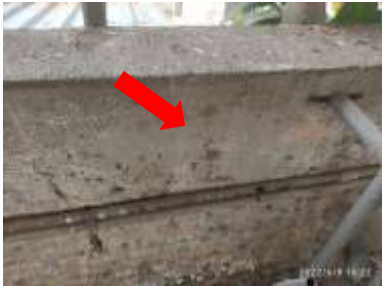
| e) | Building 2<br>Terrace | Parapet wall | | | Plaster cracks | Refer attachment<br>1-TYPE V |

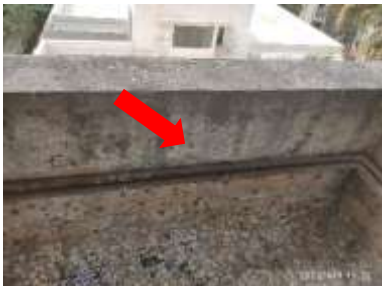
| f) | Building 2<br>Terrace | Parapet wall | | | Plaster cracks | Refer attachment<br>1-TYPE V |

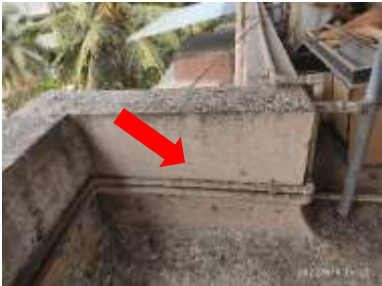
| g) | Building 2<br>Terrace | Parapet wall | | | Plaster cracks | Refer attachment<br>1-TYPE V |

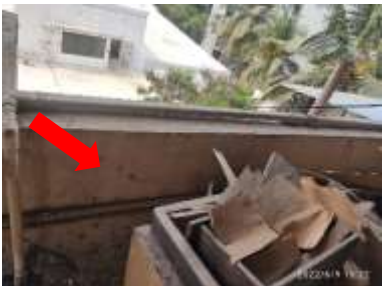
| h) | Building 2<br>Terrace | Parapet wall | | | Plaster cracks | Refer attachment<br>1-TYPE V |

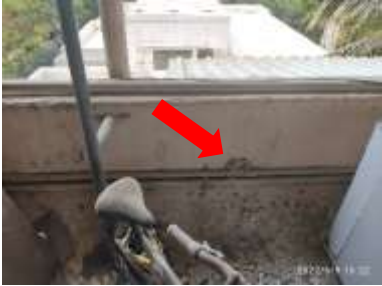
| i) | Building 2<br>Terrace | Parapet wall | | | Plaster cracks | Refer attachment<br>1-TYPE V |

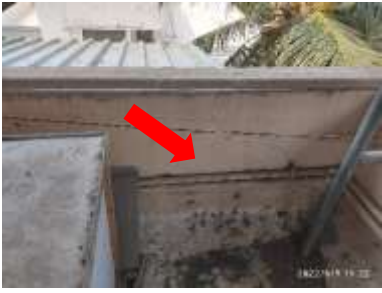
| j) | Building 2<br>Terrace | Parapet wall | | | Plaster cracks | Refer attachment<br>1-TYPE V |

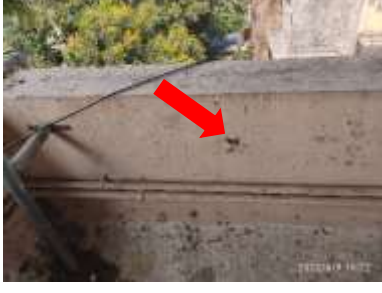
| k) | Building 2<br>Terrace | Parapet wall | | | Plaster cracks | Refer attachment<br>1-TYPE V |

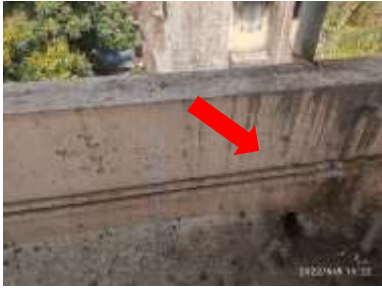
| l) | Building 2<br>Terrace | Parapet wall | | | Plaster cracks | Refer attachment<br>1-TYPE V |

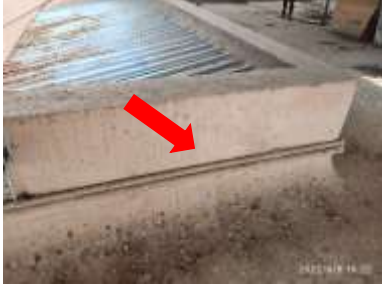
| m) | Building 2<br>Terrace | Parapet wall | | | Plaster cracks | Refer attachment<br>1-TYPE V |

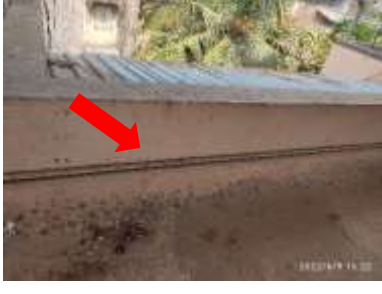
| n) | Building 2<br>Terrace | Parapet wall | | | Plaster cracks | Refer attachment<br>1-TYPE V |

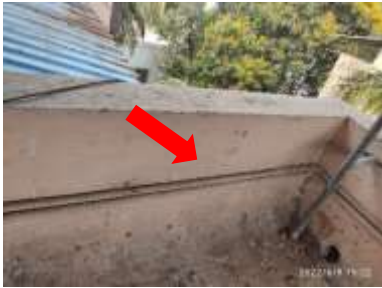
| o) | Building 2<br>Terrace | Parapet wall | | | Plaster cracks | Refer attachment<br>1-TYPE V |

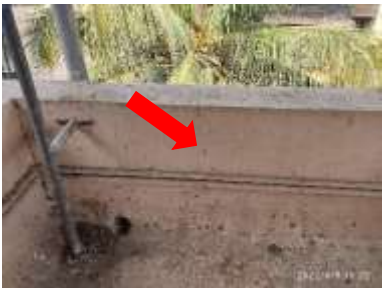
| p) | Building 2<br>Terrace | Parapet wall | | | Plaster cracks | Refer attachment<br>1-TYPE V |

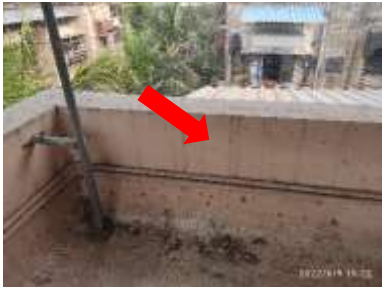
| q) | Building 2<br>Terrace | Parapet wall | | | Plaster cracks | Refer attachment<br>1-TYPE V |

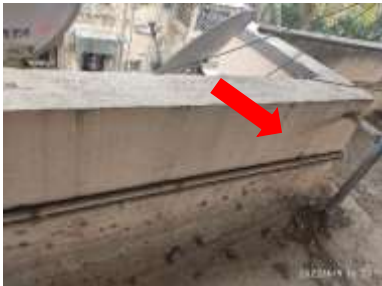
| r) | Building 2<br>Terrace | Parapet wall | | | Plaster cracks | Refer attachment<br>1-TYPE V |

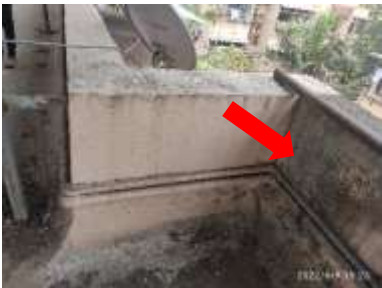
| s) | Building 2<br>Terrace | Parapet wall | | | Plaster cracks,<br>Seepages | Refer attachment<br>1-TYPE V, TYPE XI |

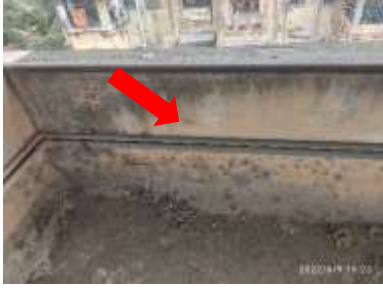
| t) | Building 2<br>Terrace | Parapet wall | | | Plaster cracks,<br>seepages | Refer attachment<br>1-TYPE V, TYPE XI |

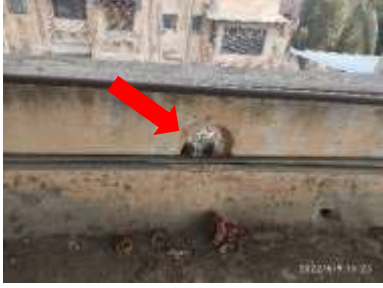
| u) | Building 2<br>Terrace | Parapet wall | | | Plaster cracks | Refer attachment<br>1-TYPE V |

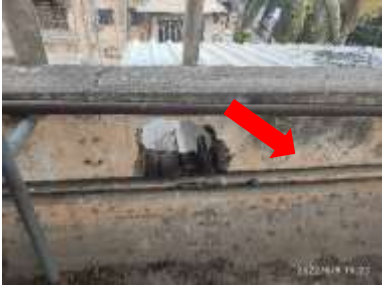
| v) | Building 2<br>Terrace | Parapet wall | | | Major<br>structural<br>crack | Refer attachment<br>1-TYPE VI |

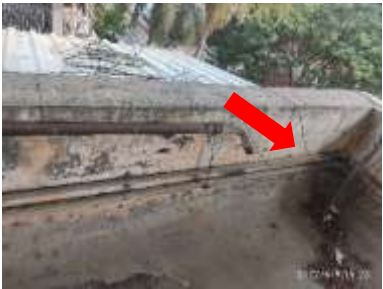
| w) | Building 2<br>Terrace | Parapet wall | | | Plaster cracks | Refer attachment<br>1-TYPE V |

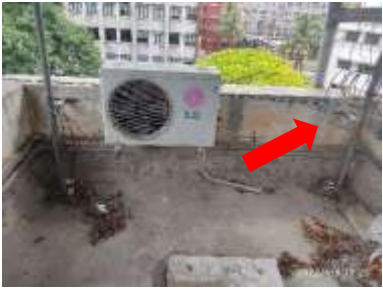
| x) | Building 2<br>Terrace | Parapet wall | | | Plaster cracks | Refer attachment<br>1-TYPE V |

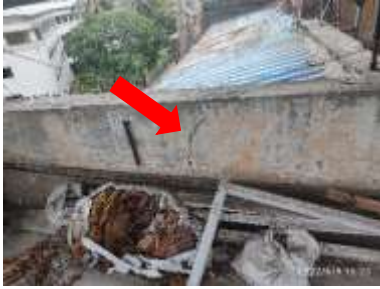
| y) | Building 2<br>Terrace | Parapet wall | | | Plaster cracks | Refer attachment<br>1-TYPE V |

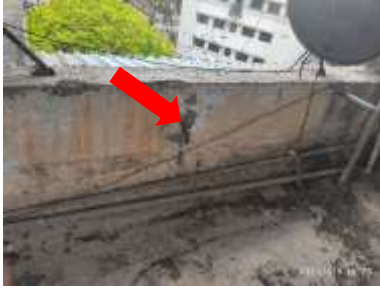
| z) | Building 2<br>Terrace | Parapet wall | | | Plaster cracks | Refer attachment<br>1-TYPE V |

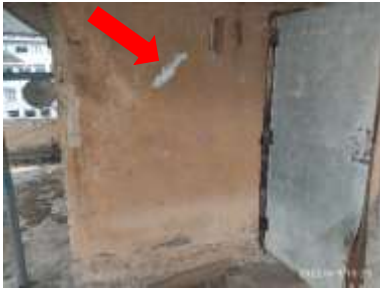
| aa) | Building 2<br>Terrace | Wall | | | Plaster with<br>hollow sound | Refer attachment<br>1-TYPE XVIII |

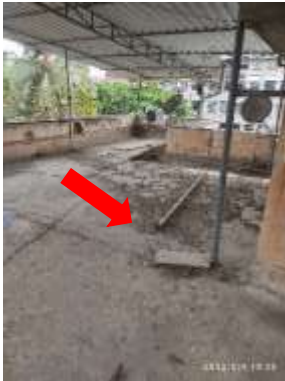
| ab) | Building 2<br>Terrace | Floor | | | Floor cracks | Refer attachment<br>1-TYPE I |

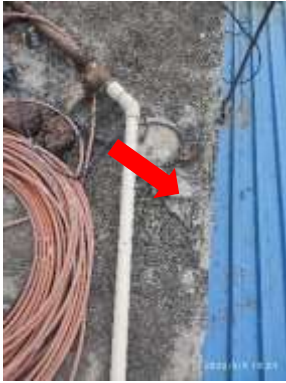
| ac) | Building 2<br>Terrace | Water tank<br>Floor | | | Plaster cracks,<br>Seepages | Refer attachment<br>1-TYPE V, TYPE XI |

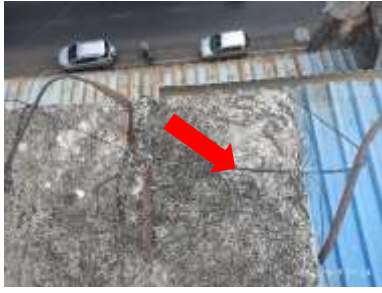
| ad) | Building 2<br>Terrace | Water Tank<br>floor | | | Plaster cracks,<br>Seepages | Refer attachment<br>1-TYPE V, TYPE XI |
