# STRUCTURAL AUDIT REPORT

NOOR CO-OP. HOUSING SOCIETY LTD,

VASHI,

**Taamra Engineering Consultants Private Limited**

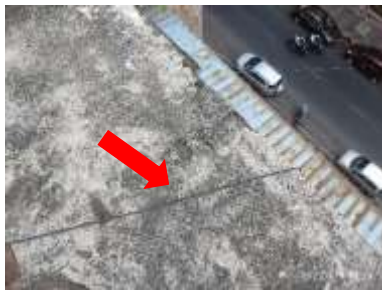
| ae) | Building 2<br>Terrace | Water Tank<br>floor | | | Surface hair<br>line cracks | Refer attachment<br>1- TYPE XXI |

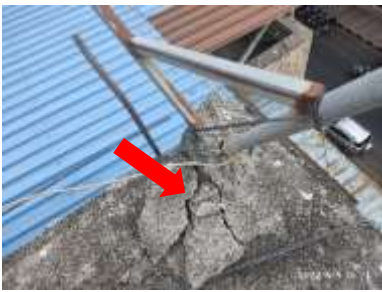
| af) | Building 2<br>Terrace | Water Tank<br>floor | | | Major plaster<br>cracks | Refer attachment<br>1-TYPE V |

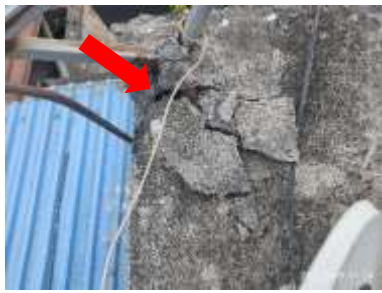
| ag) | Building 2<br>Terrace | Water Tank<br>floor | | | Major plaster<br>cracks | Refer attachment<br>1-TYPE V |

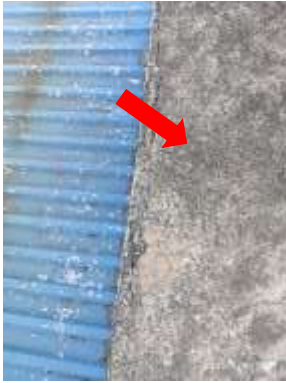
| ah) | Building 2<br>Terrace | Water Tank<br>floor | | | Major plaster<br>cracks | Refer attachment<br>1-TYPE V |

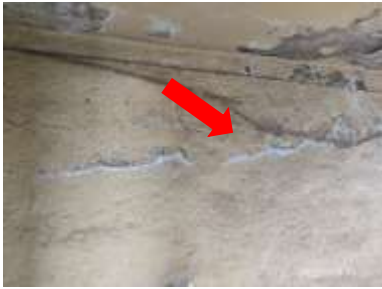
| a) | Building 2<br>Staircase<br>Mumpty<br>Room | Beam & wall | | | Separation<br>crack, plaster<br>with hollow<br>sound | Refer attachment<br>1-TYPE X, TYPE<br>XVIII |

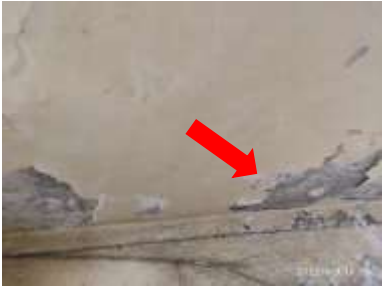
| b) | Building 2<br>Staircase<br>Mumpty<br>Room | Wall | | | Capillary<br>action marks,<br>Plaster with<br>hollow sound<br>at bottom | Refer attachment<br>1-TYPE IV. TYPE<br>XVIII |

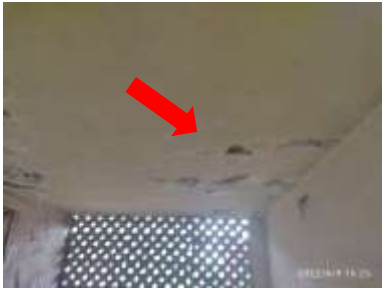
| c) | Building 2<br>Staircase<br>Mumpty<br>Room | Ceiling | | | Seepages<br>from water<br>tank, Ceiling<br>cracks | Refer attachment<br>1-TYPE XI, TYPE<br>XIII |

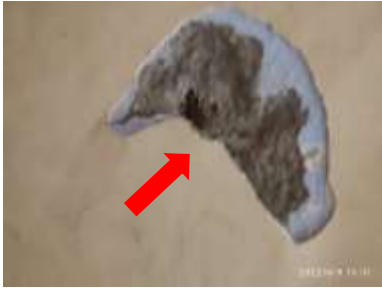
| d) | Building 2<br>Staircase<br>4 <sup>th</sup> Floor | Wall | | | Plaster cracks | Refer attachment<br>1-TYPE V |

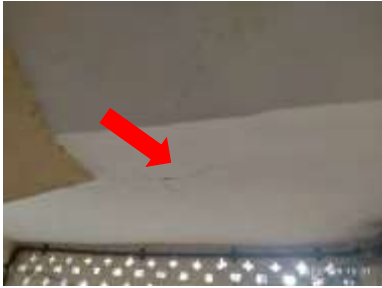
| e) | Building 2<br>Staircase<br>4 <sup>th</sup> Floor | Beam | | | Structural<br>crack | Refer attachment<br>1-TYPE VI |

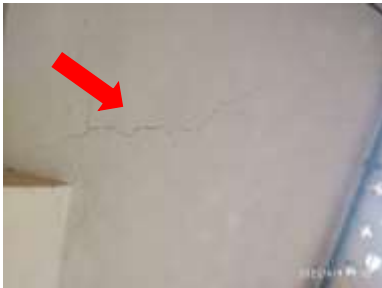
| f) | Building 2<br>Staircase<br>4 <sup>th</sup> Floor | Ceiling | | | Ceiling cracks | Refer attachment<br>1-TYPE XIII |

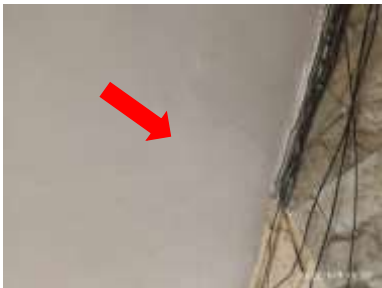
| g) | Building 2<br>Staircase<br>3 <sup>rd</sup> Floor | Waist slab | | | Plaster crack,<br>Plaster with<br>hollow sound | Refer attachment<br>1-TYPE V, TYPE<br>XVIII |

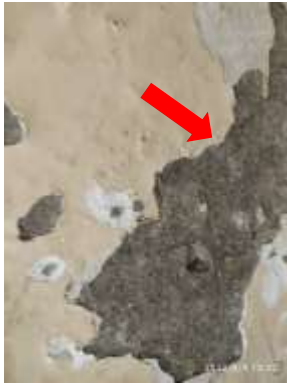
| i) | Building 2<br>Staircase<br>3 <sup>rd</sup> Floor | Wall | | | Seepages<br>from external,<br>plaster with<br>hollow sound | Refer attachment<br>1-TYPE XI, TYPE<br>XVIII |

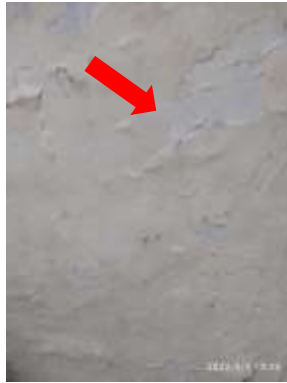
| j) | Building 2<br>Staircase<br>3 <sup>rd</sup> Floor | Ceiling | | | Seepage<br>marks | Refer attachment<br>1-TYPE III |

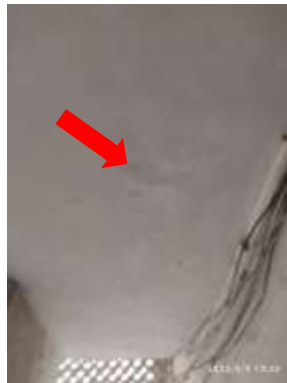
| k) | Building 2<br>Staircase<br>2 <sup>nd</sup> Floor | Waist slab | | | Plaster crack,<br>plaster with<br>hollow sound | Refer attachment<br>1-TYPE V, TYPE<br>XVIII |

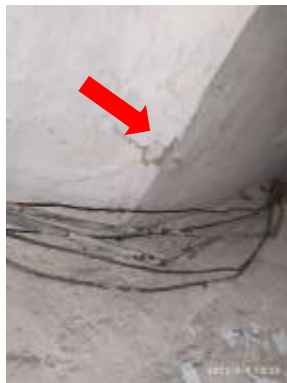
| l) | Building 2<br>Staircase<br>2 <sup>nd</sup> Floor | Waist slab | | | Plaster crack,<br>Plaster with<br>hollow sound | Refer attachment<br>1-TYPE V, TYPE<br>XVIII |

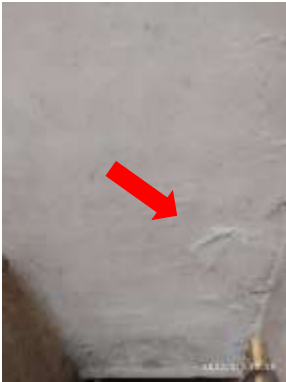
| m) | Building 2<br>Staircase<br>2 <sup>nd</sup> Floor | Waist slab | | | Plaster with hollow sound | Refer attachment 1-TYPE XVIII |

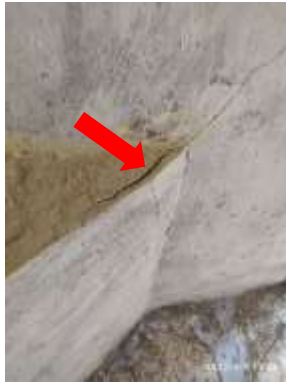
| n) | Building 2<br>Staircase<br>1 <sup>st</sup> Floor | Waist slab | | | Structural crack, Plaster with hollow sound | Refer attachment 1-TYPE VI, TYPE XVIII |

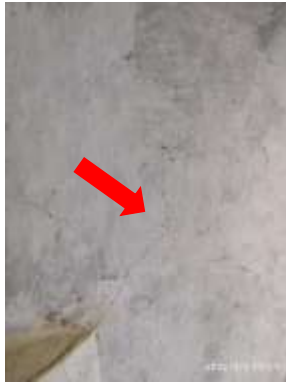
| o) | Building 2<br>Staircase<br>1 <sup>st</sup> Floor | Ceiling | | | Ceiling cracks | Refer attachment 1-TYPE XIII |

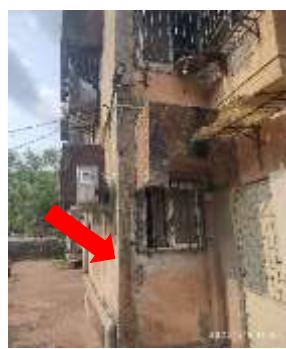
| a) | External | Column | | | Major Structural crack | Refer attachment 1-TYPE VI |

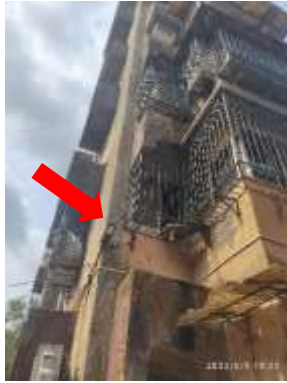
| b) | External | Column | | | Major structural crack | Refer attachment 1-TYPE VI |

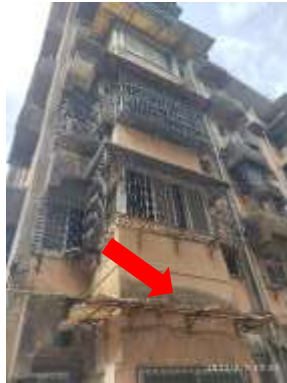
| c) | External | Lintel Beam | | | Major structural crack | Refer attachment 1-TYPE VI |

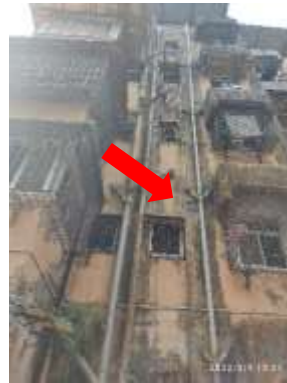
| d) | External | Plumbing line | | | Water dripping, Major seepages from pipeline | Refer attachment 1-TYPE XI |

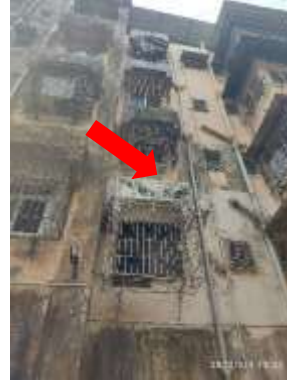
| e) | External | Column | | | Major structural crack | Refer attachment 1-TYPE VI |

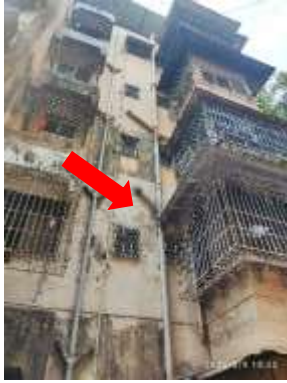
| f) | External | Plumbing line | | | Water dripping,<br>Major seepages from pipeline | Refer attachment 1-TYPE XI |

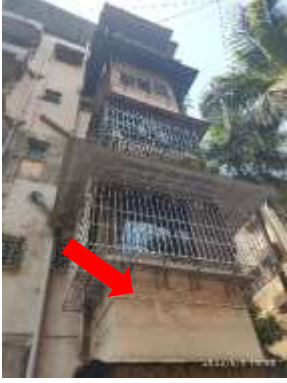
| g) | External | Balcony | | | Major structural crack | Refer attachment 1-TYPE VI |

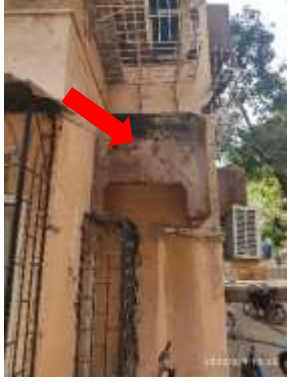
| h) | External | Chajja | | | Major structural crack,<br>Seepages | Refer attachment 1-TYPE VI |

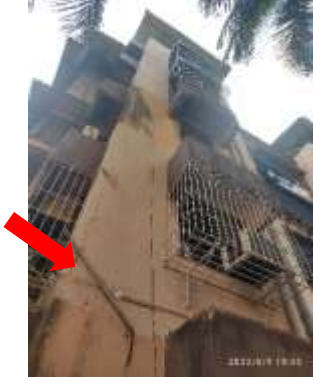
| i) | External | Column | | | Major structural crack | Refer attachment 1-TYPE VI |

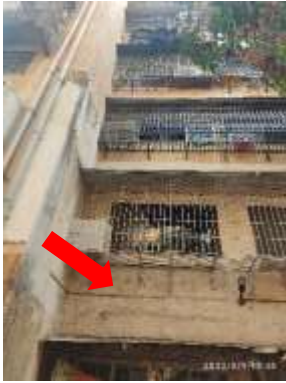
| j) | External | Beam | | | Structural crack | Refer attachment 1-TYPE VI |

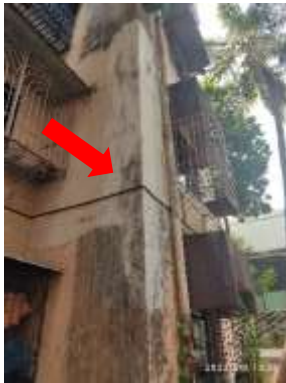
| k) | External | Column | | | Major structural crack | Refer attachment 1-TYPE VI |

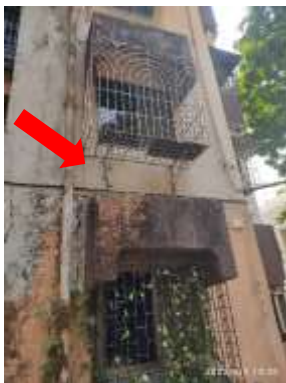
| l) | External | Column | | | Major structural crack | Refer attachment 1-TYPE VI |

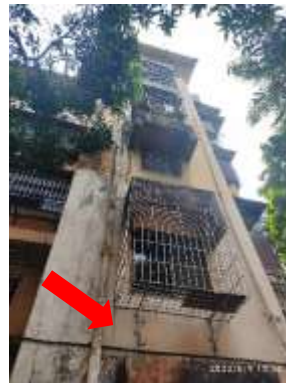
| m) | External | Column | | | Major structural crack | Refer attachment 1-TYPE VI |

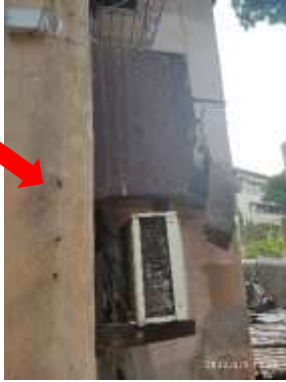
| n) | External | Chajja | | | Structural crack | Refer attachment 1-TYPE VI |

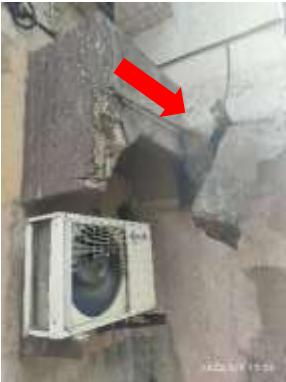
| o) | External | Chajja | | | Major structural crack (reinforcement corroded & Plaster spall off) | Refer attachment 1-TYPE VI |

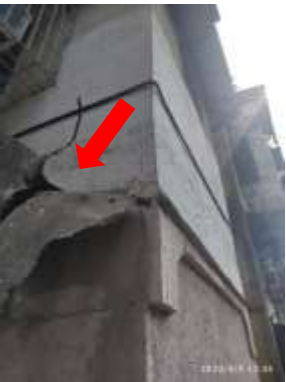
| p) | External | Column | | | Major structural crack | Refer attachment 1-TYPE VI |

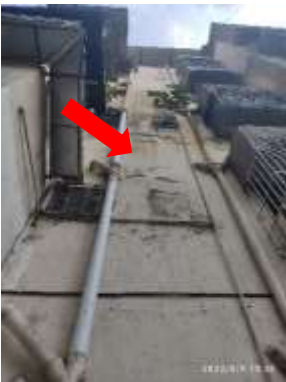
| q) | External | Pipeline | | | Seepages, Leakages through pipeline | Refer attachment 1-TYPE XI |

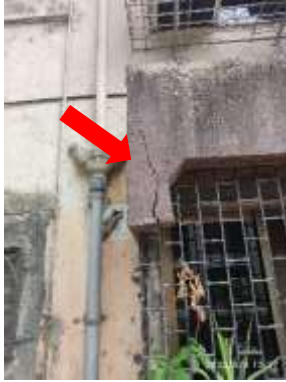
| r) | External | Chajja | | | Major structural crack | Refer attachment 1-TYPE VI |

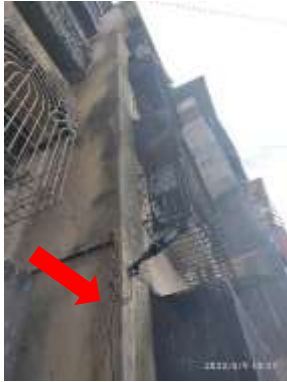
| s) | External | Column | | | Major structural crack | Refer attachment 1-TYPE VI |

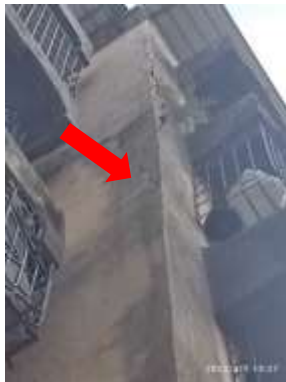
| t) | External | Column | | | Major structural crack | Refer attachment 1-TYPE VI |

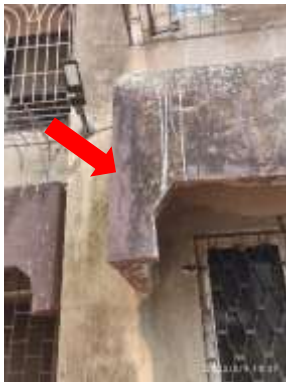
| u) | External | Chajja | | | Structural crack | Refer attachment 1-TYPE VI |

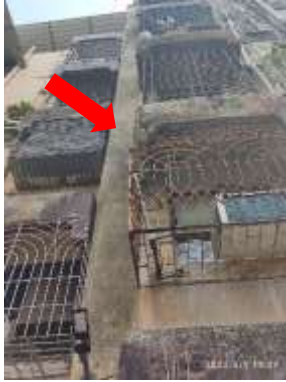
| v) | External | Column | | | Structural crack | Refer attachment 1-TYPE VI |

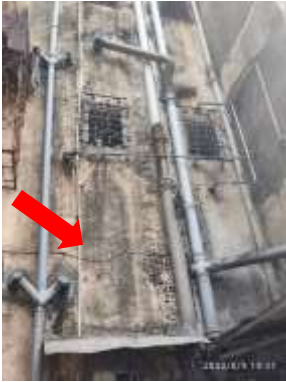
| w) | External | Plumbing | | | Seepages from external pipelines | Refer attachment 1-TYPE XI |

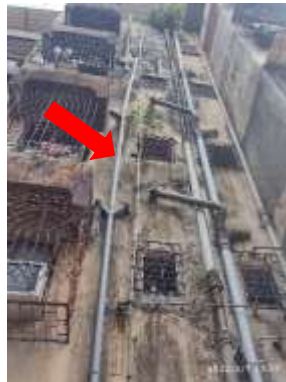
| x) | External | Plumbing | | | Seepages from external pipelines, Vegetation | Refer attachment 1-TYPE XI |

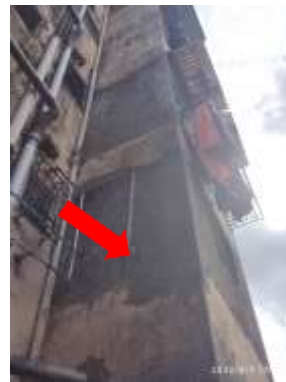
| y) | External | Dead Wall | | | Plaster cracks, Plaster with hollow sound (Major leakages from external) | Refer attachment 1-TYPE V, TYPE XVIII |

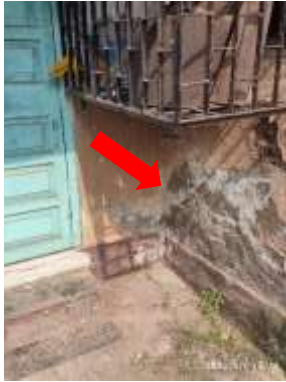
| z) | External | Wall | | | Plaster with hollow sound | Refer attachment 1-TYPE XVIII |

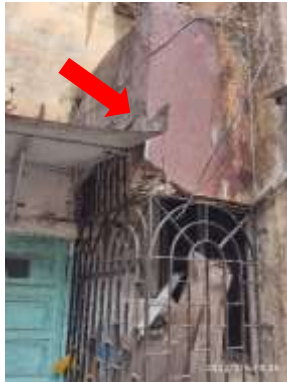
| aa) | External | Chajja | | | Major structural crack | Refer attachment 1-TYPE VI |

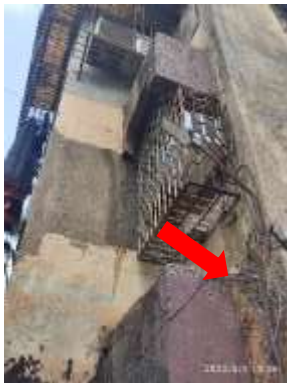
| ab) | External | Dead Wall | | | Structural crack, Major seepages | Refer attachment 1-TYPE VI, TYPE XI |

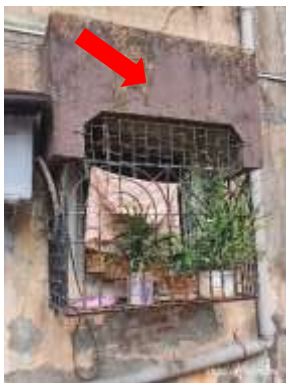
| ac) | External | Chajja | | | Plaster cracks | Refer attachment 1-TYPE V |

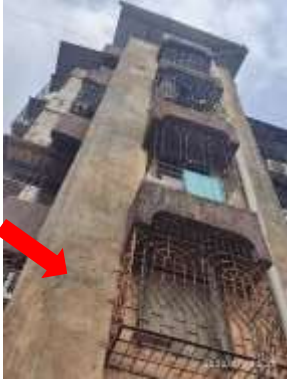
| ad) | External | Wall | | | Plaster cracks | Refer attachment<br>1-TYPE V |

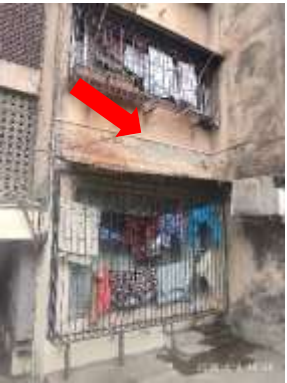
| ae) | external | Beam | | | Structural<br>crack | Refer attachment<br>1-TYPE VI |

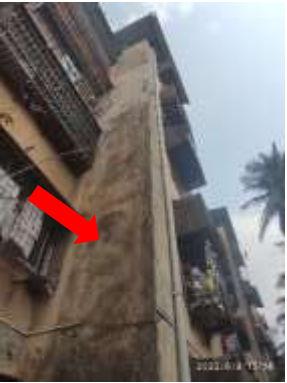
| af) | External | Dead Wall | | | Plaster cracks,<br>Plaster with<br>hollow sound<br>(Source of<br>leakages<br>inside the<br>Flat) | Refer attachment<br>1-TYPE V, TYPE<br>XVIII |

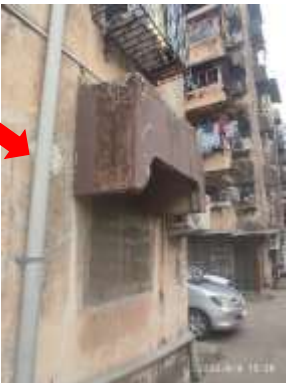
| ag) | External | Chajja | | | Plaster crack | Refer attachment<br>1-TYPE V |

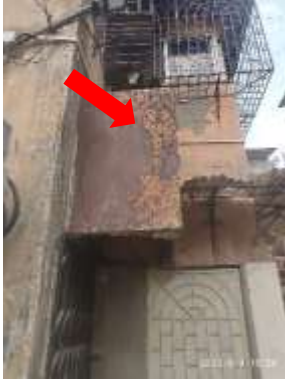
| ah) | External | Chajja | | | Structural crack | Refer attachment 1-TYPE VI |

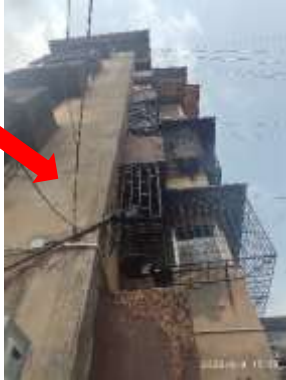
| ai) | External | Column | | | Major structural crack | Refer attachment 1-TYPE VI |

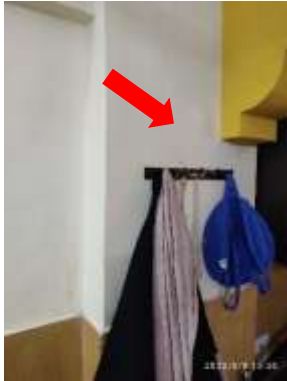
| Sr No. | LOCATION | AREA DESCRIPTION | | PHOTOS | DEFECTS | PROCESS FOR AMELIORATIONS |
|---|---|---|---|---|---|---|
| a) | Living room | Column C 2 | | | Column with hollow sound | Refer attachment 1-TYPE XVII |

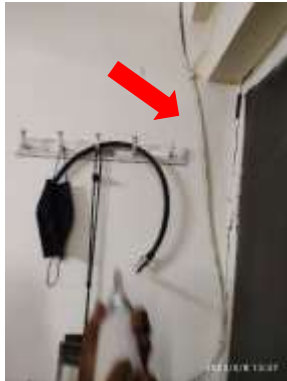
| Sr No. | LOCATION | AREA DESCRIPTION | | PHOTOS | DEFECTS | PROCESS FOR AMELIORATIONS |
|---|---|---|---|---|---|---|
| b) | Living room | Column C 1 | | | Column with hollow sound | Refer attachment 1-TYPE XVII |

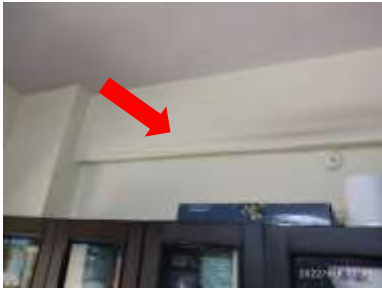
| Sr No. | LOCATION | AREA DESCRIPTION | | PHOTOS | DEFECTS | PROCESS FOR AMELIORATIONS |
|---|---|---|---|---|---|---|
| c) | Living Room | Beam | | | Structural crack | Refer attachment 1-TYPE VI |

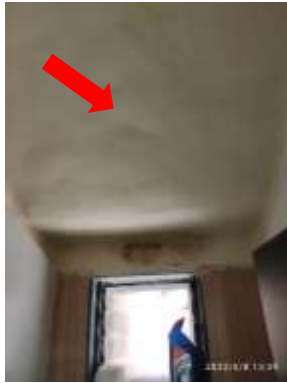
| Sr No. | LOCATION | AREA DESCRIPTION | | PHOTOS | DEFECTS | PROCESS FOR AMELIORATIONS |
|---|---|---|---|---|---|---|
| d) | Toilet | Sunk | | | Seepage marks | Refer attachment 1-TYPE III |

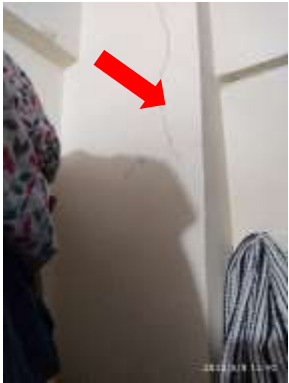
| e) | Bedroom<br>1 | Column<br>C 6 | | | Structural<br>crack | Refer attachment<br>1-TYPE VI |

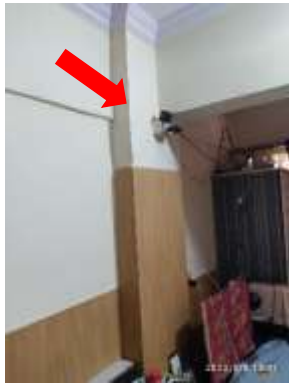
| f) | Bedroom<br>1 | Column<br>C 4 | | | Column with<br>hollow sound | Refer attachment<br>1-TYPE XVIII |

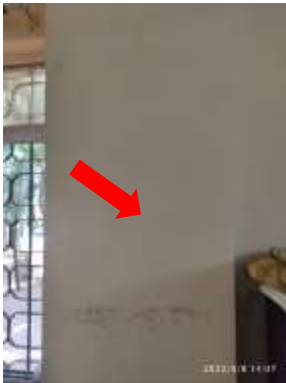
| a) | Bedroom<br>1 | Column<br>C 5 | | | Plaster crack,<br>column with<br>hollow sound | Refer attachment<br>1-TYPE V, TYPE<br>XVII |

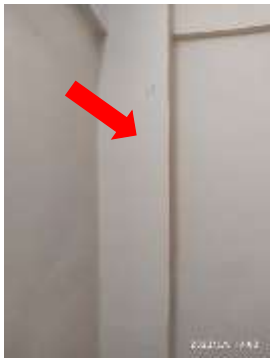
| b) | Bedroom<br>1 | Column 7 | | | Column with<br>hollow sound | Refer attachment<br>1-TYPE XVII |

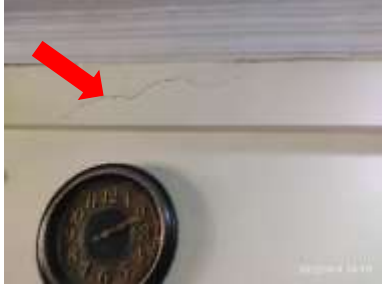
| a) | Living Room | Beam | | | Structural crack | Refer attachment 1-TYPE VI |

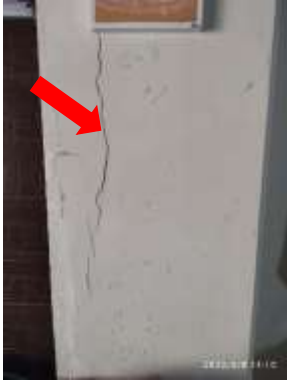
| b) | Living Room | Column C 8 | | | Major structural crack | Refer attachment 1-TYPE VI |

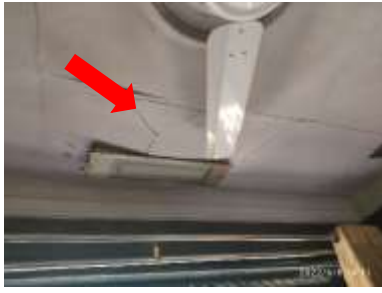
| c) | Living Room | False ceiling | | | (Need to check) | Refer attachment 1-TYPE |

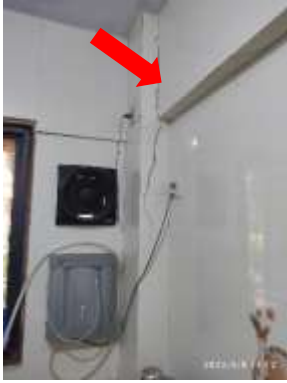
| d) | Kitchen | Column C 9 | | | Major structural crack | Refer attachment 1-TYPE VI |

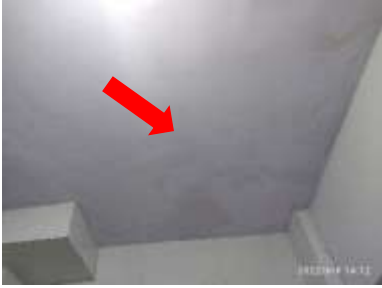
| e) | Kitchen | Ceiling | | | Seepages from flat no 3A/8 | Refer attachment 1-TYPE XI |

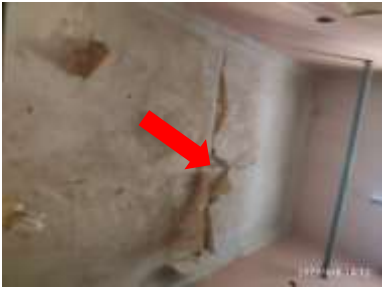
| f) | Bathroom | Ceiling | | | Ceiling seepages from flat no 3A/8 | Refer attachment 1-TYPE XI |

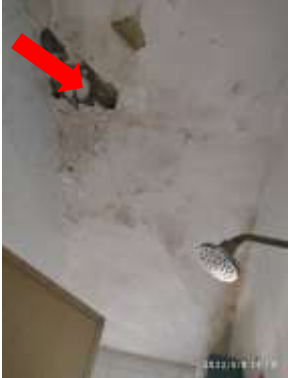
| g) | Bathroom | Ceiling | | | Ceiling seepages from flat no 3A/8 | Refer attachment 1-TYPE XI |

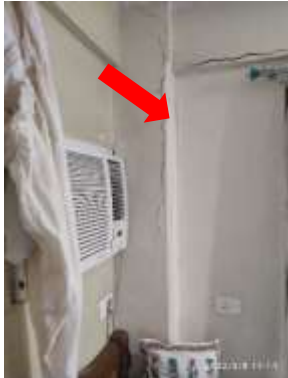
| h) | Bedroom 1 | Column C 13 | | | Major Structural crack | Refer attachment 1-TYPE VI |

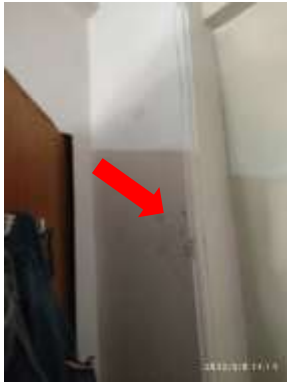
| j) | Bedroom | Column C 16 | | | Plaster crack, Column with hollow sound | Refer attachment 1-TYPE V, TYPE XVII |

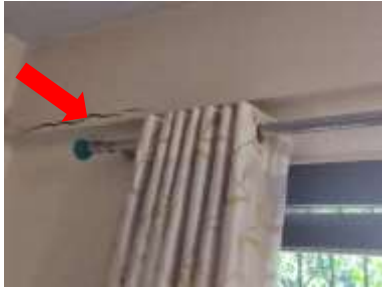
| k) | Bedroom | Beam | | | Major structural crack | Refer attachment 1-TYPE VI |

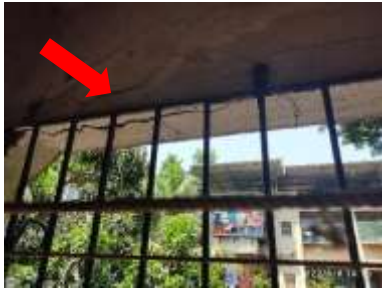
| l) | Bedroom | Chajja | | | Major structural crack | Refer attachment 1-TYPE VI |

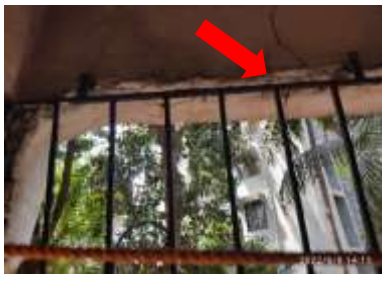
| m) | Bedroom | Chajja | | | Plaster crack | Refer attachment 1-TYPE V |

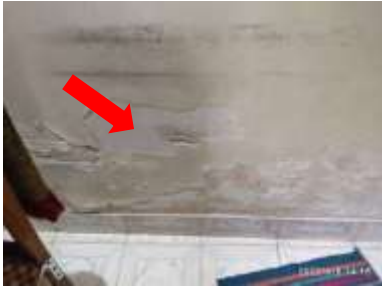
| n) | Bedroom 1 | Wall | | | Seepages from adjacent bathroom | Refer attachment 1-TYPE XI |

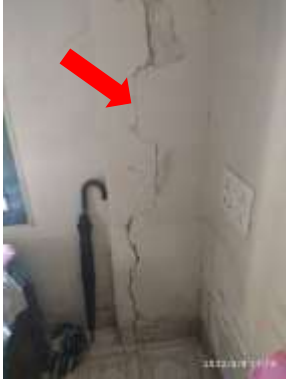
| o) | Living Room | Column C 18 | | | Major structural crack | Refer attachment 1-TYPE VI |

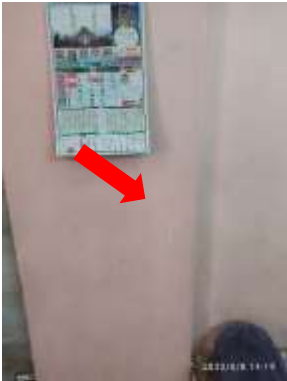
| a) | Living Room | Column C 20 | | | Plaster crack, Column with hollow sound | Refer attachment 1-TYPE V, TYPE XVII |

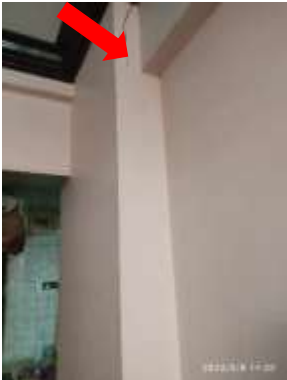
| b) | Living Room | Column C 20 | | | Structural crack | Refer attachment 1-TYPE VI |

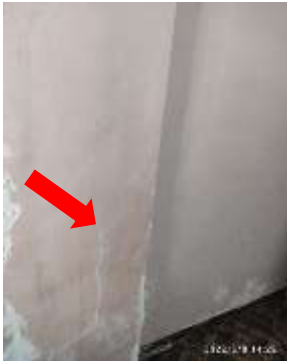
| c) | Bedroom<br>1 | Column<br>C 21 | | | Structural<br>crack, Column<br>with hollow<br>sound | Refer attachment<br>1-TYPE VI, TYPE<br>XVII |

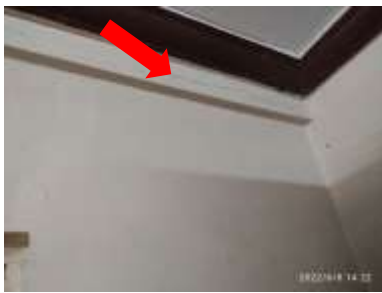
| d) | Bedroom<br>1 | Beam | | | Structural<br>crack | Refer attachment<br>1-TYPE VI |

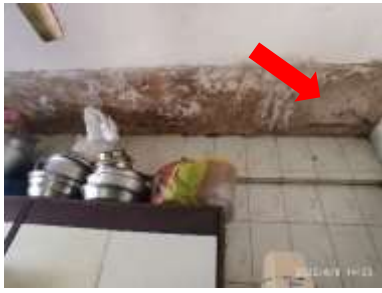
| e) | Kitchen | Ceiling | | | Ceiling cracks,<br>(reinforcement<br>corroded) | Refer attachment<br>1-TYPE XIII |

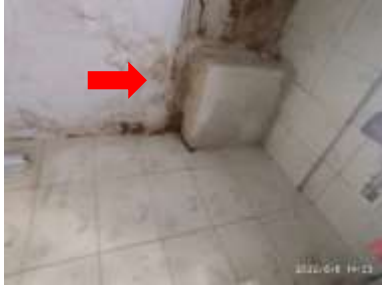
| f) | Kitchen | Sunk | | | Seepage<br>from flat no<br>3A/9 | Refer attachment<br>1-TYPE XI |

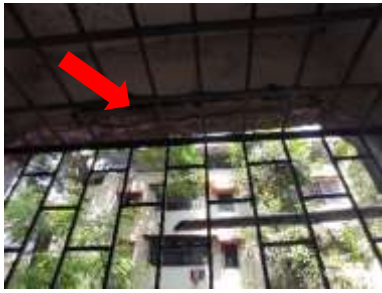
| g) | Kitchen | Chajja | | | Major<br>structural<br>crack | Refer attachment<br>1-TYPE VI |

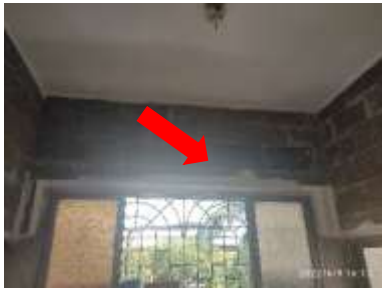
| a) | Living Room | Lintel Beam | | | Window top lintel found with crack | Refer attachment 1-TYPE XIX |

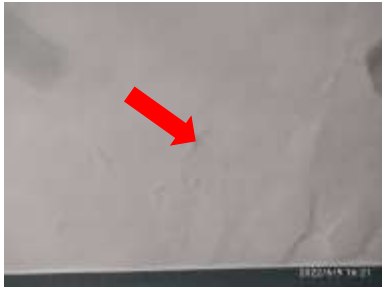
| c) | Living Room | Ceiling | | | Ceiling crack | Refer attachment 1-TYPE XIII |

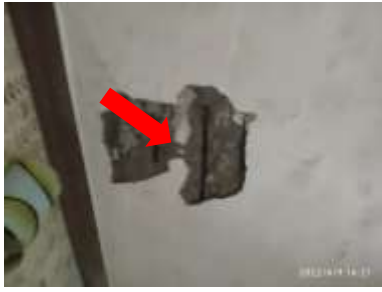
| d) | Bedroom | Ceiling | | | Major structural crack, ceiling cracks (Reinforcement corroded) | Refer attachment 1-TYPE VI, TYPE XIII |

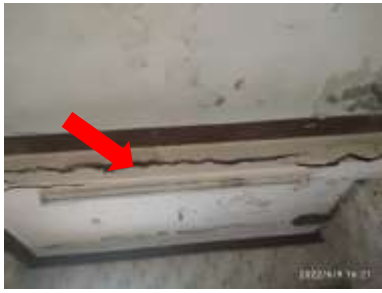
| e) | Bedroom | Beam | | | Major structural crack | Refer attachment 1-TYPE VI |

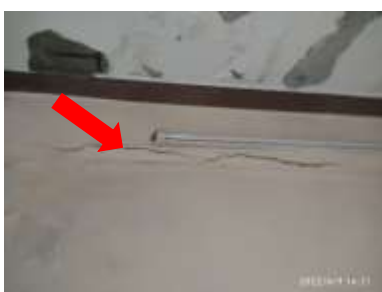
| f) | Bedroom | Beam | | | Major structural crack | Refer attachment 1-TYPE VI |

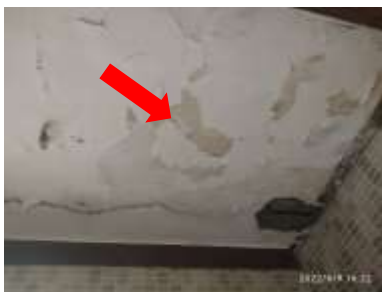
| g) | Bedroom Balcony | Ceiling | | | Ceiling cracks, Structural crack (Reinforcement corroded & Plaster spall off) | Refer attachment 1-TYPE XIII, TYPE VI |

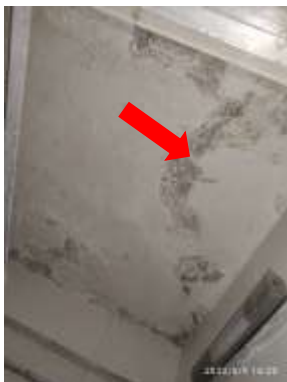
| h) | Bathroom | Ceiling | | | Ceiling cracks | Refer attachment 1-TYPE XIII |

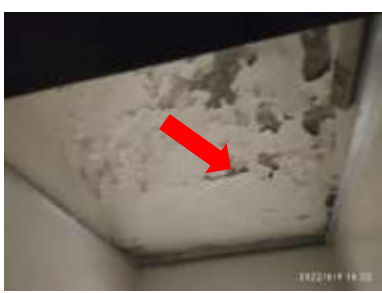
| i) | Toilet | Ceiling | | | Ceiling cracks. Seepages | Refer attachment 1-TYPE XIII, TYPE XI |

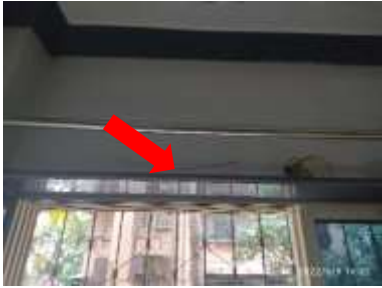
| j) | Bedroom | Balcony | | | Window Top lintel found with crack | Refer attachment 1-TYPE XIX |

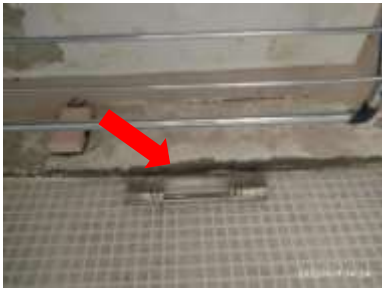
| k) | Passage | Beam | | | Seepage from flat no 3A/10 | Refer attachment 1-TYPE XI |

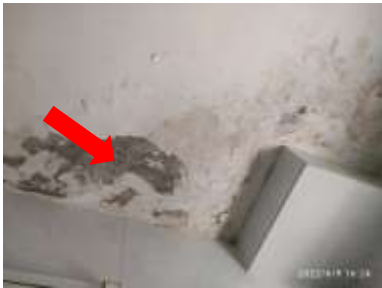
| l) | Passage | Ceiling | | | Seepage from flat no 3A/10 | Refer attachment 1-TYPE XI |

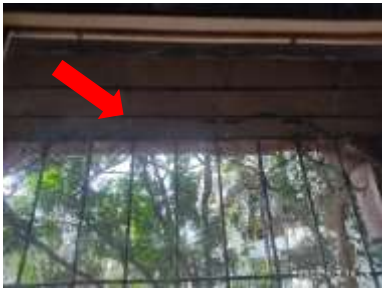
| m) | Passage | Chajja | | | Major structural crack | Refer attachment 1-TYPE VI |

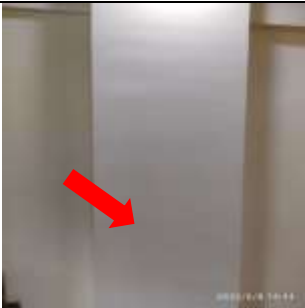
| a) | Living room | Column C 8 | | | Column with hollow sound t bottom | Refer attachment 1-TYPE XVII |

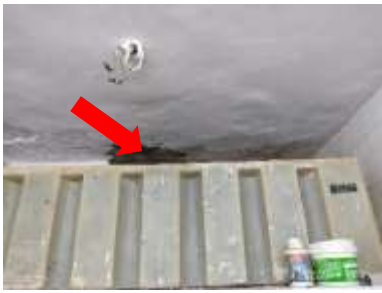
| b) | Kitchen | Ceiling | | | Major seepages from flat no 3A/11, Water dripping | Refer attachment 1-TYPE XI, TYPE IX |

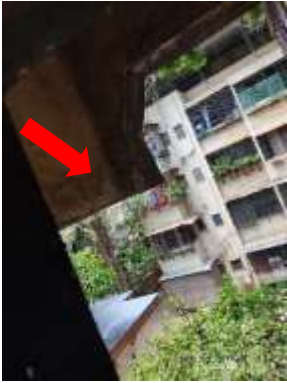
| c) | Kitchen | Chajja | | | Structural crack | Refer attachment 1-TYPE VI |

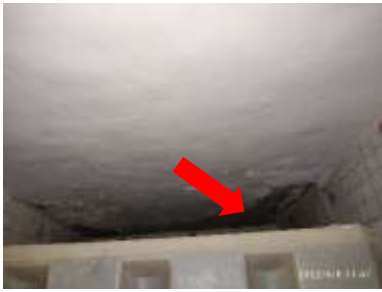
| d) | Kitchen | Ceiling | | | Major seepages from flat no 3A/11, Water dripping | Refer attachment 1-TYPE XI, TYPE IX |

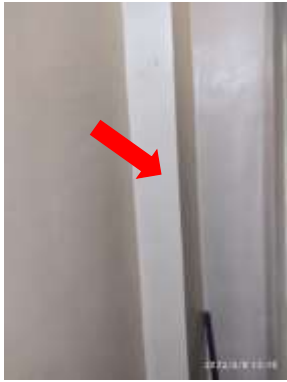
| e) | Bedroom | Column C 13 | | | Column with hollow sound | Refer attachment 1-TYPE XVII |

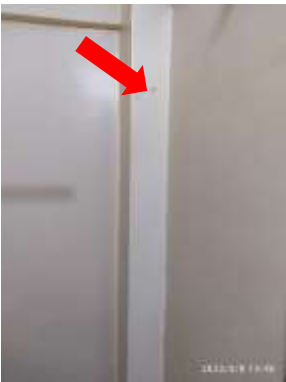
| f) | Bedroom | Column C 14 | | | Column with hollow sound | Refer attachment 1-TYPE XVII |

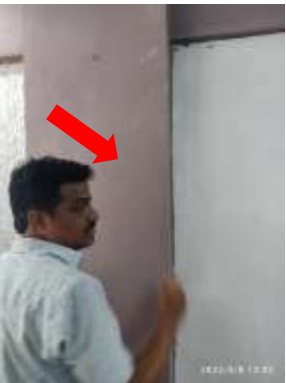
| a) | Living Room | Column C 20 | | | Column with hollow sound | Refer attachment 1-TYPE XVII |

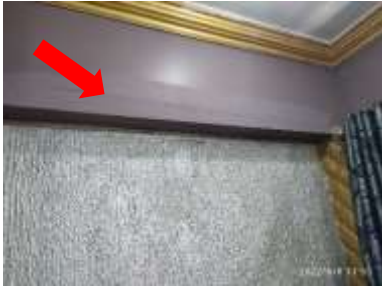
| c) | Bedroom | Beam | | | Plaster with hollow sound | Refer attachment 1-TYPE XVIII |

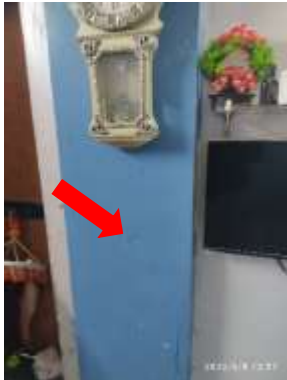
| d) | Bedroom | Column C 21 | | | Structural crack at bottom | Refer attachment 1-TYPE VI |

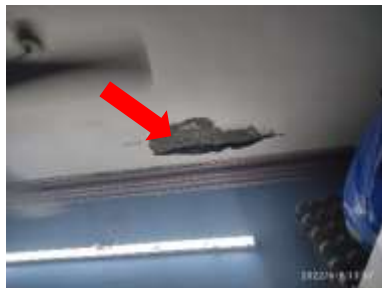
| e) | Bedroom 1 Balcony | Ceiling | | | Ceiling cracks | Refer attachment 1-TYPE XIII |

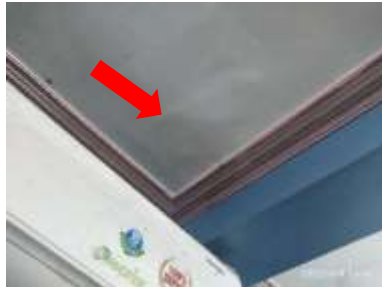
| f) | Bedroom 1 | Ceiling | | | Ceiling cracks | Refer attachment 1-TYPE XIII |

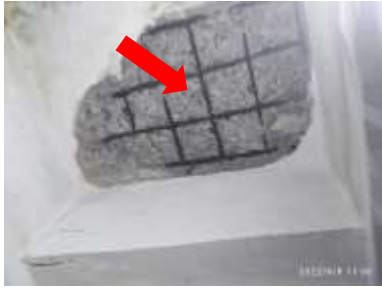
| g) | Toilet | Ceiling | | | Ceiling cracks<br>(Reinforcement corroded & plaster spall off) | Refer attachment<br>1-TYPE XIII |

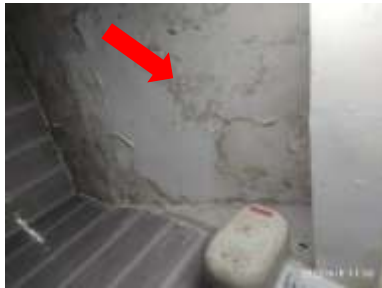
| h) | Toilet | Sunk | | | Major<br>seepage from<br>flat no 3A/12 | Refer attachment<br>1-TYPE XI |

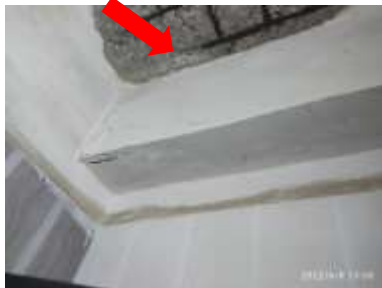
| i) | Toilet | Beam | | | Major<br>structural<br>crack | Refer attachment<br>1-TYPE VI |

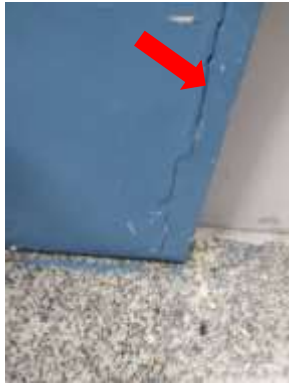
| j) | Bedroom<br>2 | Column | | | Major<br>structural<br>crack | Refer attachment<br>1-TYPE VI |

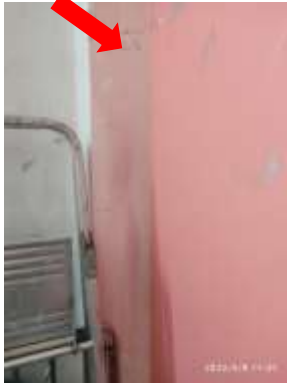
| k) | Bedroom<br>2 | Column<br>C 8 | | | Column with<br>hollow sound | Refer attachment<br>1-TYPE XVII |

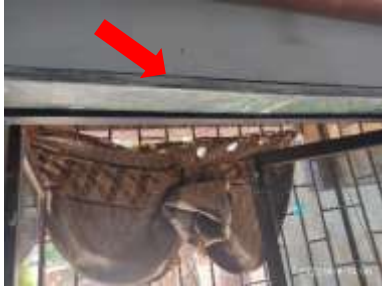
| l) | Bedroom<br>2 | Lintel Beam | | | Window top<br>lintel found<br>with crack | Refer attachment<br>1-TYPE XIX |

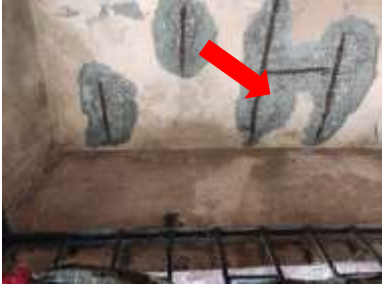
| m) | Bedroom<br>2<br>External | Chajja | | | Major<br>structural<br>crack<br>(Corroded &<br>plaster spall<br>off) | Refer attachment<br>1-TYPE VI |

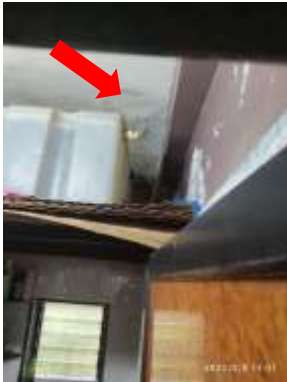
| n) | Bathroom | Ceiling | | | Ceiling cracks | Refer attachment<br>1-TYPE XIII |

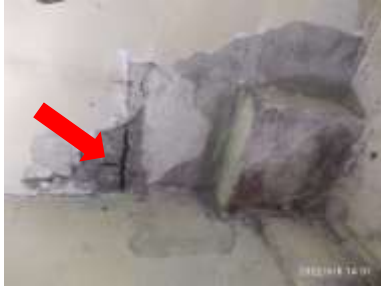
| o) | Kitchen | Ceiling | | | Ceiling cracks<br>(Corroded & plaster spall off) | Refer attachment<br>1-TYPE XIII |

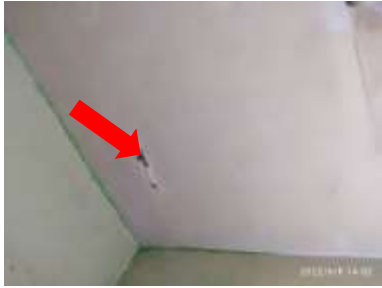
| p) | Kitchen | Ceiling | | | Ceiling cracks | Refer attachment<br>1-TYPE XIII |

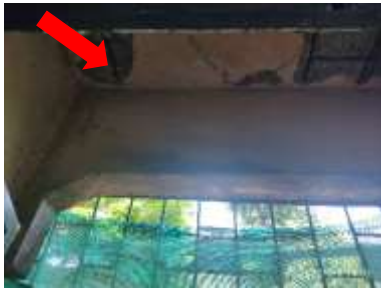
| q) | Kitchen | Chajja | | | Major structural crack<br>(Corroded & plaster spall off) | Refer attachment<br>1-TYPE VI |

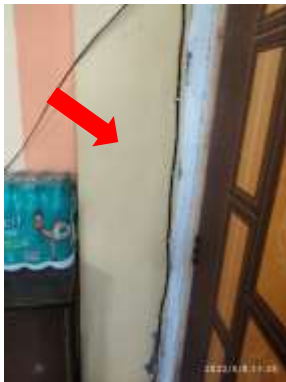
| a) | Living room | Column C 1 | | | Plaster crack | Refer attachment<br>1-TYPE V |

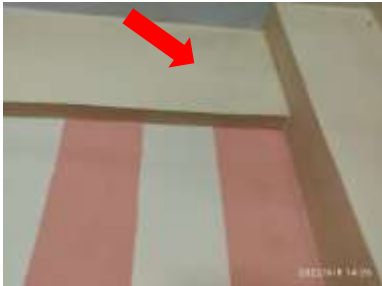
| b) | Living Room | Beam | | | Plaster crack | Refer attachment 1-TYPE V |

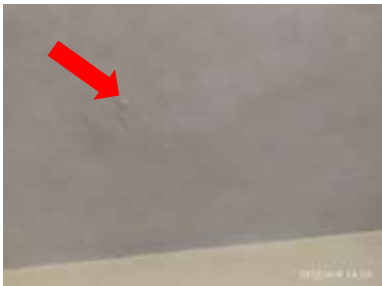
| c) | Living Room | Ceiling | | | Ceiling cracks | Refer attachment 1-TYPE XIII |

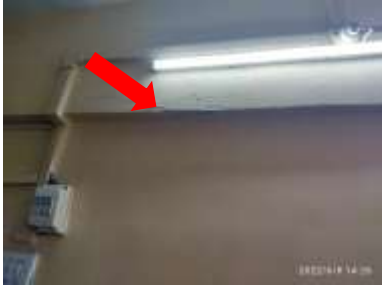
| d) | Living room | Beam | | | Structural crack | Refer attachment 1-TYPE VI |

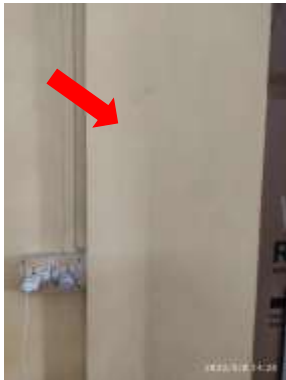
| e) | Living room | Column C 2 | | | Structural crack, Column with hollow sound | Refer attachment 1-TYPE VI, TYPE XVIII |

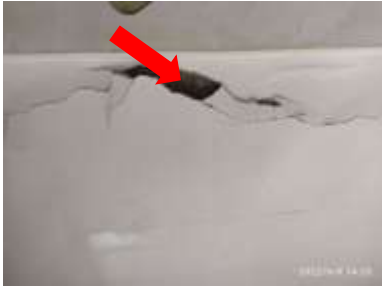
| f) | Living Room Balcony | Ceiling | | | Major structural crack, Ceiling cracks (Plaster spall off) | Refer attachment 1-TYPE VI, TYPE XIII |

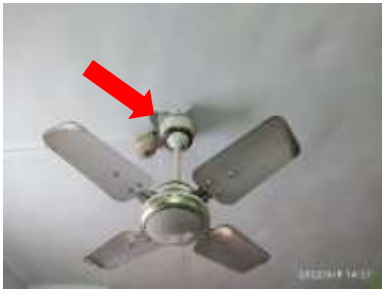
| g) | Kitchen | Ceiling | | | Ceiling cracks | Refer attachment<br>1-TYPE XIII |

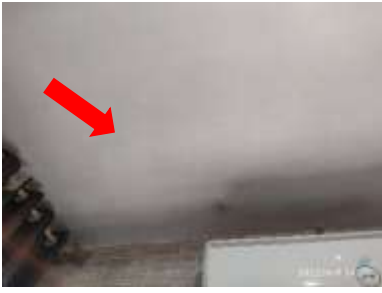
| i) | Bedroom<br>1 | Ceiling | | | Ceiling cracks | Refer attachment<br>1-TYPE XIII |

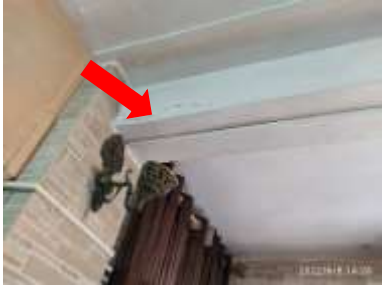
| j) | Bedroom<br>1 | Beam | | | Structural<br>cracks | Refer attachment<br>1-TYPE VI |

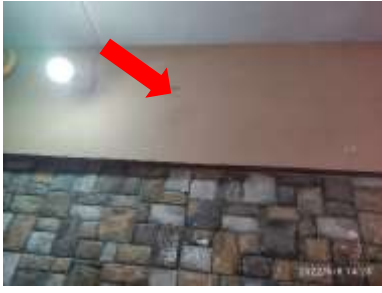
| k) | Bedroom<br>1 | Beam | | | Plaster with<br>hollow sound | Refer attachment<br>1-TYPE XVIII |

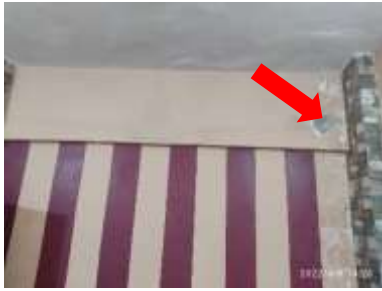
| l) | Bedroom<br>1 | Beam | | | Structural crack | Refer attachment 1-TYPE VI |

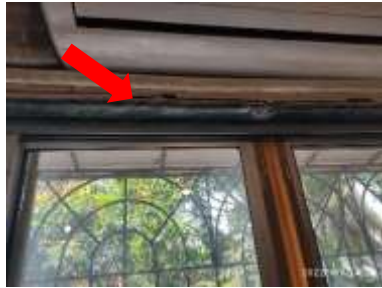
| m) | Bedroom<br>1 | Lintel beam | | | Window top lintel found with crack, Structural crack | Refer attachment 1-TYPE XIX |

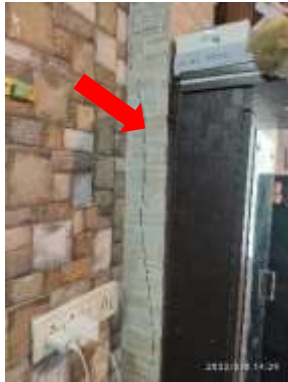
| n) | Kitchen | Column C 4 | | | Major structural crack | Refer attachment 1-TYPE VI |

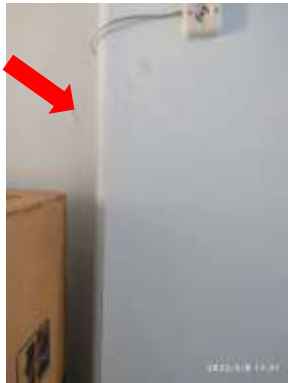
| a) | Living Room | Column C 8 | | | Plaster crack, Column with hollow sound | Refer attachment 1-TYPE V, TYPE XVII |

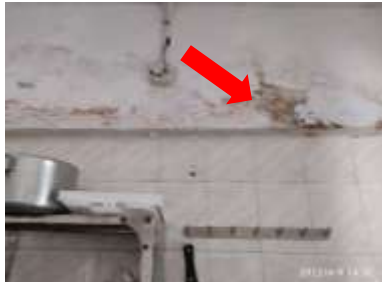
| b) | Kitchen | Beam | | | Seepages from flat no 3A/14 | Refer attachment 1-TYPE XI |

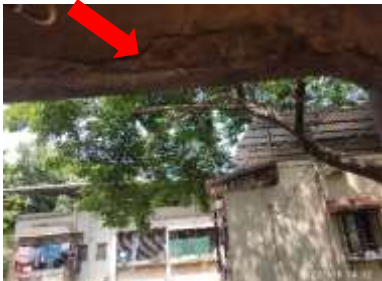
| c) | Kitchen | Chajja | | | Structural crack | Refer attachment 1-TYPE VI |

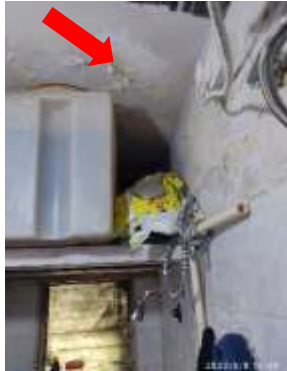
| d) | Bathroom | Ceiling | | | Seepages from flat no 3A/14 | Refer attachment 1-TYPE XI |

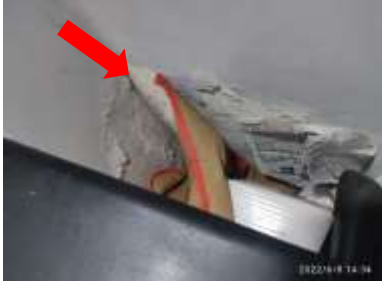
| e) | Toilet | Wall | | | Seepages from flat no 3A/14 | Refer attachment 1-TYPE XI |

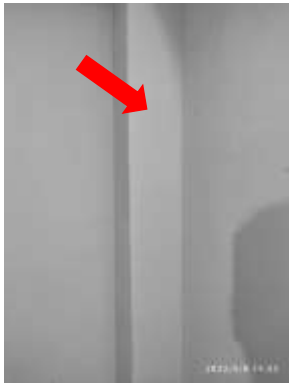
| f) | Bedroom | Column C 13 | | | Column with hollow sound | Refer attachment 1-TYPE XVII |

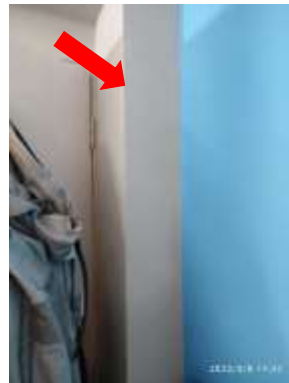
| g) | Bedroom | Column C 14 | | | Column with hollow sound | Refer attachment 1-TYPE XVII |

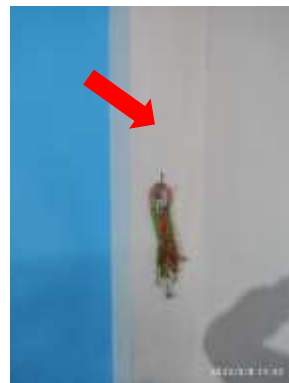
| h) | Bedroom | Column C 15 | | | Column with hollow sound | Refer attachment 1-TYPE XVII |

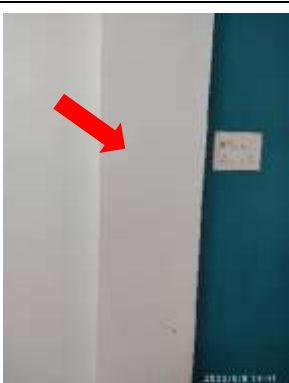
| a) | Living Room | Column C 19 | | | Plaster crack | Refer attachment 1-TYPE V |

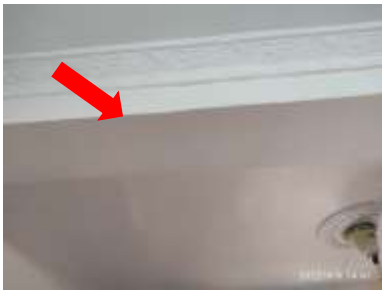
| b) | Living Room | Beam | | | Plaster crack | Refer attachment 1-TYPE V |

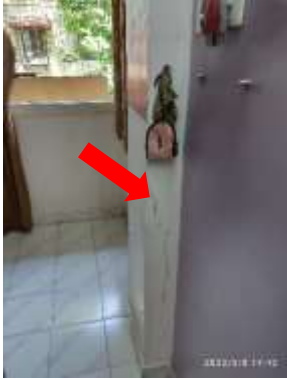
| c) | Bedroom | Column C 12 | | | Major structural crack | Refer attachment 1-TYPE VI |

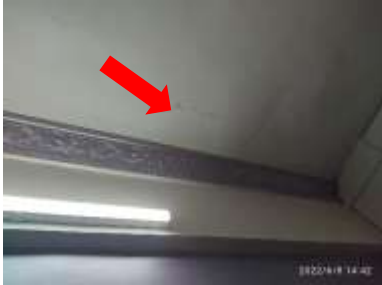
| d) | Bedroom | Ceiling | | | Ceiling cracks | Refer attachment 1-TYPE XIII |

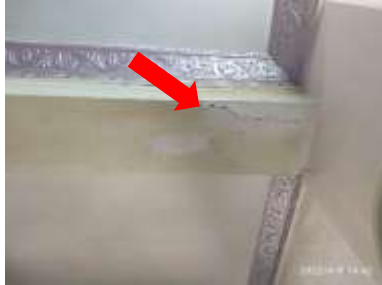
| e) | Bedroom | Beam | | | Structural crack | Refer attachment 1-TYPE VI |

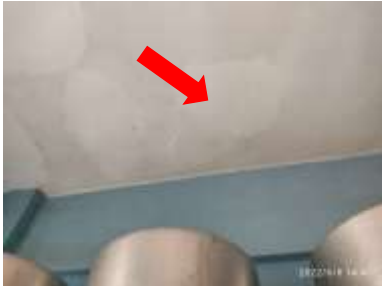
| f) | Kitchen | Ceiling | | | Ceiling cracks | Refer attachment 1-TYPE XIII |

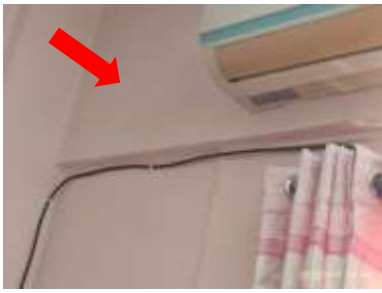
| h) | Bedroom 2 | Beam | | | Plaster cracks | Refer attachment 1-TYPE V |

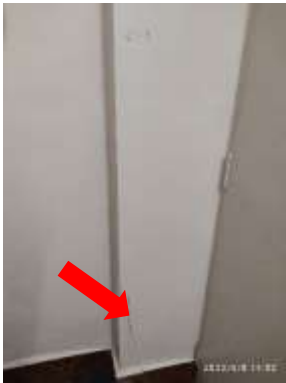
| a) | Loving room | Column C 1 | | | Structural crack | Refer attachment 1-TYPE VI |

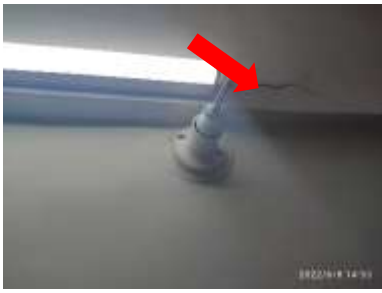
| b) | Living Room | Beam | | | Structural crack | Refer attachment 1-TYPE VI |

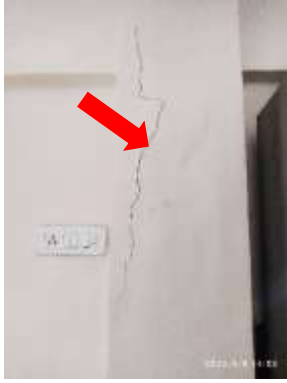
| c) | Living room | Column C 2 | | | Major structural crack | Refer attachment 1-TYPE VI |

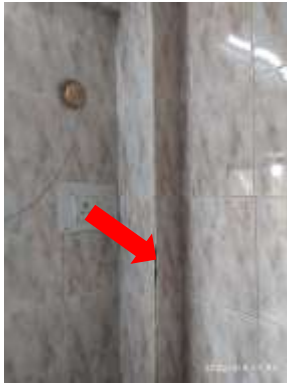
| d) | Kitchen | Column C 3 | | | Tile crack (need to remove & check) | Refer attachment 1-TYPE I |

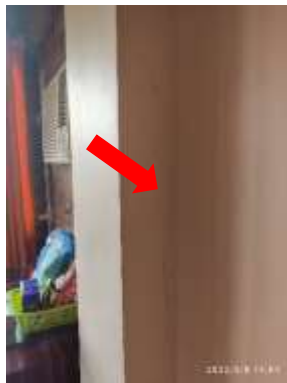
| e) | Bedroom 1 | Column C 5 | | | Structural crack | Refer attachment 1-TYPE VI |

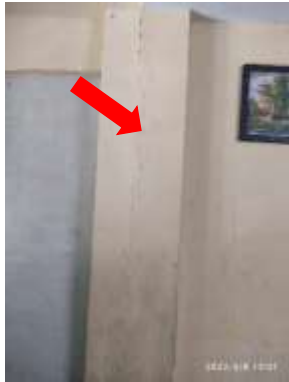
| a) | Living Room | Column C 8 | | | Major structural crack | Refer attachment 1-TYPE VI |

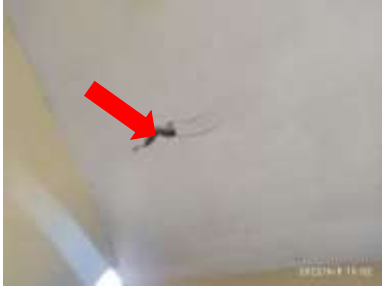
| b) | Bedroom balcony | Ceiling | | | Ceiling cracks | Refer attachment 1-TYPE XIII |

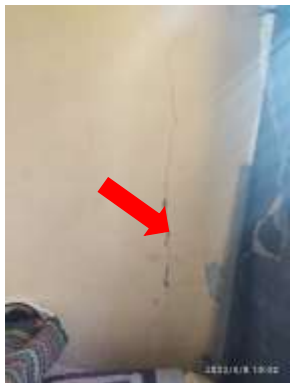
| c) | Bedroom balcony | Wall | | | Plaster crack | Refer attachment 1-TYPE V |

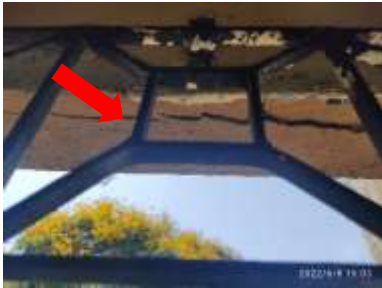
| d) | External | Chajja | | | Major structural crack | Refer attachment 1-TYPE VI |

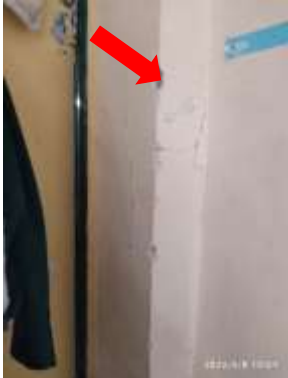
| e) | Bedroom 2 | Column C 16 | | | Major Structural crack (Structural distress) | Refer attachment 1-TYPE VI |

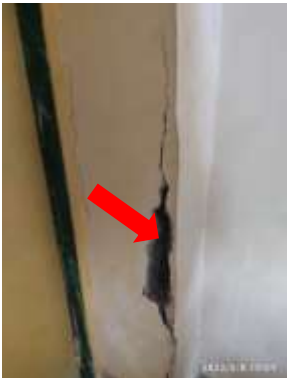
| f) | Bedroom 2 | Column C 16 | | | Major Structural crack (Structural distress) | Refer attachment 1-TYPE VI |

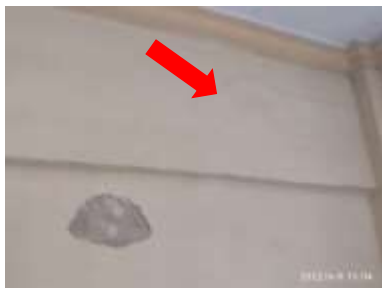
| g) | Bedroom 2 | beam | | | Plaster crack | Refer attachment 1-TYPE V |

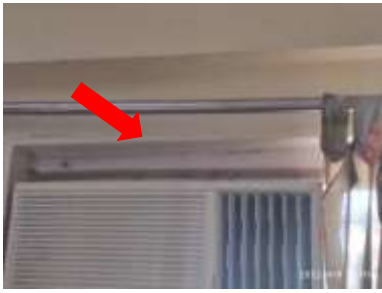
| h) | Bedroom 2 | Lintel beam | | | Window top lintel found with crack | Refer attachment 1-TYPE XIX |

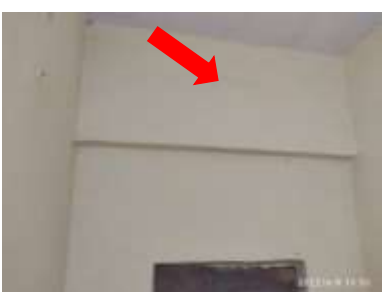
| i) | Bathroom | Beam | | | Plaster crack | Refer attachment 1-TYPE V |

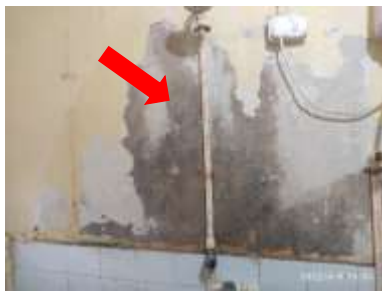
| j) | Kitchen | Wall | | | Capillary action marks from adjacent bathroom | Refer attachment 1-TYPE IV |

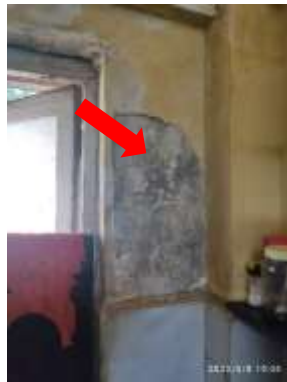
| k) | Kitchen | Wall | | | Capillary action marks from adjacent bathroom | Refer attachment 1-TYPE IV |

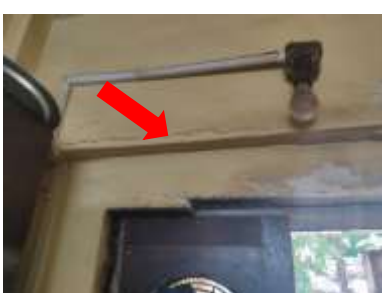
| l) | Kitchen | Beam | | | Major structural crack | Refer attachment 1-TYPE VI |

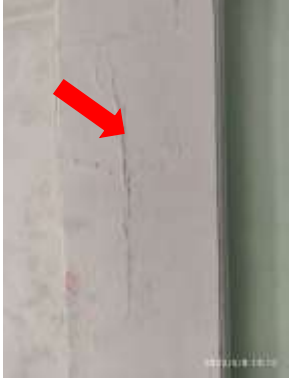
| a) | Living Room | Column C 20 | | | Structural crack, column with hollow sound | Refer attachment 1-TYPE VI, TYPE XVII |

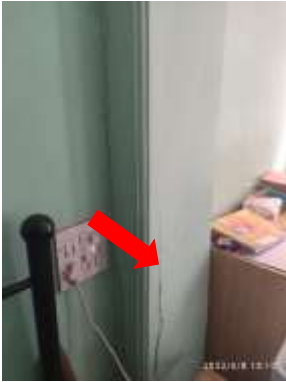
| b) | Living Room | Column C 19 | | | Major structural crack at bottom of column | Refer attachment 1-TYPE VI |

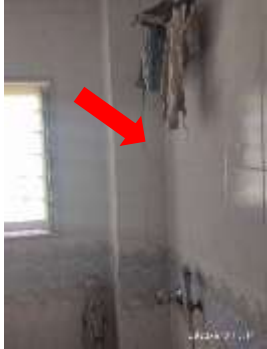
| c) | Toilet | Column C 22 | | | Structural crack | Refer attachment 1-TYPE VI |
