# STRUCTURAL AUDIT REPORT

NOOR CO-OP. HOUSING SOCIETY LTD,

VASHI,

**Taamra Engineering Consultants Private Limited**

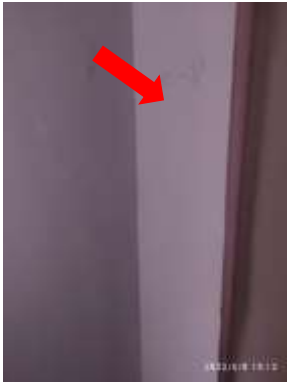
| d) | Bedroom | Column C 8 | | | Column with hollow sound | Refer attachment 1-TYPE XVII |

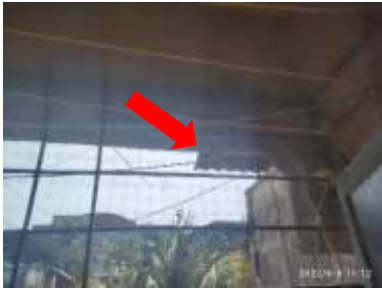
| e) | External | Chajja | | | Major structural crack | Refer attachment 1-TYPE VI |

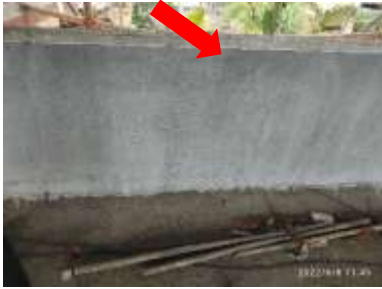
| Sr No. | LOCATION | AREA DESCRIPTION | | PHOTOS | DEFECTS | PROCESS FOR AMELIORATIONS |
|---|---|---|---|---|---|---|
| a) | Terrace | Parapet wall | | | Plaster crack | Refer attachment 1-TYPE V |

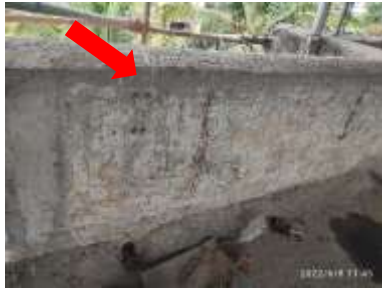
| Sr No. | LOCATION | AREA DESCRIPTION | | PHOTOS | DEFECTS | PROCESS FOR AMELIORATIONS |
|---|---|---|---|---|---|---|
| b) | Terrace | Parapet wall | | | Plaster crack | Refer attachment 1-TYPE V |

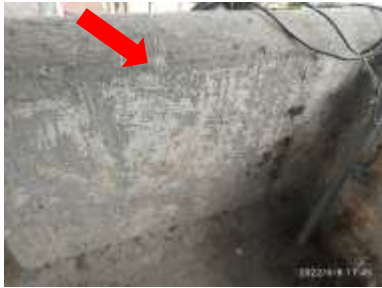
| Sr No. | LOCATION | AREA DESCRIPTION | | PHOTOS | DEFECTS | PROCESS FOR AMELIORATIONS |
|---|---|---|---|---|---|---|
| c) | Terrace | Parapet wall | | | Plaster crack | Refer attachment 1-TYPE V |

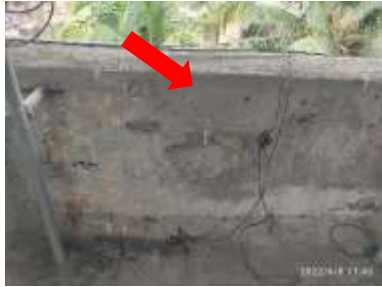
| Sr No. | LOCATION | AREA DESCRIPTION | | PHOTOS | DEFECTS | PROCESS FOR AMELIORATIONS |
|---|---|---|---|---|---|---|
| d) | Terrace | Parapet wall | | | Plaster crack | Refer attachment 1-TYPE V |

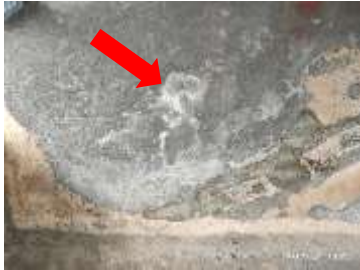
| Sr No. | LOCATION | AREA DESCRIPTION | | PHOTOS | DEFECTS | PROCESS FOR AMELIORATIONS |
|---|---|---|---|---|---|---|
| e) | Terrace | Parapet wall | | | Plaster crack | Refer attachment 1-TYPE V |

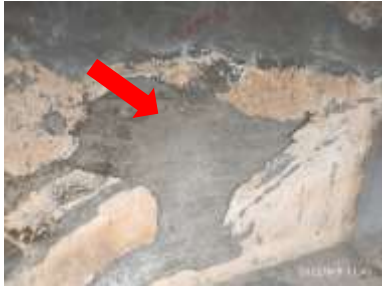
| f) | Terrace | Parapet wall | | | Plaster crack | Refer attachment<br>1-TYPE V |

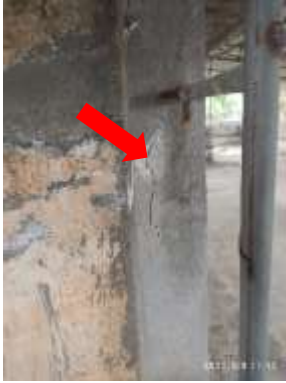
| g) | Terrace | Column | | | Structural<br>crack | Refer attachment<br>1-TYPE VI |

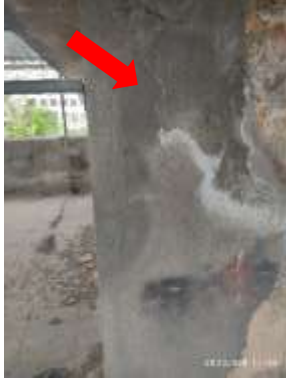
| h) | Terrace | Column | | | Structural<br>crack, Column<br>with hollow<br>sound | Refer attachment<br>1-TYPE VI, TYPE<br>XVII |

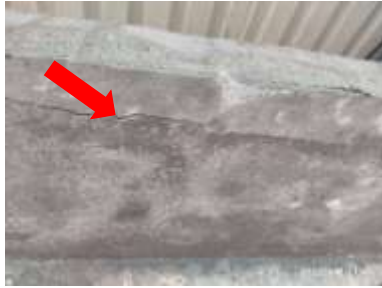
| i) | Terrace | Chajja | | | Structural<br>crack | Refer attachment<br>1-TYPE VI |

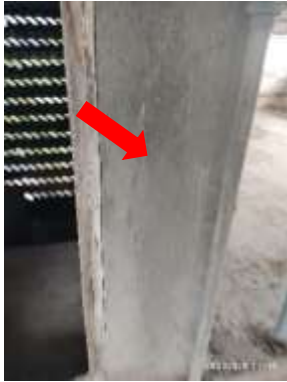
| j) | Terrace | Column | | | Column with hollow sound | Refer attachment 1-TYPE XVII |

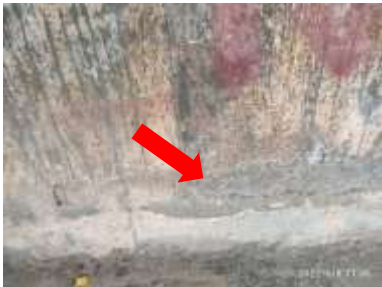
| k) | Terrae | Wall | | | Plaster with hollow sound | Refer attachment 1-TYPE XVIII |

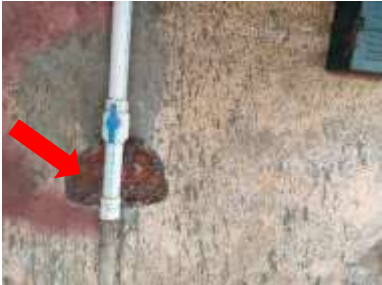
| l) | Terrace | Wall | | | Plaster crack | Refer attachment 1-TYPE V |

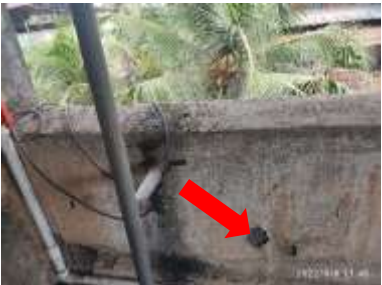
| m) | Terrace | Parapet wall | | | Plaster crack | Refer attachment 1-TYPE V |

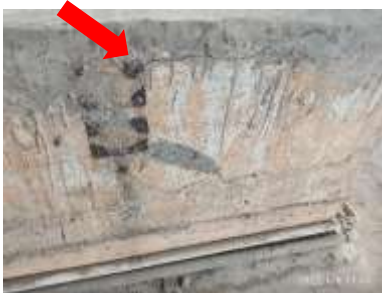
| n) | Terrace | Parapet wall | | | Plaster crack | Refer attachment 1-TYPE V |

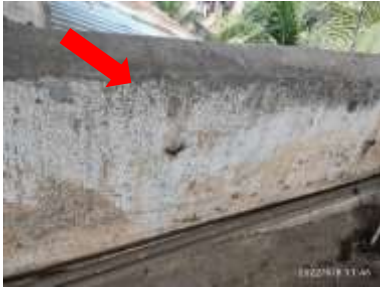
| o) | Terrace | Parapet wall | | | Plaster crack | Refer attachment<br>1-TYPE V |

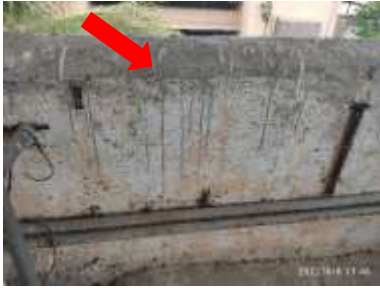
| p) | Terrace | Parapet wall | | | Plaster crack | Refer attachment<br>1-TYPE V |

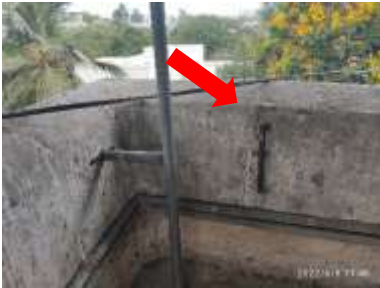
| q) | Terrace | Parapet wall | | | Plaster crack | Refer attachment<br>1-TYPE V |

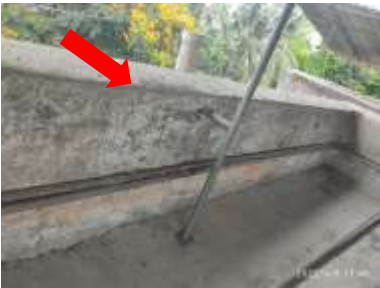
| r) | Terrace | Parapet wall | | | Plaster crack | Refer attachment<br>1-TYPE V |

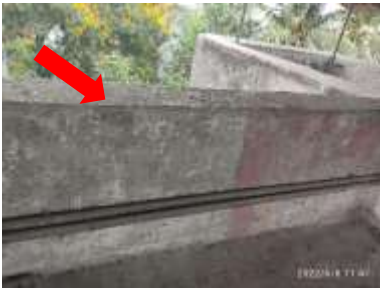
| s) | Terrace | Parapet wall | | | Plaster crack | Refer attachment<br>1-TYPE V |

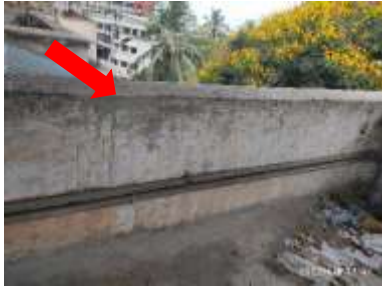
| t) | Terrace | Parapet wall | | | Plaster crack | Refer attachment<br>1-TYPE V |

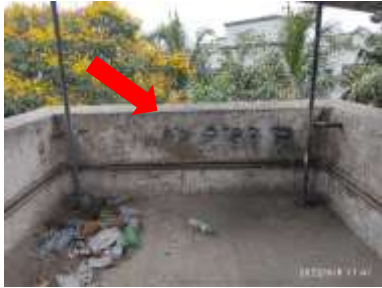
| u) | Terrace | Parapet wall | | | Plaster crack | Refer attachment<br>1-TYPE V |

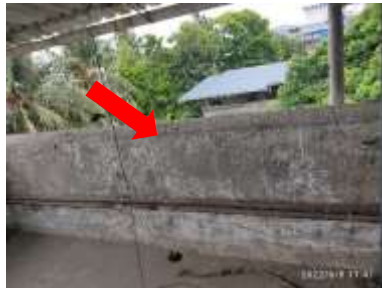
| v) | Terrace | Parapet wall | | | Plaster crack | Refer attachment<br>1-TYPE V |

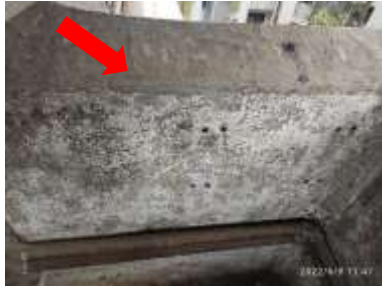
| w) | Terrace | Parapet wall | | | Plaster crack | Refer attachment<br>1-TYPE V |

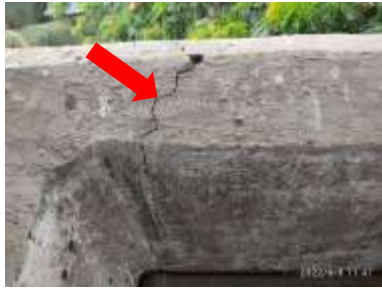
| x) | Terrace | Parapet wall | | | Plaster crack | Refer attachment<br>1-TYPE V |

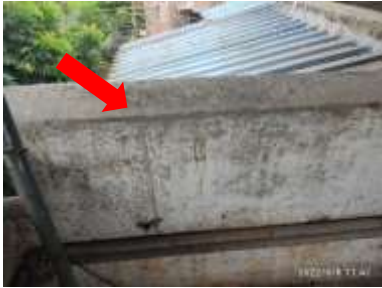
| y) | Terrace | Parapet wall | | | Plaster crack | Refer attachment 1-TYPE V |

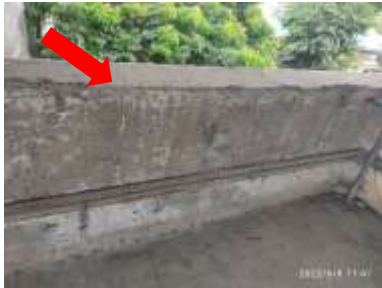
| z) | Terrace | Parapet wall | | | Plaster crack | Refer attachment 1-TYPE V |

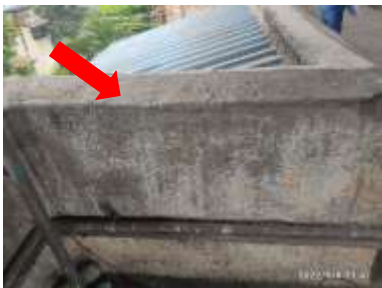
| aa) | Terrace | Parapet wall | | | Plaster crack | Refer attachment 1-TYPE V |

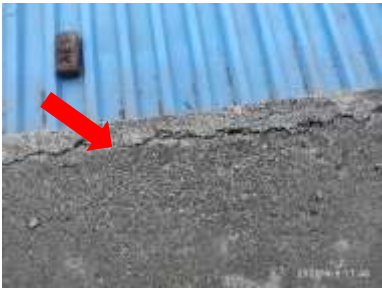
| ab) | Water tank | Floor | | | Structural crack | Refer attachment 1-TYPE VI |

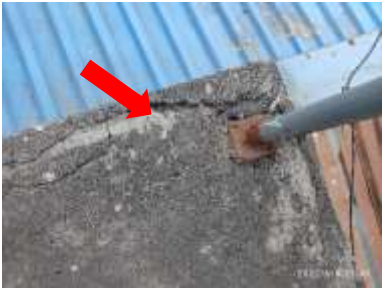
| ac) | Water tank | Floor | | | Structural crack | Refer attachment 1-TYPE VI |

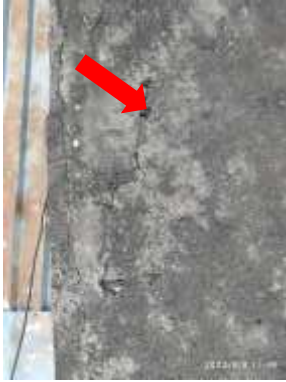
| ad) | Water tank | Floor | | | Structural crack | Refer attachment 1-TYPE VI |

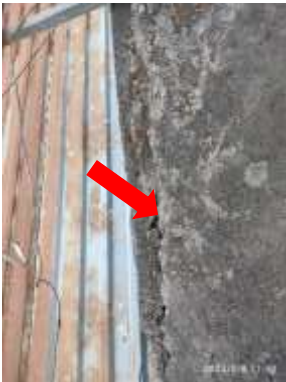
| ae) | Water tank | Floor | | | Structural crack | Refer attachment 1-TYPE VI |

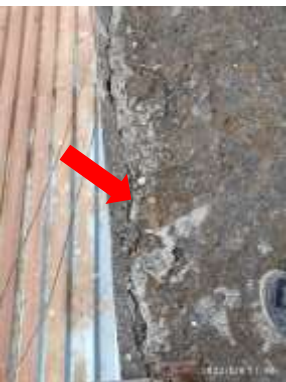
| af) | Water tank | Floor | | | Structural crack | Refer attachment 1-TYPE VI |

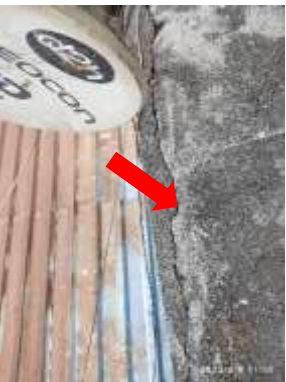
| ag) | Water tank | Floor | | | Structural crack | Refer attachment 1-TYPE VI |

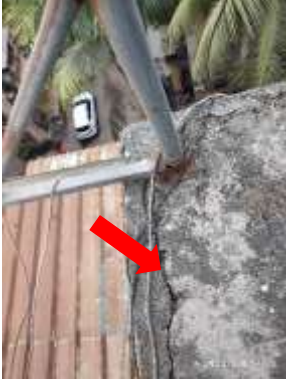
| ah) | Water tank | Floor | | | Structural crack | Refer attachment 1-TYPE VI |

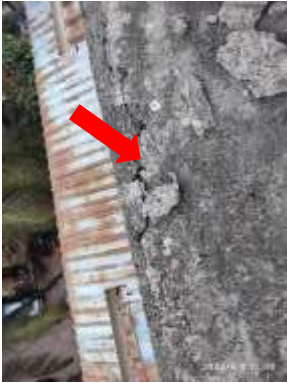
| ai) | Water tank | Floor | | | Structural crack | Refer attachment 1-TYPE VI |

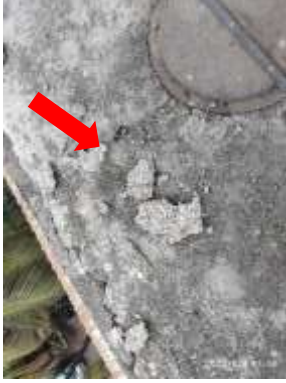
| aj) | Water tank | Floor | | | Structural crack | Refer attachment 1-TYPE VI |

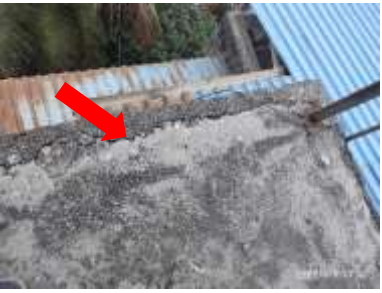
| ak) | Water tank | Floor | | | Structural crack | Refer attachment 1-TYPE VI |

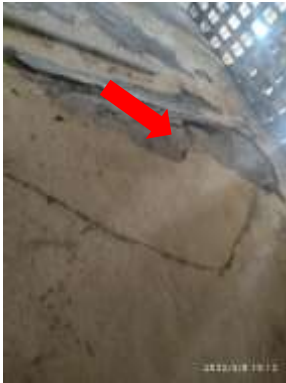
| a) | Mumpty Room | Wall | | | Plaster with hollow sound | Refer attachment 1-TYPE XVIII |

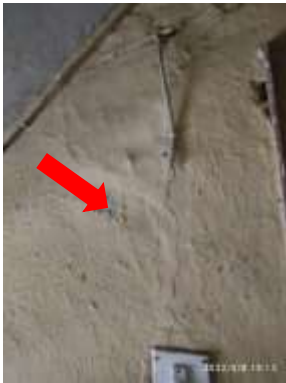
| b) | Mumpty Room | Wall | | | Plaster with hollow sound, Plaster crack | Refer attachment 1-TYPE XVIII, TYPE V |

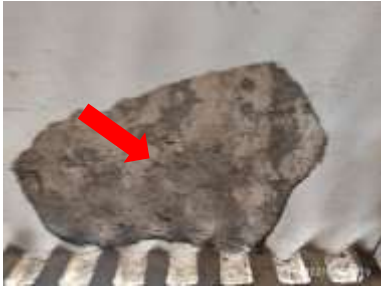
| c) | Staircase 4 <sup>th</sup> Floor | Ceiling | | | Ceiling cracks (plaster spall off) | Refer attachment 1-TYPE XIII |

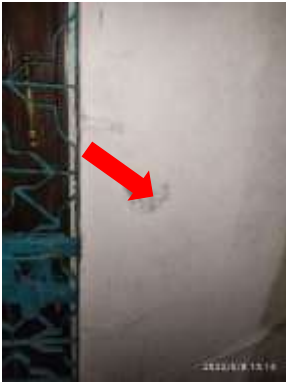
| d) | Staircase 3 <sup>rd</sup> Floor | Wall | | | Plaster with hollow sound | Refer attachment 1-TYPE XVIII |

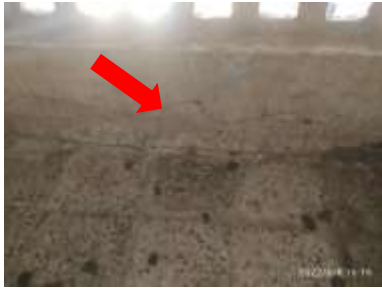
| e) | Staircase<br>3 <sup>rd</sup> Floor | Beam | | | Structural crack | Refer attachment<br>1-TYPE VI |

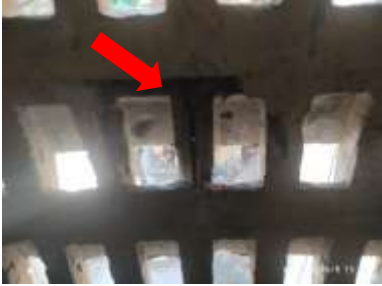
| g) | Staircase<br>3 <sup>rd</sup> Floor | RCC Grill | | | Structural crack | Refer attachment<br>1-TYPE VI |

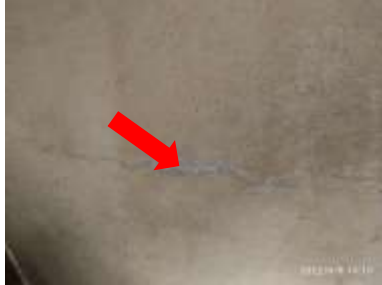
| h) | Staircase<br>3 <sup>rd</sup> Floor | Wall | | | Plaster with hollow sound | Refer attachment<br>1-TYPE XVIII |

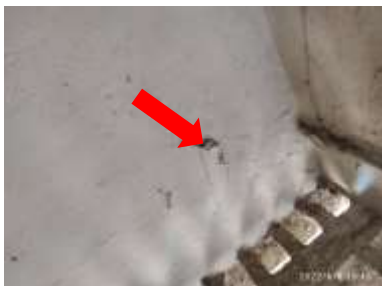
| i) | Staircase<br>2 <sup>nd</sup> Floor | Ceiling | | | Ceiling cracks | Refer attachment<br>1-TYPE XIII |

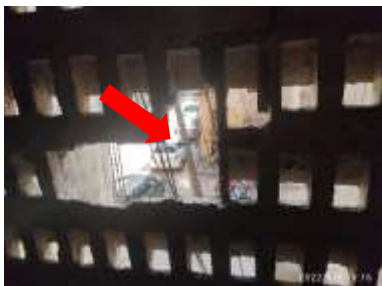
| j) | Staircase<br>2 <sup>nd</sup> Floor | Rcc Grills | | | Damaged | - |

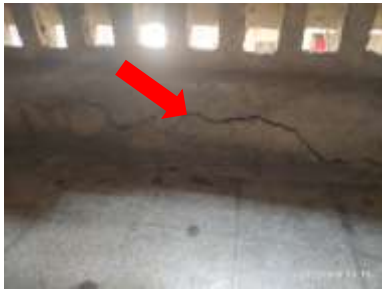
| k) | Staircase<br>2 <sup>nd</sup> Floor | Beam | | | Major<br>Structural<br>crack | Refer attachment<br>1-TYPE VI |

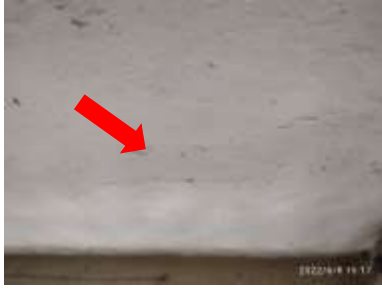
| l) | Staircase<br>1 <sup>st</sup> Floor | Ceiling | | | Ceiling cracks | Refer attachment<br>1-TYPE XIII |

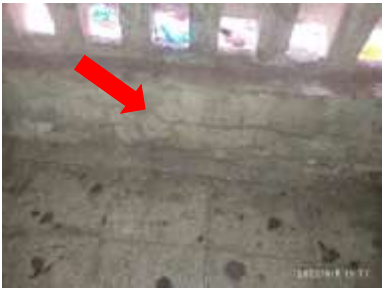
| m) | Staircase<br>1 <sup>st</sup> Floor | Beam | | | Structural<br>crack | Refer attachment<br>1-TYPE VI |

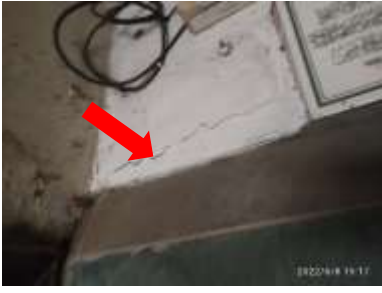
| n) | Staircase<br>1 <sup>st</sup> Floor | Beam | | | Structural<br>crack | Refer attachment<br>1-TYPE VI |

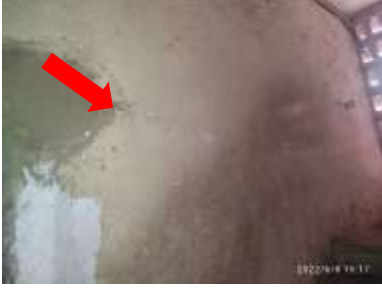
| o) | Staircase<br>1 <sup>st</sup> Floor | Wall | | | Plaster with<br>hollow sound | Refer attachment<br>1-TYPE XVIII |

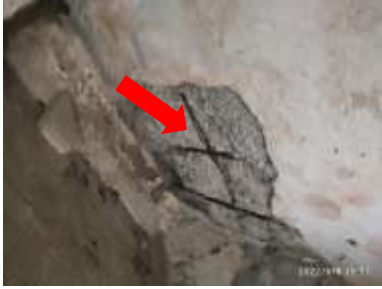
| p) | Ground Floor | Waist slab | | | Major structural crack (Corroded & plaster spall off) | Refer attachment 1-TYPE VI |

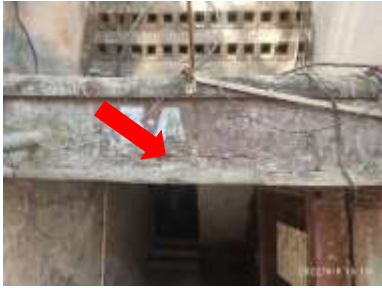
| q) | Ground floor | Chajja | | | Structural crack | Refer attachment 1-TYPE VI |

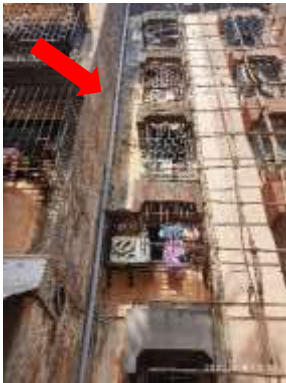
| a) | External | Dead Wall | | | Seepages, Plaster cracks | Refer attachment 1-TYPE XI, TYPE V |

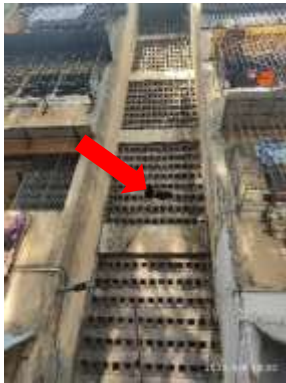
| b) | External | RCC grills | | | Damaged | - |

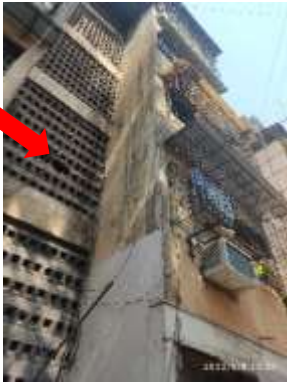
| c) | External | RCC Grills | | | Damaged | - |

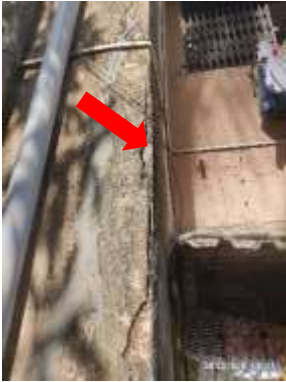
| d) | External | Column | | | Major structural crack<br>(Structural distress) | Refer attachment<br>1-TYPE VI |

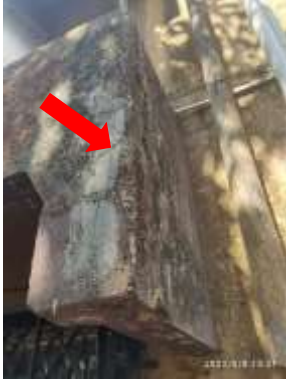
| e) | External | Chajja | | | Structural crack | Refer attachment<br>1-TYPE VI |

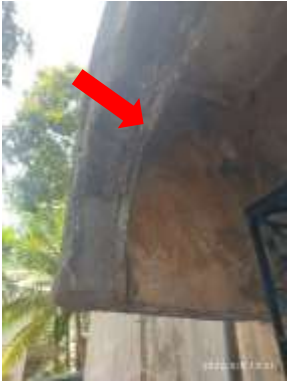
| f) | External | Chajja | | | Structural crack | Refer attachment<br>1-TYPE VI |

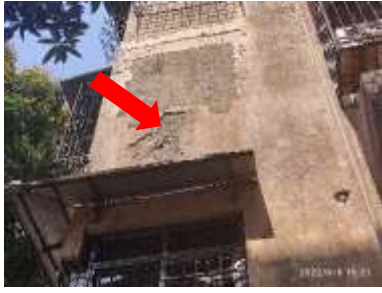
| g) | External | Wall | | | Seepages,<br>Plaster cracks | Refer attachment<br>1-TYPE XI, TYPE V |

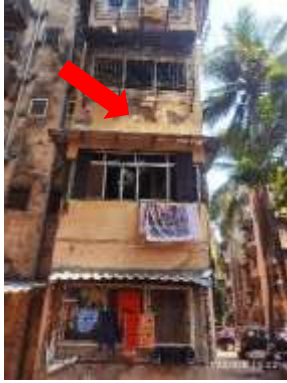
| h) | External | Wall | | | Seepages,<br>Plaster crack | Refer attachment<br>1-TYPE XI, TYPE V |

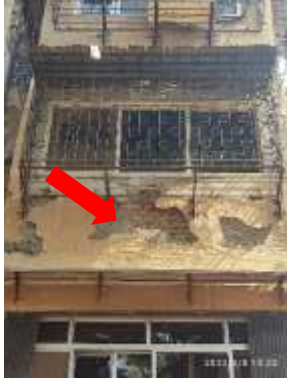
| i) | External | Wall | | | Plaster spall<br>off, Damaged | - |

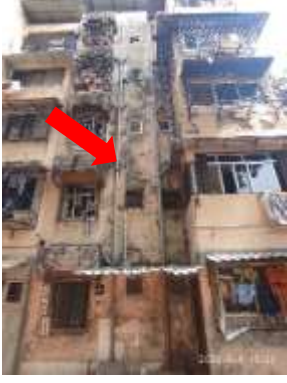
| j) | External | Plumbing Line | | | Water<br>dripping,<br>Seepages | Refer attachment<br>1-TYPE IX, TYPE<br>XI |

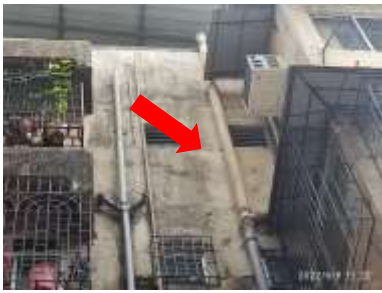
| k) | External | Beam | | | Structural crack | Refer attachment 1-TYPE VI |

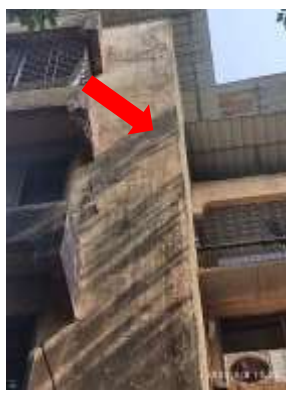
| l) | External | Column | | | Major structural crack, Structural distress | Refer attachment 1-TYPE VI |

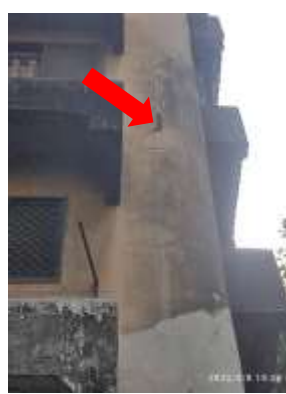
| m) | External | Column | | | Structural crack | Refer attachment 1-TYPE VI |

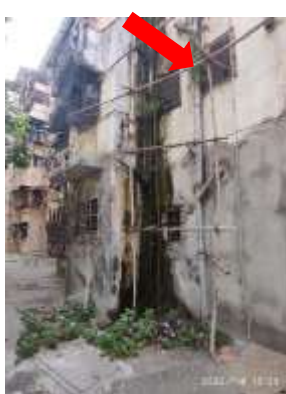
| n) | External | Plumbing Line | | | Major seepages, water dripping, Vegetation | Refer attachment 1-TYPE XI, TYPE IX, TYPE XXII |

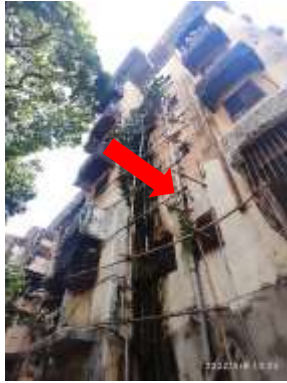
| o) | External | Plumbing Line | | | Major seepages, water dripping, Vegetation | Refer attachment 1-TYPE XI, TYPE IX, TYPE XXII |

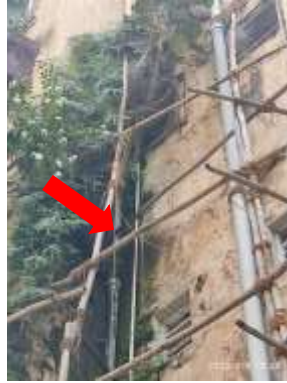
| p) | External | Plumbing Line | | | Major seepages, water dripping, Vegetation | Refer attachment 1-TYPE XI, TYPE IX, TYPE XXII |

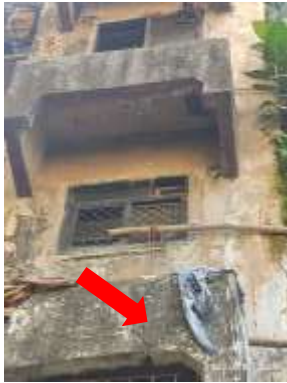
| q) | external | Chajja | | | Structural crack (Plaster spall off) | Refer attachment 1-TYPE VI |

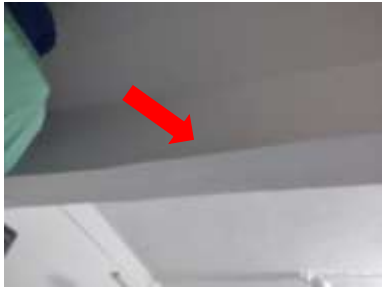
| Sr No. | LOCATION | AREA DESCRIPTION | | PHOTOS | DEFECTS | PROCESS FOR AMELIORATIONS |
|---|---|---|---|---|---|---|
| a) | Bedroom 1 | Beam | | | Plaster with hollow sound | Refer attachment 1-TYPE XVIII |

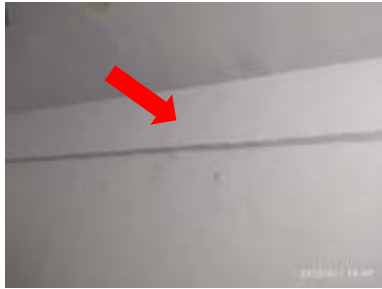
| Sr No. | LOCATION | AREA DESCRIPTION | | PHOTOS | DEFECTS | PROCESS FOR AMELIORATIONS |
|---|---|---|---|---|---|---|
| b) | Kitchen | Beam | | | Plaster with hollow sound | Refer attachment 1-TYPE XVIII |

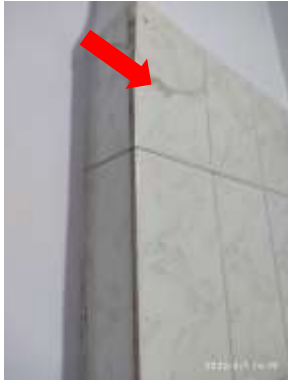
| Sr No. | LOCATION | AREA DESCRIPTION | | PHOTOS | DEFECTS | PROCESS FOR AMELIORATIONS |
|---|---|---|---|---|---|---|
| c) | Kitchen | Column C 7 | | | Tile cracks (need to check inside) | Refer attachment 1-TYPE I |

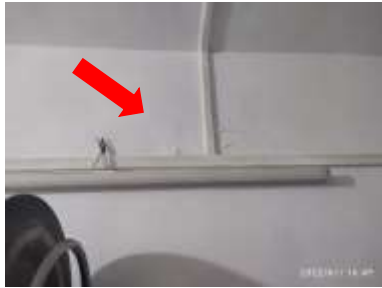
| Sr No. | LOCATION | AREA DESCRIPTION | | PHOTOS | DEFECTS | PROCESS FOR AMELIORATIONS |
|---|---|---|---|---|---|---|
| d) | Bedroom 2 | Beam | | | Plaster with hollow sound | Refer attachment 1-TYPE XVIII |

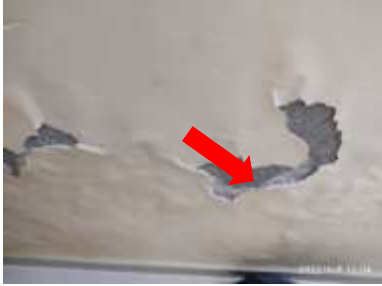
| a) | Living Room | Wall | | | Capillary action marks from adjacent bathroom | Refer attachment 1-TYPE IV |

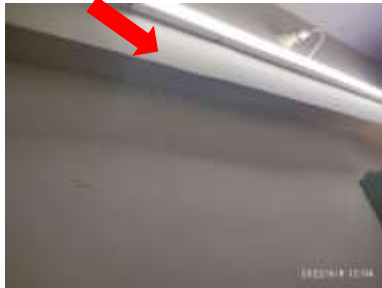
| b) | Living room | Beam | | | Plaster crack | Refer attachment 1-TYPE V |

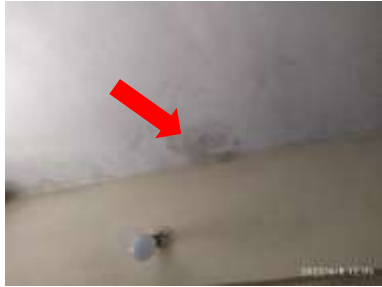
| c) | Kitchen | Ceiling | | | Seepages from flat no 3B/20 | Refer attachment 1-TYPE XI |

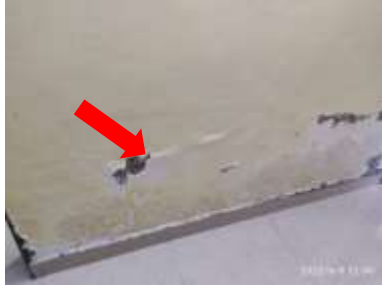
| d) | Bedroom 1 | Wall | | | Capillary action marks from adjacent bathroom | Refer attachment 1-TYPE IV |

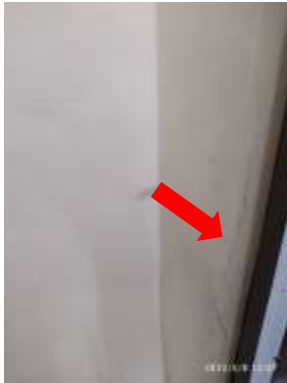
| e) | Bedroom 1 | Wall | | | Plaster crack | Refer attachment 1-TYPE V |

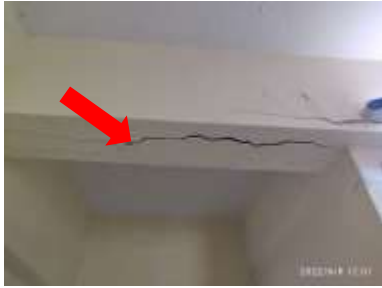
| f) | Bedroom<br>2 | Beam | | | Major structural crack | Refer attachment 1-TYPE VI |

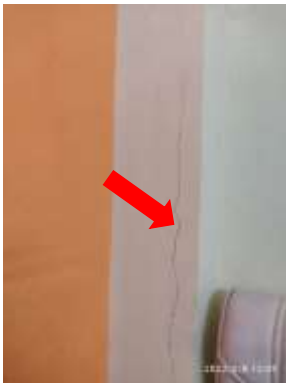
| g) | Bedroom<br>2 | Column C 17 | | | Structural crack | Refer attachment 1-TYPE VI |

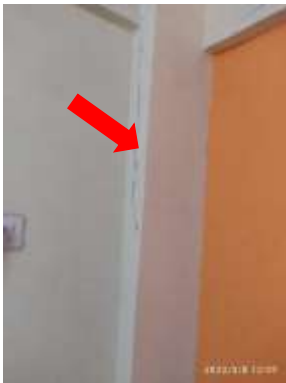
| h) | Bedroom<br>2 | Column C 16 | | | Major structural crack | Refer attachment 1-TYPE VI |

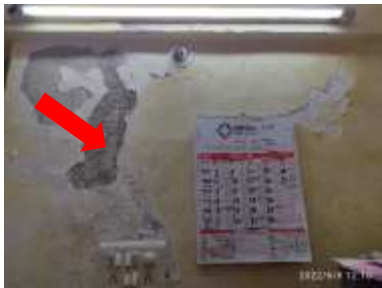
| i) | Bedroom<br>2 | Wall | | | Seepages from flat no 3B/20 | Refer attachment 1-TYPE XI |

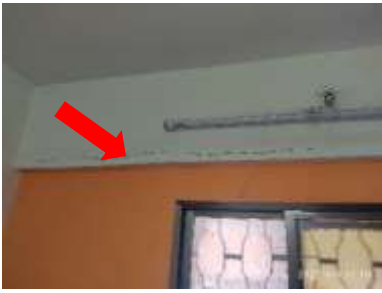
| j) | Bedroom<br>2 | Lintel beam | | | Major structural crack. Window top lintel found with crack | Refer attachment 1-TYPE VI, TYPE XIX |

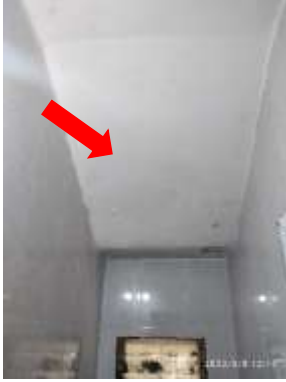
| l) | Toilet | Sunk | | | Seepages from flat 3B/20 | Refer attachment 1-TYPE XI |

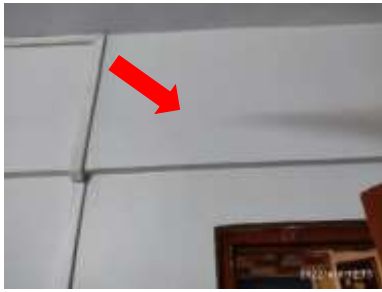
| a) | Living Room | Beam | | | Plaster with hollow sound | Refer attachment 1-TYPE XVIII |

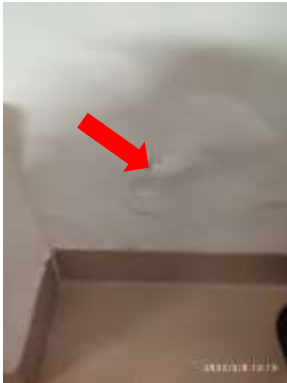
| b) | Living Room | Wall | | | Capillary action marks from adjacent bathroom | Refer attachment 1-TYPE IV |

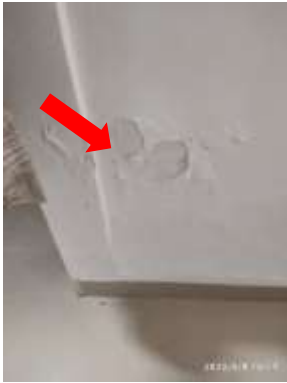
| c) | Living Room | Wall | | | Capillary action marks from adjacent bathroom | Refer attachment 1-TYPE IV |

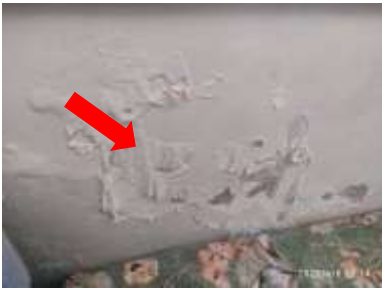
| d) | Living Room | Wall | | | Capillary action marks from adjacent bathroom | Refer attachment 1-TYPE IV |

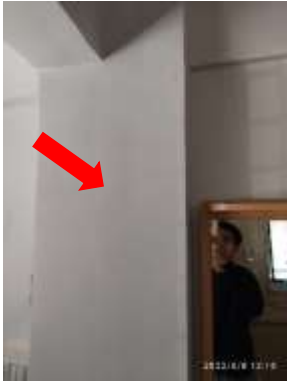
| e) | Bedroom | Column C 23 | | | Column with hollow sound | Refer attachment 1-TYPE XVII |

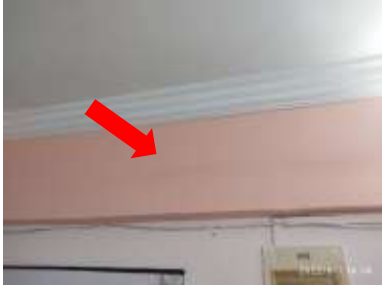
| a) | Living Room | Beam | | | Beam with hollow sound | Refer attachment 1-TYPE XVIII |

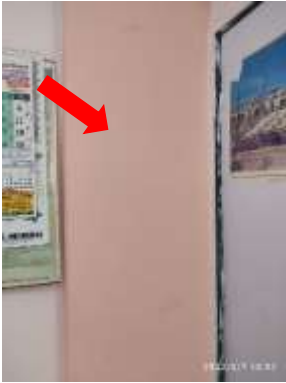
| b) | Living Room | Column C 4 | | | Column with hollow sound | Refer attachment 1-TYPE XVII |

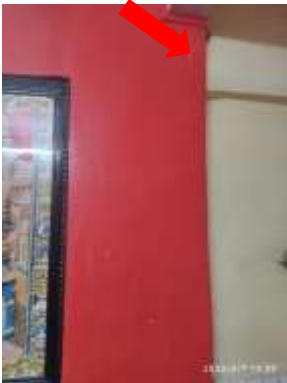
| a) | Living Room | Column C 10 | | | Structural crack at top | Refer attachment 1-TYPE VI |

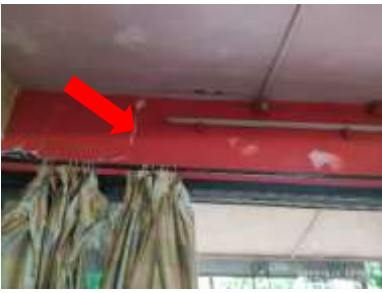
| b) | Living Room | Lintel beam | | | Structural crack | Refer attachment 1-TYPE VI |

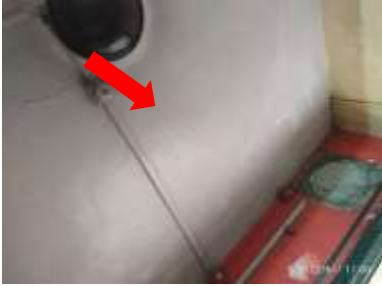
| c) | Living Room Balcony | Ceiling | | | Ceiling cracks | Refer attachment 1-TYPE XIII |

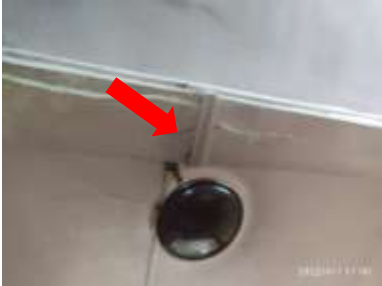
| d) | Living Room | Beam | | | Major structural crack | Refer attachment 1-TYPE VI |

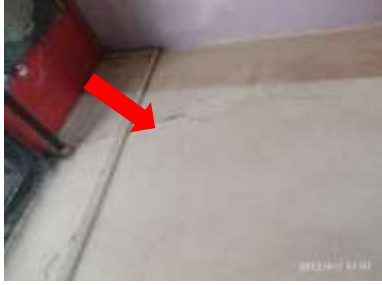
| e) | Bedroom 1 | Wall | | | Plaster crack, Plaster with hollow sound | Refer attachment 1-TYPE V, TYPE XVIII |

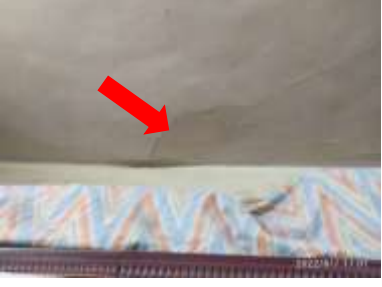
| f) | Bedroom 1 | Ceiling | | | Ceiling cracks | Refer attachment 1-TYPE XIII |

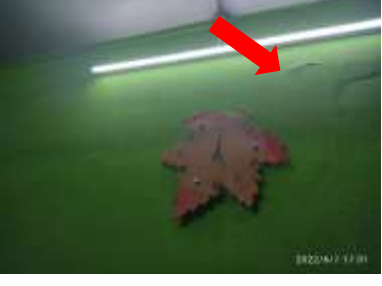
| g) | Bedroom 1 | Beam | | | Plaster crack, plaster with hollow sound | Refer attachment 1-TYPE V, TYPE XVIII |

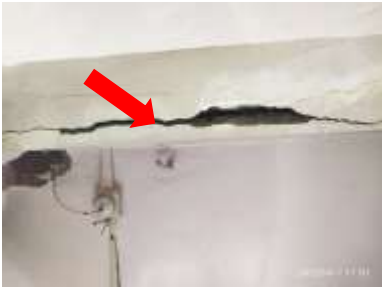
| h) | Bedroom 1 | Beam | | | Major structural crack | Refer attachment 1-TYPE VI |

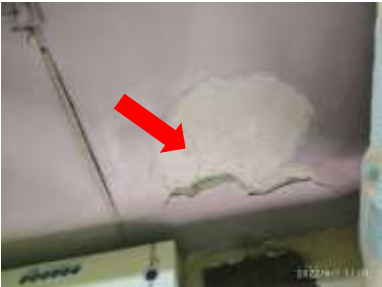
| i) | Bedroom 1 | Ceiling | | | Ceiling cracks | Refer attachment 1-TYPE XIII |

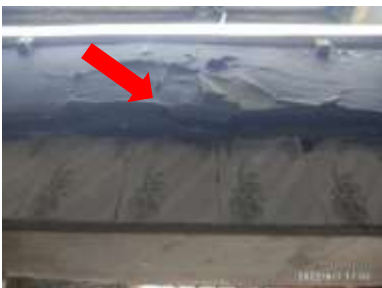
| j) | Kitchen | Lintel Beam | | | Major structural crack, Window top lintel found with crack | Refer attachment 1-TYPE VI, TYPE XIX |

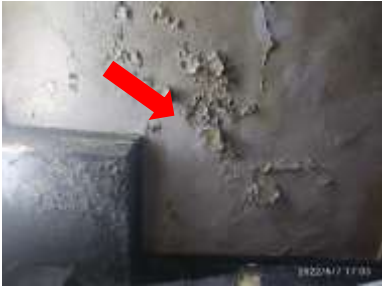
| k) | Kitchen | Ceiling | | | Seepages from flat no 3B/23 | Refer attachment 1-TYPE XI |

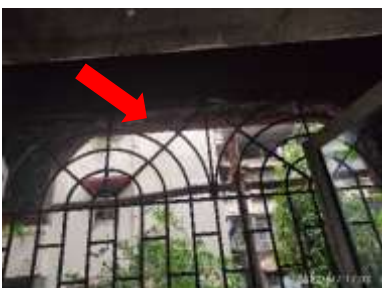
| l) | Kitchen | Chajja | | | Major structural crack | Refer attachment 1-TYPE VI |

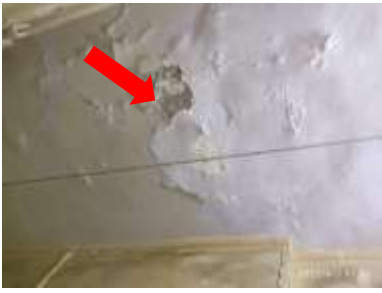
| m) | Passage | Ceiling | | | Seepages from flat no 3B/23 bathroom | Refer attachment 1-TYPE XI |

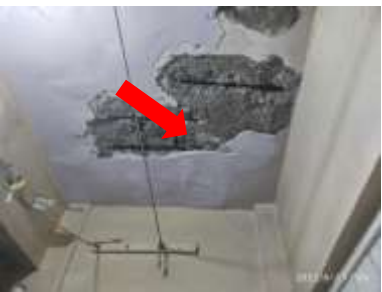
| n) | Passage | Ceiling | | | Ceiling cracks, Major structural crack (Steel corroded & Plaster spall off) | Refer attachment 1-TYPE XIII, TYPE VI |

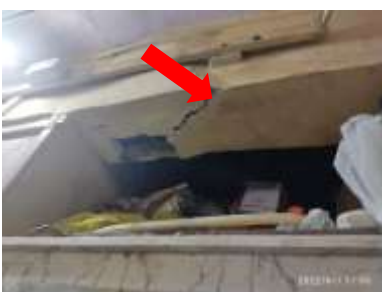
| o) | Passage | Beam | | | Major structural crack (need immediate support) | Refer attachment 1-TYPE VI |

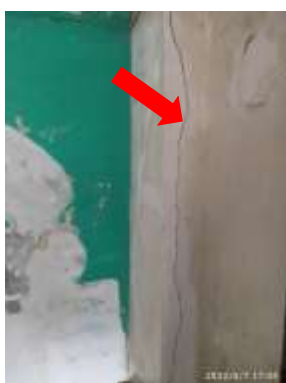
| p) | Bedroom 2 | Column C 14 | | | Structural crack | Refer attachment 1-TYPE VI |

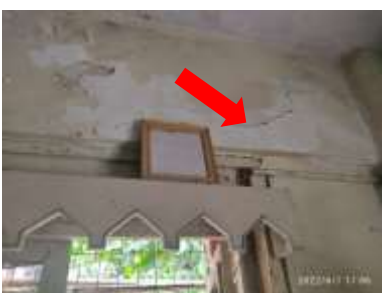
| q) | Bedroom 2 | Beam | | | Structural crack | Refer attachment 1-TYPE VI |

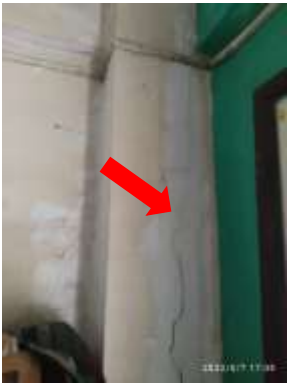
| r) | Bedroom<br>2 | Column<br>C 15 | | | Major<br>structural<br>crack | Refer attachment<br>1-TYPE VI |

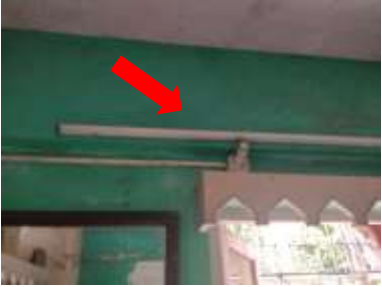
| s) | Bedroom<br>2 | Beam | | | Structural<br>crack,<br>Window top<br>lintel found<br>with crack | Refer attachment<br>1-TYPE VI, TYPE<br>XIX |

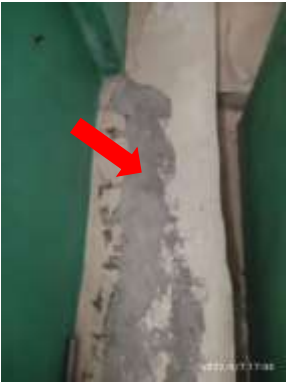
| t) | Bedroom<br>2 | Column<br>C 18 | | | Major<br>Structural<br>crack | Refer attachment<br>1-TYPE VI |

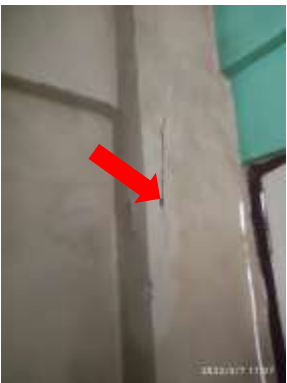
| u) | Bedroom<br>2 | Column<br>C 17 | | | Structural<br>crack | Refer attachment<br>1-TYPE VI |

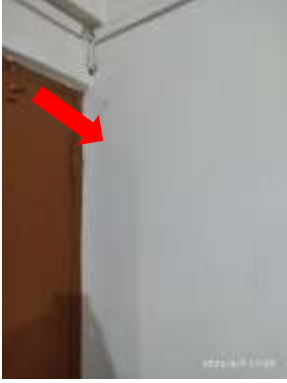
| a) | Living Room | Column C 18 | | | Column with hollow sound | Refer attachment 1-TYPE XVII |

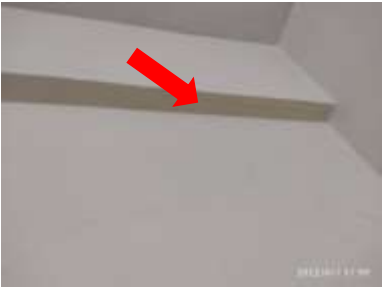
| b) | Living room | Beam | | | Structural crack | Refer attachment 1-TYPE VI |

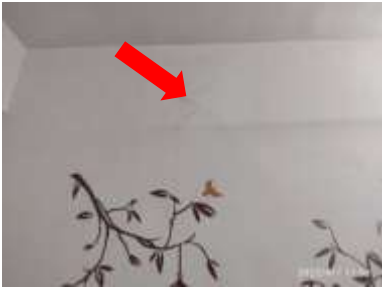
| c) | Living Room | Beam | | | Plaster crack | Refer attachment 1-TYPE V |

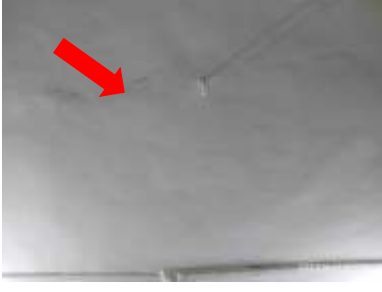
| d) | Living room | Ceiling | | | Ceiling cracks | Refer attachment 1-TYPE XIII |

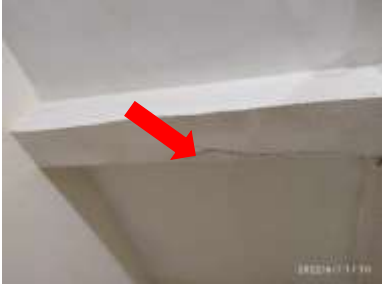
| e) | Living Room | Beam | | | Major structural crack | Refer attachment 1-TYPE VI |

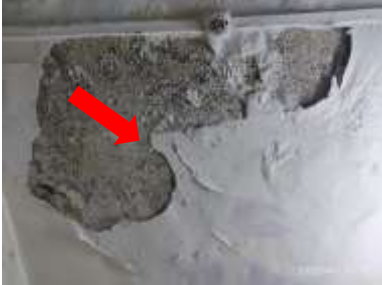
| f) | Kitchen | Ceiling | | | Major seepages from flat no 3B/24 | Refer attachment 1-TYPE XI |

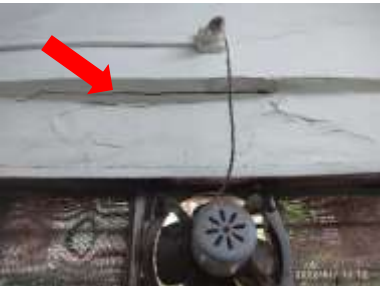
| g) | Kitchen | Beam | | | Major structural crack | Refer attachment 1-TYPE VI |

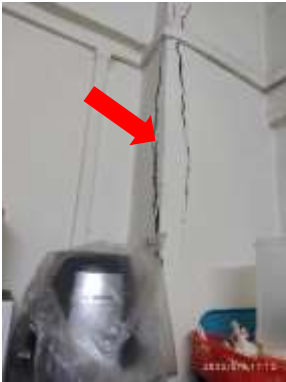
| h) | Kitchen | Column C 20 | | | Major structural crack | Refer attachment 1-TYPE VI |

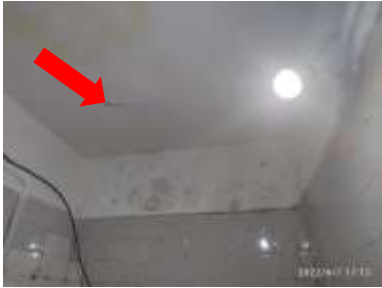
| i) | Bathroom | ceiling | | | Major seepages from flat no 3B/24 | Refer attachment 1-TYPE XI |

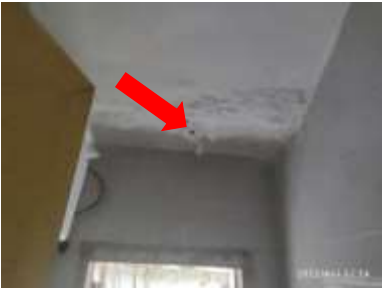
| j) | Toilet | Sunk | | | Major seepages from flat no 3B/24 | Refer attachment 1-TYPE XI |

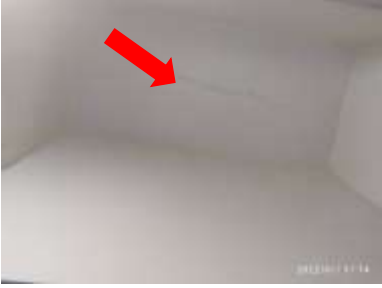
| k) | Passage | Ceiling | | | Ceiling cracks | Refer attachment 1-TYPE XIII |

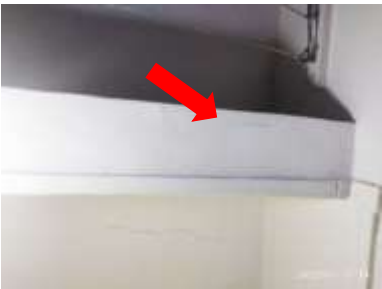
| l) | Passage | Beam | | | Structural crack | Refer attachment 1-TYPE VI |

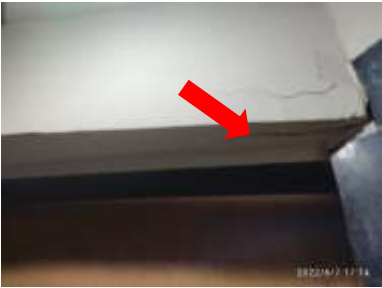
| m) | Passage | Lintel Beam | | | Structural crack | Refer attachment 1-TYPE VI |

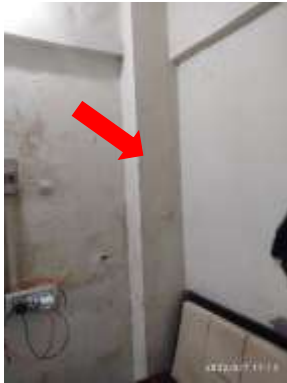
| n) | Bedroom | Column C 24 | | | Structural crack | Refer attachment 1-TYPE VI |

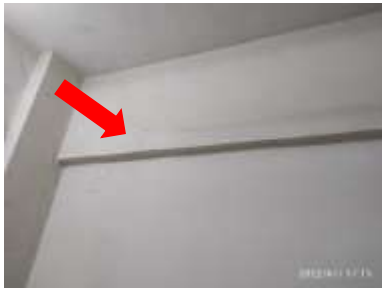
| o) | Bedroom | Beam | | | Structural crack | Refer attachment 1-TYPE VI |

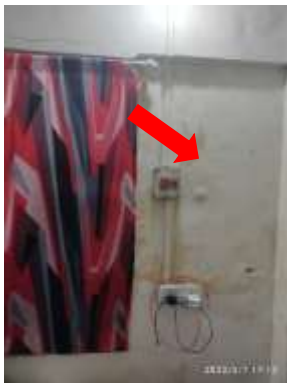
| p) | Bedroom | Wall | | | Seepages from external from damaged pipes | Refer attachment 1-TYPE XI |

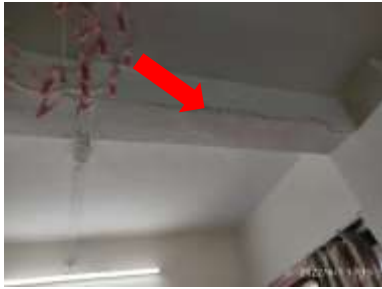
| r) | Bedroom | Beam | | | Major structural crack | Refer attachment 1-TYPE VI |

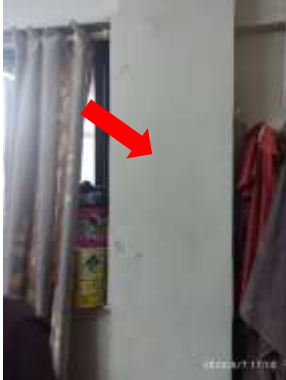
| s) | Bedroom | Column C 23 | | | Plaster crack, Column with hollow sound | Refer attachment 1-TYPE V, TYPE XVII |

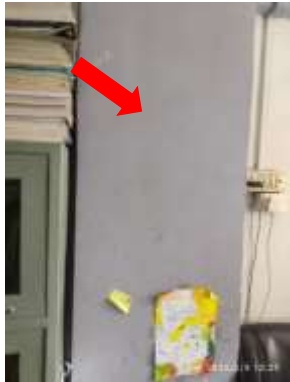
| b) | Living room | Column C 2 | | | Column with hollow sound | Refer attachment 1-TYPE XVII |

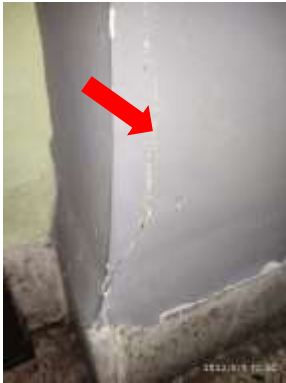
| c) | Living Room | Column C 3 | | | Structural crack at bottom | Refer attachment 1-TYPE VI |

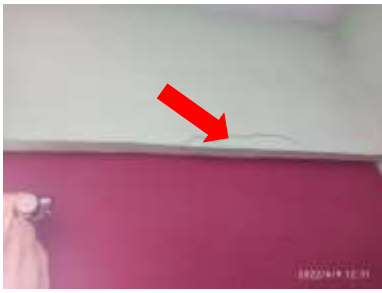
| d) | Bedroom | beam | | | Structural crack | Refer attachment 1-TYPE VI |

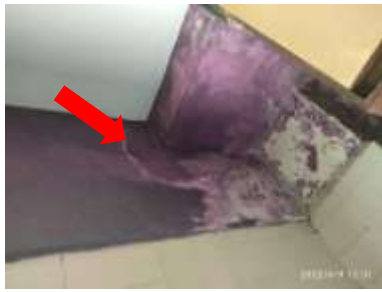
| e) | Kitchen | Sunk | | | Seepage from flat no 3B/25 | Refer attachment 1-TYPE XI |

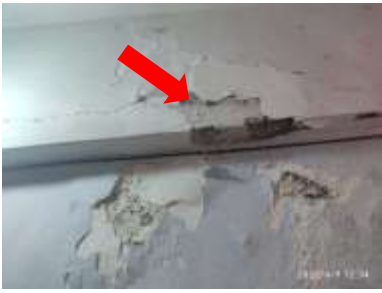
| g) | Bedroom | Beam | | | Major structural crack (Structural distress) | Refer attachment 1-TYPE VI |

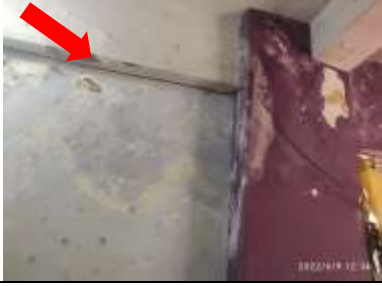
| h) | Bedroom | Beam & Column | | | Major seepages from flat no 3B/25 | Refer attachment 1-TYPE XI |

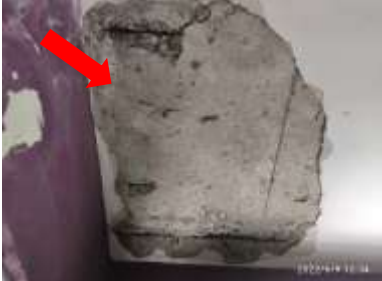
| i) | Bedroom | Balcony Ceiling | | | Major structural crack, Ceiling crack (Plaster spall off) | Refer attachment 1-TYPE VI, TYPE XIII |

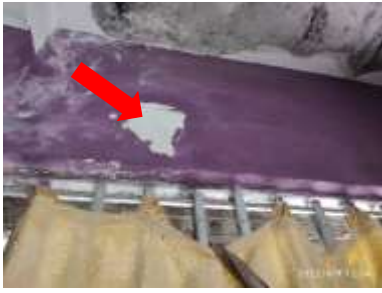
| j) | Bedroom | Lintel beam | | | Structural crack, Window top lintel found with crack | Refer attachment 1-TYPE VI, TYPE XIX |

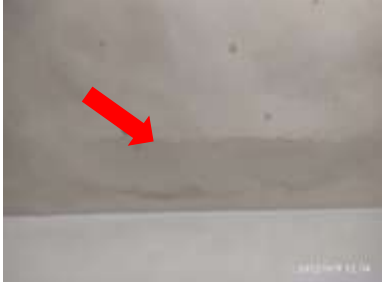
| k) | Bedroom | Ceiling | | | Ceiling cracks | Refer attachment 1-TYPE XIII |

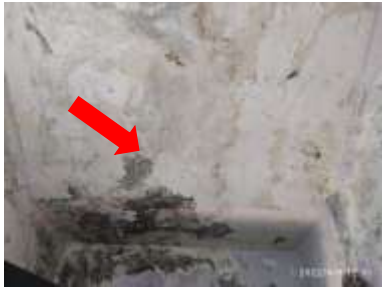
| l) | Toilet | Sunk | | | Major seepages from flat no 3B/25 | Refer attachment 1-TYPE XI |

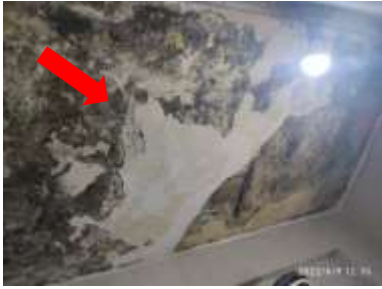
| m) | Bathroom | Ceiling | | | Major seepages from flat no 3B/25 | Refer attachment 1-TYPE XI |

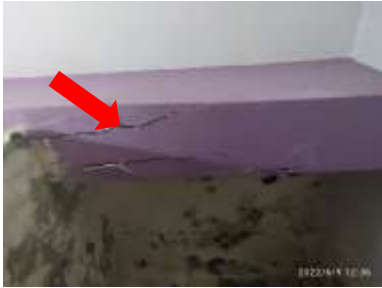
| n) | Passage | Beam | | | Major structural crack | Refer attachment 1-TYPE VI |

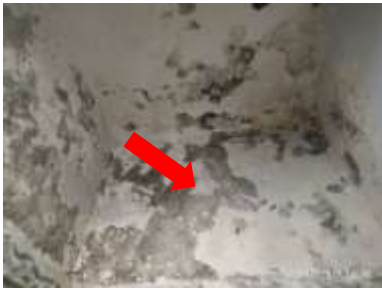
| o) | Passage | Ceiling | | | Major seepages from flat no 3B/25 | Refer attachment 1-TYPE XI |

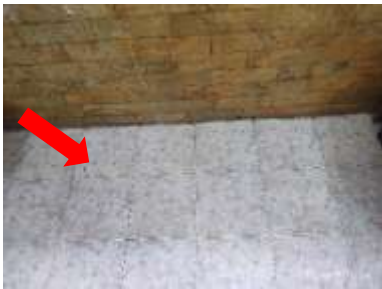
| b) | Bedroom | Floor | | | Sloping down | Refer attachment 1-TYPE |

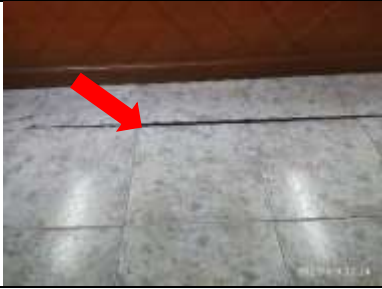
| c) | Bedroom | Floor | | | Floor tile uplift | Refer attachment 1-TYPE XXVI |

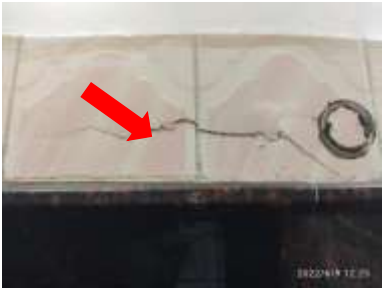
| d) | Passage | Wall | | | Tile crack | Refer attachment 1-TYPE I |

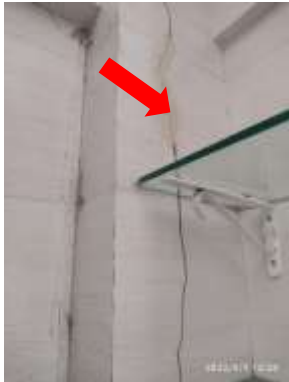
| e) | Passage | Column C 15 | | | Major structural crack | Refer attachment 1-TYPE VI |

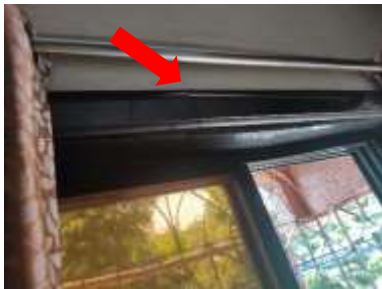
| f) | Bedroom | Lintel beam | | | Window top lintel found with crack | Refer attachment 1-TYPE XIX |

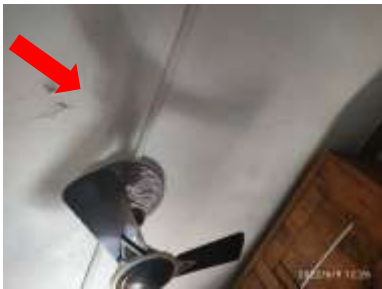
| g) | Bedroom | Ceiling | | | Ceiling crack | Refer attachment 1-TYPE XIII |

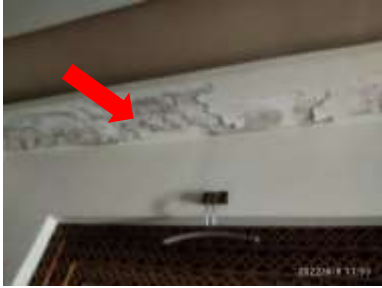
| a) | Living Room | Ceiling | | | Seepages from Flat no 3B/27 | Refer attachment 1-TYPE XI |

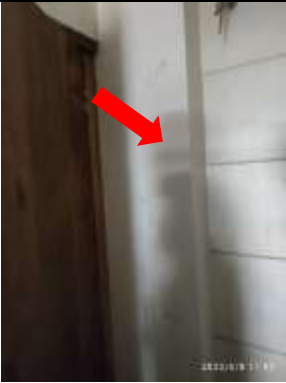
| b) | Living Room | Column | | | Column with hollow sound | Refer attachment 1-TYPE XVII |

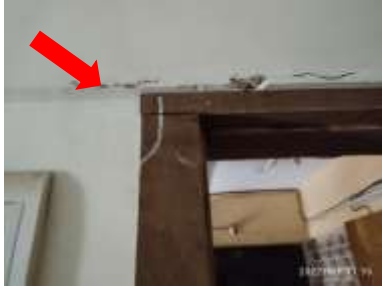
| c) | Living Room | Beam | | | Structural crack | Refer attachment 1-TYPE VI |

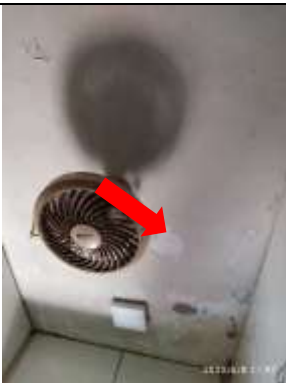
| d) | Kitchen | Ceiling | | | Seepages from Flat no 3B/27 | Refer attachment 1-TYPE XI |

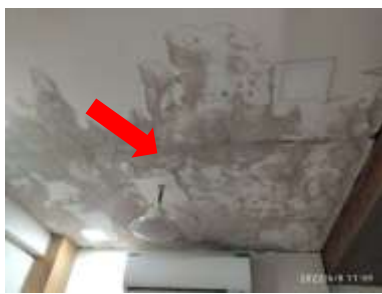
| e) | Bedroom 1 | Ceiling | | | Seepages from Flat no 3B/27 | Refer attachment 1-TYPE XI |

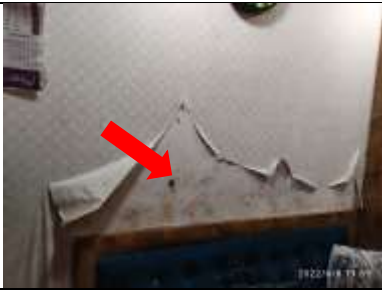
| f) | Bedroom | Wall | | | Capillary action marks | Refer attachment 1-TYPE IV |

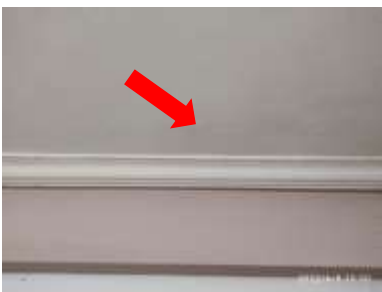
| a) | Living Room | Ceiling | | | Ceiling cracks | Refer attachment 1-TYPE XIII |

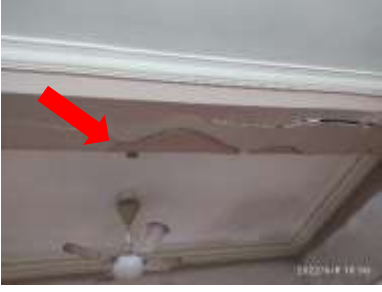
| b) | Living Room | Beam | | | Major structural crack (need support immediately) | Refer attachment 1-TYPE VI |

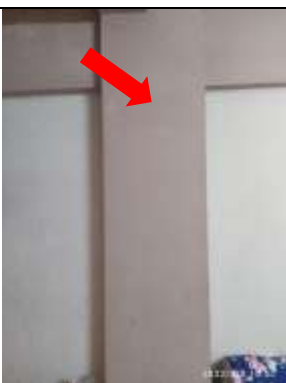
| c) | Living room | Column C 1 | | | Plaster crack, column with hollow sound | Refer attachment 1-TYPE V, TYPE XVII |

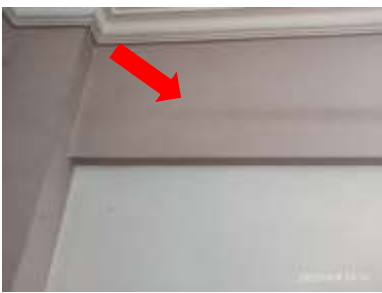
| d) | Living Room Balcony | Beam | | | Plaster crack, plaster with hollow sound | Refer attachment 1-TYPE V, TYPE XVIII |

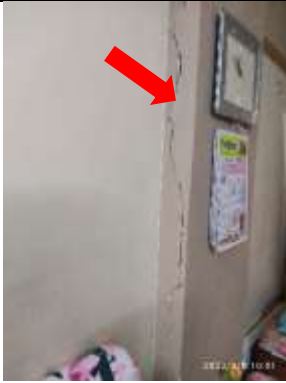
| e) | Living room | Column C 2 | | | Major structural crack | Refer attachment 1-TYPE VI |

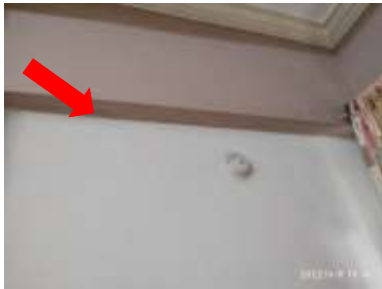
| f) | Living room | Beam | | | Structural crack | Refer attachment 1-TYPE VI |

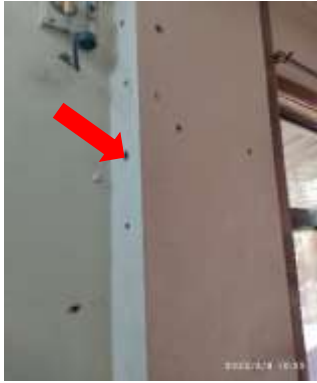
| g) | Bedroom | Column C 5 | | | Column with hollow sound, Reinforcement visible | Refer attachment 1-TYPE XVII |
