# STRUCTURAL AUDIT REPORT

NOOR CO-OP. HOUSING SOCIETY LTD,

VASHI,

**Taamra Engineering Consultants Private Limited**

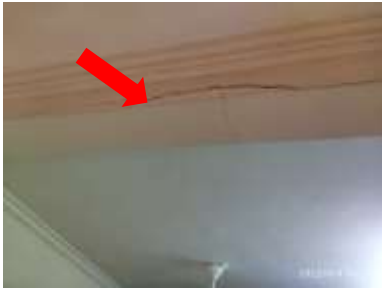
| h) | Bedroom 1 | Beam | | | Major structural crack | Refer attachment 1-TYPE VI |

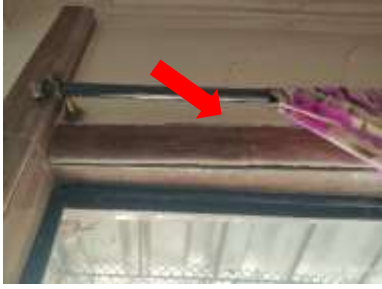
| i) | Bedroom | Lintel Beam | | | Window top lintel found with crack | Refer attachment 1-TYPE XIX |

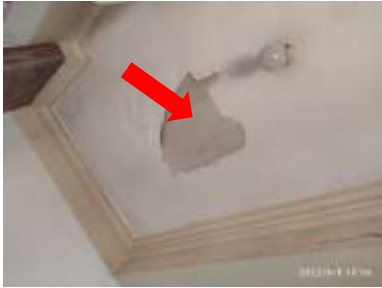
| j) | Bedroom balcony | Ceiling | | | Ceiling crack | Refer attachment 1-TYPE XIII |

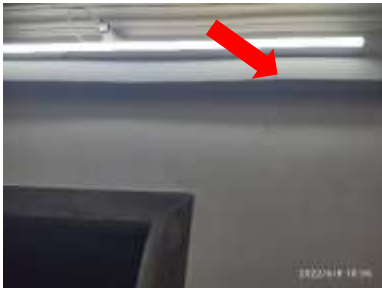
| k) | Bedroom 1 | Beam | | | Separation crack | Refer attachment 1-TYPE X |

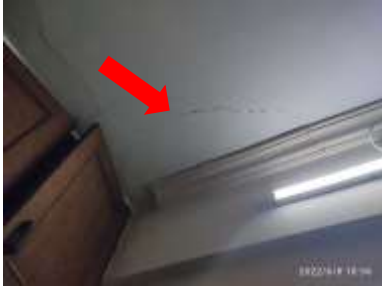
| l) | Bedroom 1 | Ceiling | | | Ceiling cracks | Refer attachment 1-TYPE XIII |

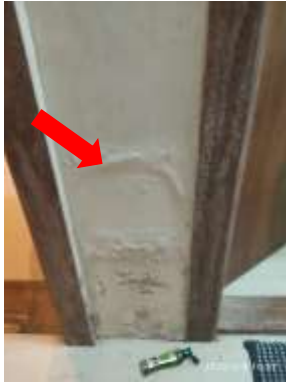
| m) | Passage | Wall | | | Capillary action marks from adjacent bathroom | Refer attachment 1-TYPE IV |

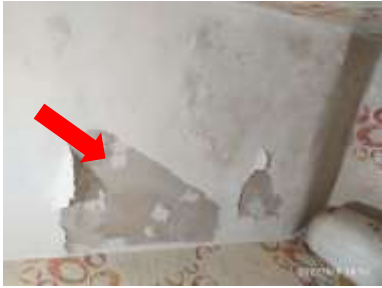
| n) | Toilet | Ceiling | | | Seepages from flat no 3B/28 | Refer attachment 1-TYPE XI |

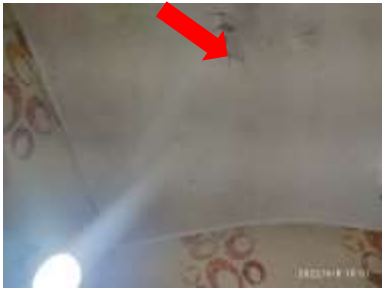
| o) | Bathroom | ceiling | | | Ceiling cracks | Refer attachment 1-TYPE XIII |

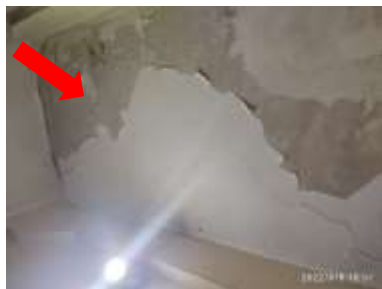
| p) | Bathroom | ceiling | | | Ceiling cracks | Refer attachment 1-TYPE XIII |

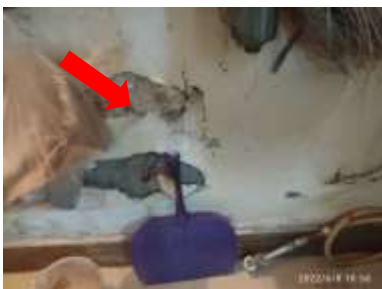
| q) | Passage | Wall | | | Seepages from adjacent bathroom | Refer attachment 1-TYPE XI |

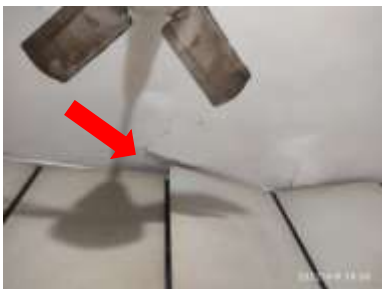
| r) | Kitchen | Ceiling | | | Ceiling cracks | Refer attachment 1-TYPE XIII |

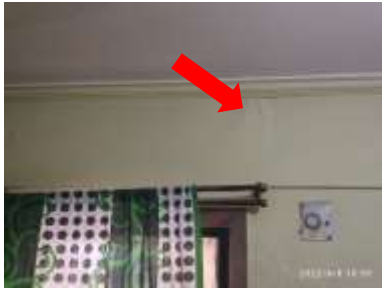
| s) | Bedroom 2 | Beam | | | Plaster crack, beam found with crack | Refer attachment 1-TYPE V, TYPE XVIII |

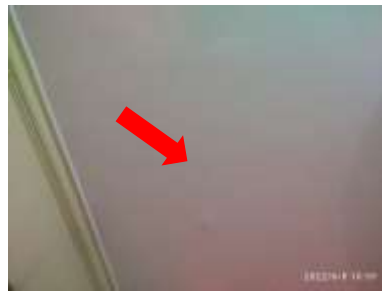
| t) | Bedroom 1 | Ceiling | | | Ceiling crack | Refer attachment 1-TYPE XIII |

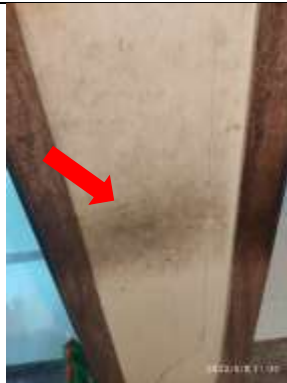
| u) | Living room | Column C 3 | | | Structural crack | Refer attachment 1-TYPE VI |

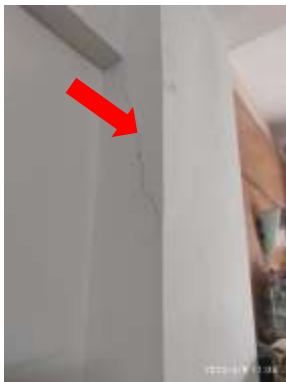
| a) | Living room | Column C 10 | | | Structural crack | Refer attachment 1-TYPE VI |

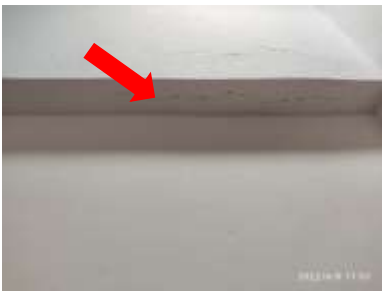
| b) | Living Room | Beam | | | Structural crack | Refer attachment 1-TYPE VI |

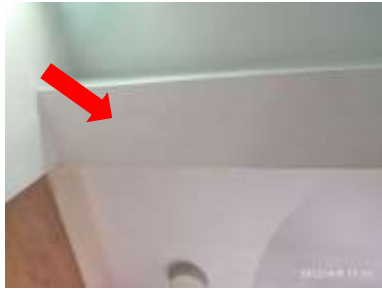
| c) | Living Room | Beam | | | Structural crack | Refer attachment 1-TYPE VI |

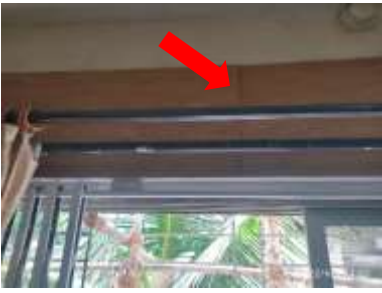
| d) | Living Room | Lintel Beam | | | Tile crack | Refer attachment 1-TYPE I |

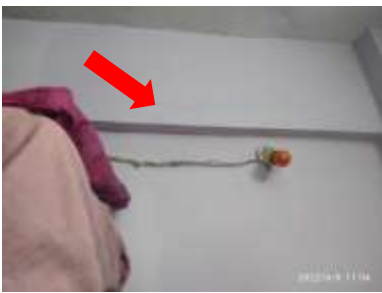
| e) | Bedroom 1 | Beam | | | Plaster crack | Refer attachment 1-TYPE V |

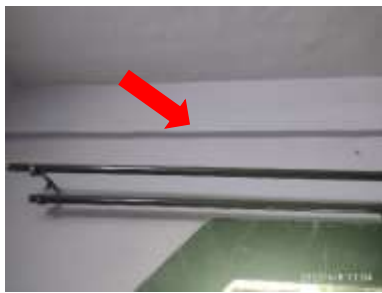
| f) | Bedroom 1 | Beam | | | Plaster with hollow sound | Refer attachment 1-TYPE XVIII |

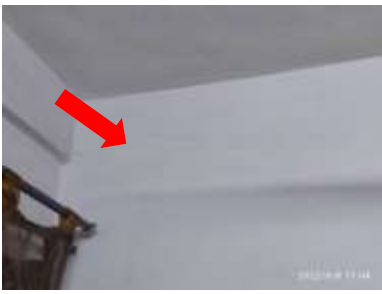
| g) | Bedroom<br>1 | Beam | | | Plaster crack,<br>plaster with<br>hollow sound | Refer attachment<br>1-TYPE V, TYPE<br>XVIII |

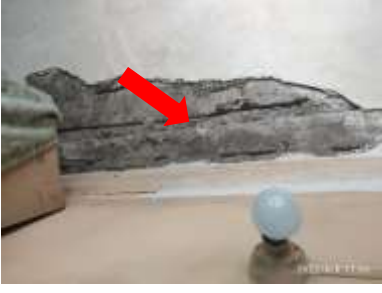
| h) | Bedroom<br>1<br>Balcony | Ceiling | | | Ceiling cracks<br>(Steel<br>corroded &<br>plaster spill<br>out) | Refer attachment<br>1-TYPE XIII |

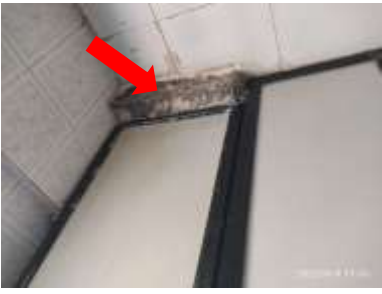
| i) | Kitchen | Sunk | | | Seepage<br>marks | Refer attachment<br>1-TYPE III |

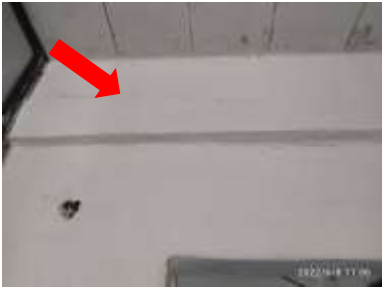
| j) | Kitchen | Beam | | | Beam found<br>with crack | Refer attachment<br>1-TYPE XV |

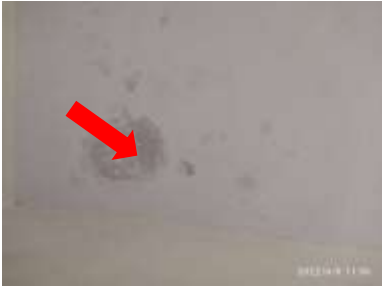
| k) | Passage | Ceiling | | | Seepage<br>marks | Refer attachment<br>1-TYPE III |

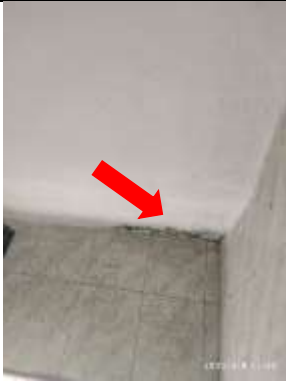
| l) | Toilet | sunk | | | Seepages,<br>plaster crack | Refer attachment<br>1-TYPE XI, TYPE V |

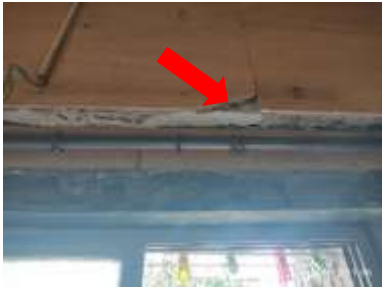
| m) | Bedroom<br>2 | Beam | | | Window top<br>lintel found<br>with crack,<br>Structural<br>crack | Refer attachment<br>1-TYPE XIX TYPE<br>VI |

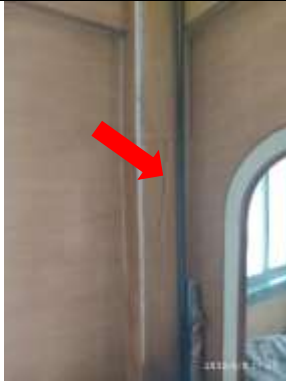
| n) | Bedroom<br>2 | Column<br>C 16 | | | Tile crack<br>(need to<br>check inside) | Refer attachment<br>1-TYPE I |

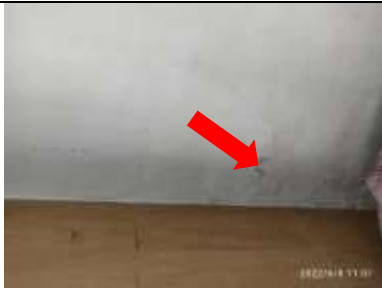
| o) | Bedroom<br>2 | Ceiling | | | Ceiling crack | Refer attachment<br>1-TYPE XIII |

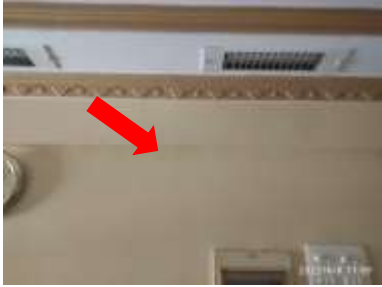
| a) | Living Room | Beam | | | Plaster with hollow sound | Refer attachment 1-TYPE XVIII |

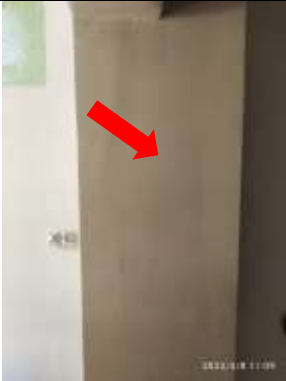
| b) | Living Room | Column C 19 | | | Column with hollow sound, plaster crack | Refer attachment 1-TYPE XVII, TYPE V |

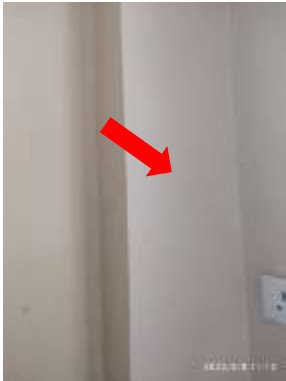
| c) | Kitchen | Column C 20 | | | Column with hollow sound | Refer attachment 1-TYPE XVII |

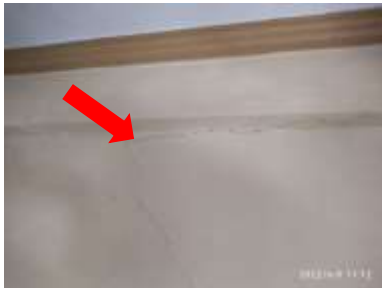
| d) | Kitchen | Beam | | | Structural crack | Refer attachment 1-TYPE VI |

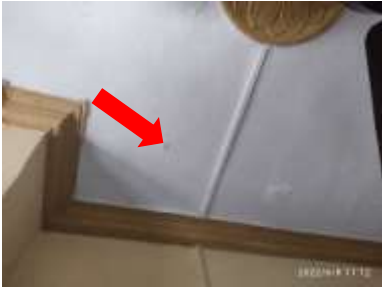
| e) | Kitchen | Ceiling | | | Ceiling cracks | Refer attachment<br>1-TYPE XIII |

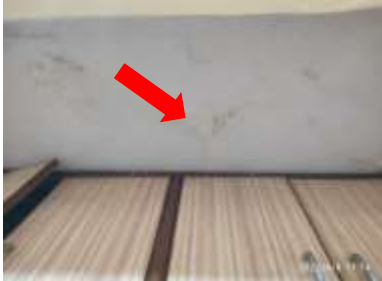
| f) | Passage | Ceiling | | | Seepages<br>from external<br>damaged<br>pipeline | Refer attachment<br>1-TYPE XI |

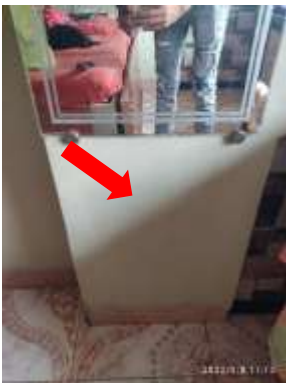
| g) | Bedroom<br>2 | Column<br>C 22 | | | Column with<br>hollow sound<br>at bottom | Refer attachment<br>1-TYPE XVII |

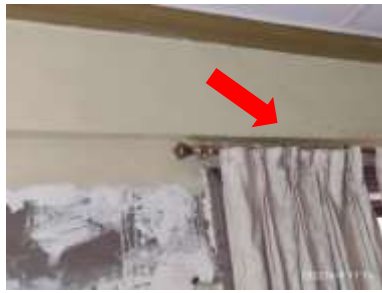
| h) | Bedroom<br>2 | Beam | | | Plaster crack | Refer attachment<br>1-TYPE V |

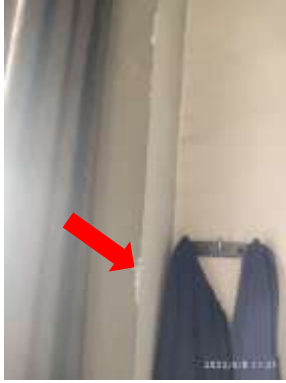
| a) | Living room | Column C 1 | | | Column with hollow sound | Refer attachment 1-TYPE XVII |

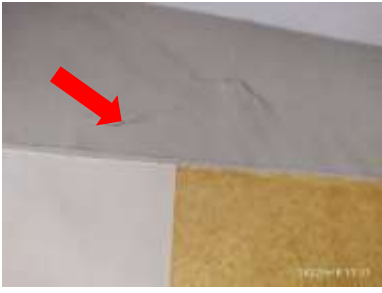
| b) | Living Room | Beam | | | Structural crack, Plaster with hollow sound | Refer attachment 1-TYPE VI, TYPE XVIII |

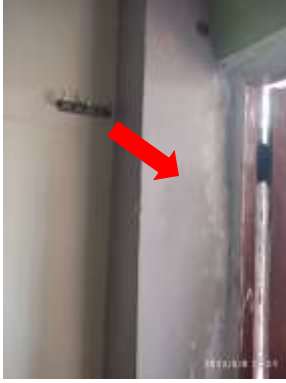
| c) | Bedroom 1 | Column C 5 | | | Plaster crack, Plaster with hollow sound | Refer attachment 1-TYPE V, TYPE XVIII |

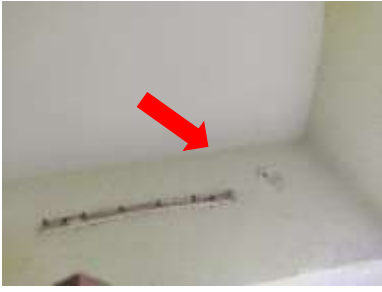
| d) | Bedroom 1 Balcony | Ceiling | | | Ceiling crack | Refer attachment 1-TYPE XIII |

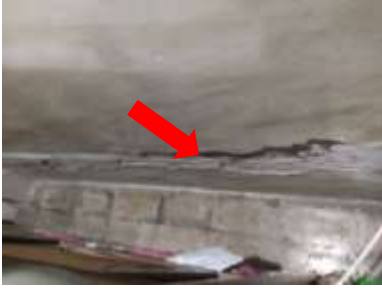
| e) | Bathroom | Ceiling | | | Ceiling cracks & seepages | Refer attachment 1-TYPE XIII, TYPE XI |

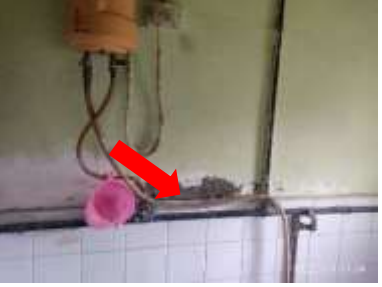
| f) | Bathroom | Wall | | | Capillary action marks | Refer attachment 1-TYPE IV |

2. Capillary action marks & leakages through Bathroom at many Flats observed. The Toilet area water proofing needs to be redone. Chemical water proofing on the sunk areas and on the walls around up to a height of at least one foot above the floor level should be done.

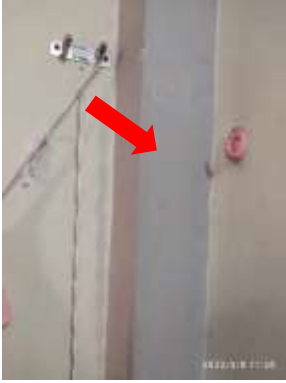
| g) | Bedroom 2 | Column C 8 | | | Plaster crack | Refer attachment 1-TYPE V |

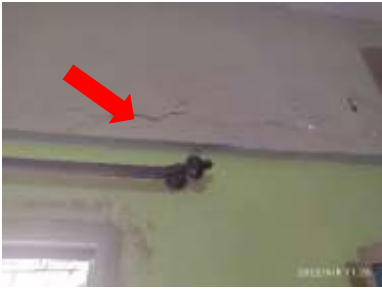
| h) | Bedroom 2 | Beam | | | Structural crack | Refer attachment 1-TYPE VI |

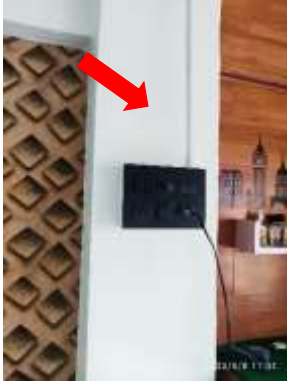
| a) | Living room | Column C 10 | | | Column with hollow sound | Refer attachment 1-TYPE XVII |

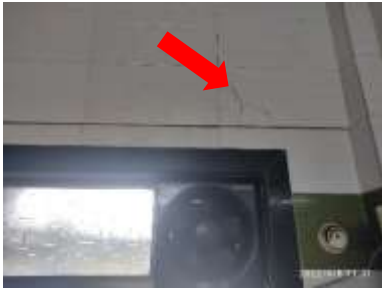
| b) | Kitchen | Beam | | | Tile crack (need to check inside) | Refer attachment 1-TYPE I |

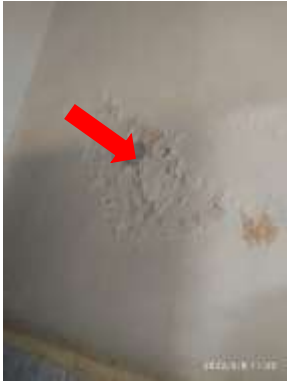
| c) | Passage | Wall | | | Seepages from adjacent bathroom | Refer attachment 1-TYPE XI |

1. Most of the leakages from the bathrooms inside the Flats & Duct damaged Pipelines (Mention in AUDIT RECORD & OBSERVATION). Leakages Sources could be leakages from pipelines embedded or the water proofing in the enclosure is not effective any more. Need to waterproof with proper methodology and check the Pipeline materials and connections.

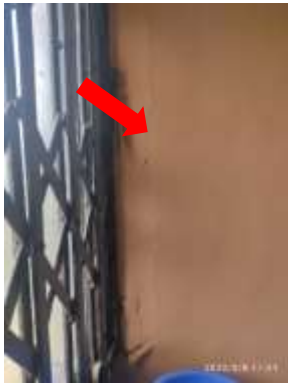
| d) | Passage | Wall | | | Plaster crack, Plaster with hollow sound | Refer attachment 1-TYPE V, TYPE XVIII |

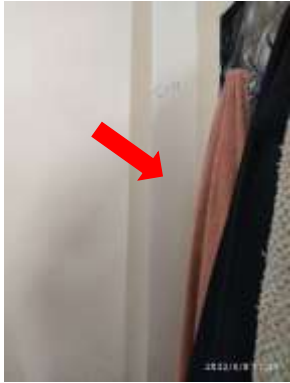
| e) | Bedroom<br>2 | Column<br>C 11 | | | Column with<br>hollow sound | Refer attachment<br>1-TYPE XVII |

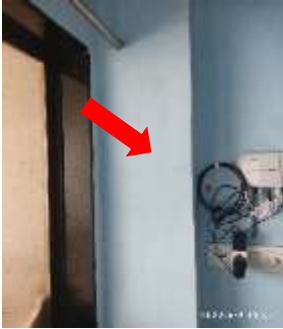
| a) | Living<br>room | Column<br>C 19 | | | Column with<br>hollow sound | Refer attachment<br>1-TYPE XVII |

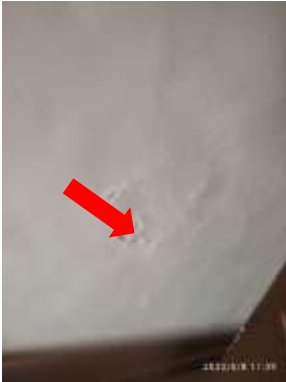
| b) | Living<br>room | Wall | | | Seepage<br>marks | Refer attachment<br>1-TYPE III |

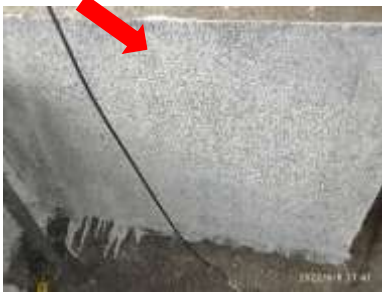
| Sr No. | LOCATION | AREA DESCRIPTION | | PHOTOS | DEFECTS | PROCESS FOR AMELIORATIONS |
|---|---|---|---|---|---|---|
| a) | Terrace | Parapet Wall | | | Plaster crack | Refer attachment 1-TYPE V |

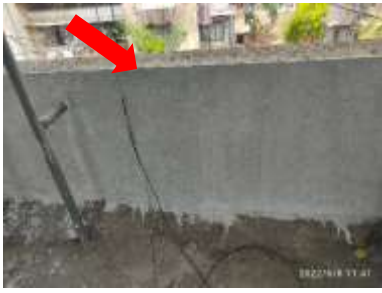
| Sr No. | LOCATION | AREA DESCRIPTION | | PHOTOS | DEFECTS | PROCESS FOR AMELIORATIONS |
|---|---|---|---|---|---|---|
| b) | Terrace | Parapet Wall | | | Plaster crack | Refer attachment 1-TYPE V |

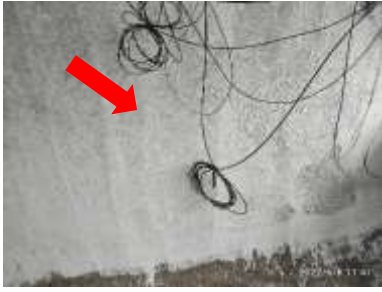
| Sr No. | LOCATION | AREA DESCRIPTION | | PHOTOS | DEFECTS | PROCESS FOR AMELIORATIONS |
|---|---|---|---|---|---|---|
| c) | Terrace | Parapet Wall | | | Plaster crack | Refer attachment 1-TYPE V |

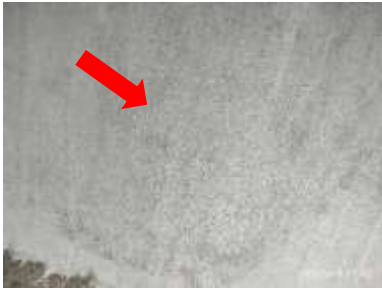
| Sr No. | LOCATION | AREA DESCRIPTION | | PHOTOS | DEFECTS | PROCESS FOR AMELIORATIONS |
|---|---|---|---|---|---|---|
| d) | Terrace | Parapet Wall | | | Plaster crack | Refer attachment 1-TYPE V |

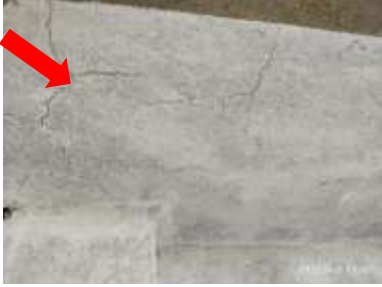
| g) | Terrace | Chajja | | | Plaster crack | Refer attachment<br>1-TYPE V |

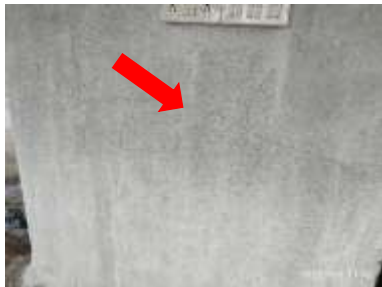
| i) | Terrace | Wall | | | Plaster crack | Refer attachment<br>1-TYPE V |

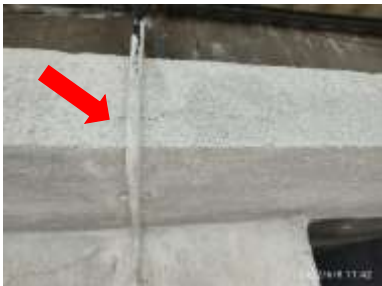
| j) | Terrace | Chajja | | | Plaster crack | Refer attachment<br>1-TYPE V |

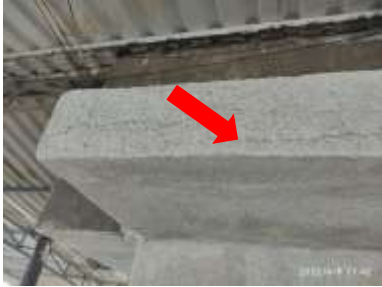
| k) | Terrace | Chajja | | | Structural crack | Refer attachment 1-TYPE VI |

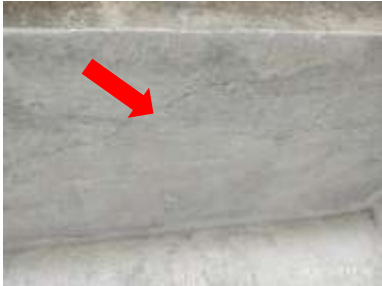
| n) | Terrace | Chajja | | | Structural crack | Refer attachment 1-TYPE VI |

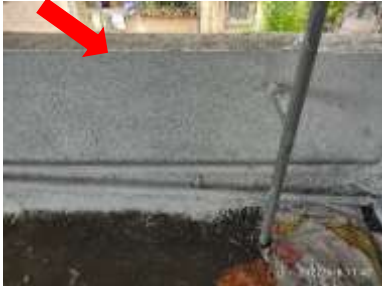
| s) | Terrace | Parapet Wall | | | Plaster crack | Refer attachment 1-TYPE V |

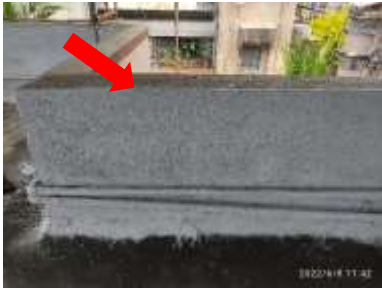
| t) | Terrace | Parapet Wall | | | Plaster crack | Refer attachment 1-TYPE V |

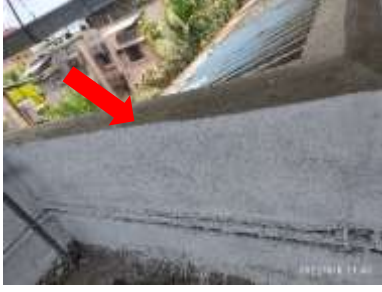
| u) | Terrace | Parapet Wall | | | Plaster crack | Refer attachment 1-TYPE V |

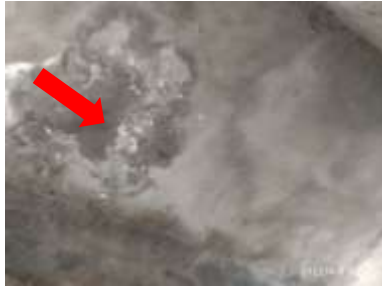
| a) | Mumpty room | Ceiling | | | Seepages from water tank | Refer attachment 1-TYPE XI |

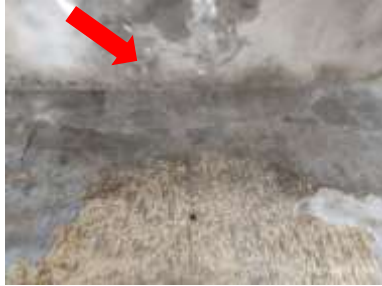
| b) | Mumpty room | Beam | | | Structural crack | Refer attachment 1-TYPE VI |

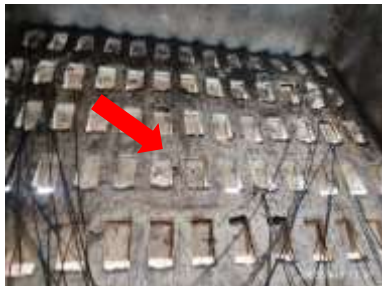
| c) | Mumpty room | RCC grills | | | Plaster cracks | Refer attachment 1-TYPE V |
